# **National Oceanography Centre**

## **Cruise Report No. 03**

### **RRS *Discovery* Cruise 360**

Trials of the Autosub LR AUV, HyBIS, PELAGRA,  
Ellsworth Camera and MYRTLE-X Lander systems

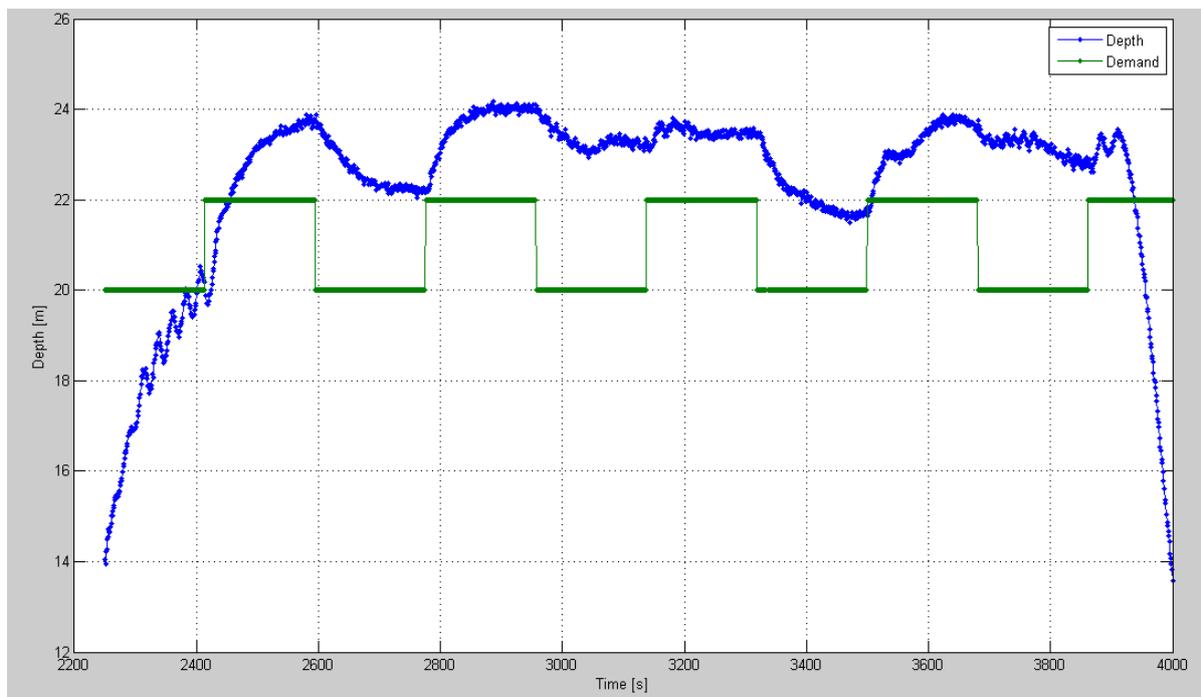
Figure 2. Depth Demand (green), and achieved depth for mission 9. Due to fault, the AUV lost control at 3900 seconds, and the mission was aborted.

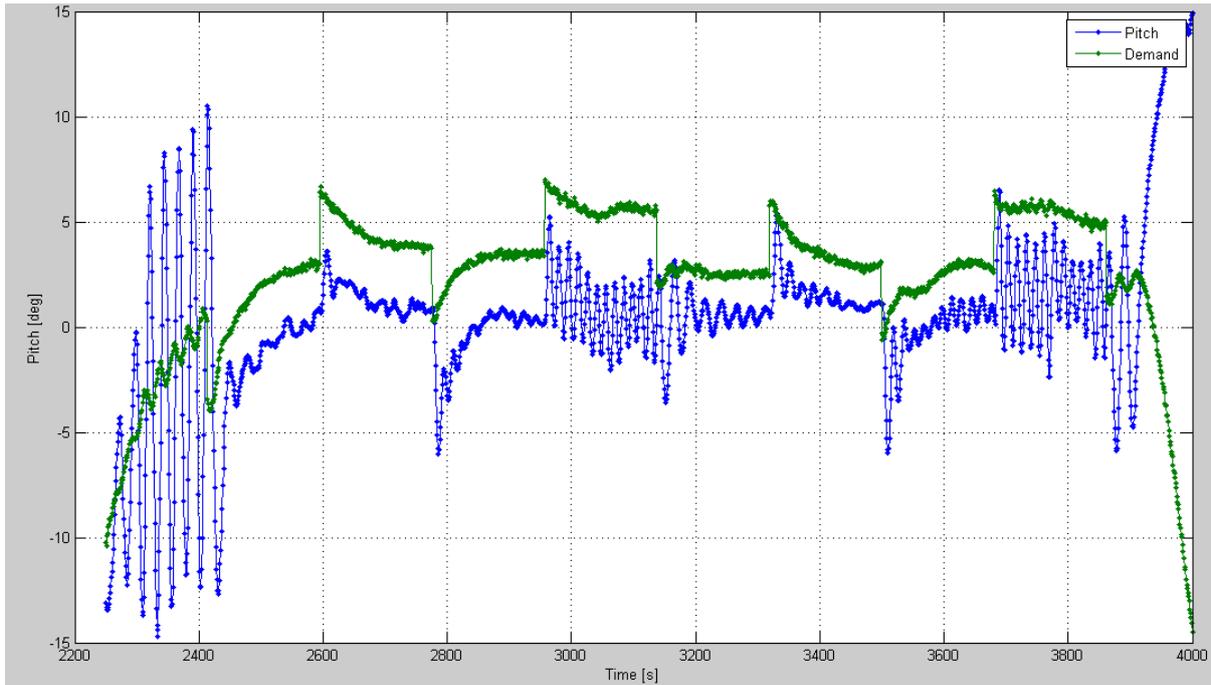
Figure 3. The Pitch demand (green), and pitch achieved for the set of control coefficients. The best control was achieved for the first three sets of control parameter at the start of the run. Best results are for  $I = 0.05$ ,  $P = 0.6$ , where  $P$  and  $I$  are the control coefficients (2<sup>nd</sup> demand, 2600 to 2750 seconds). The start of the test begins at 2400 seconds.

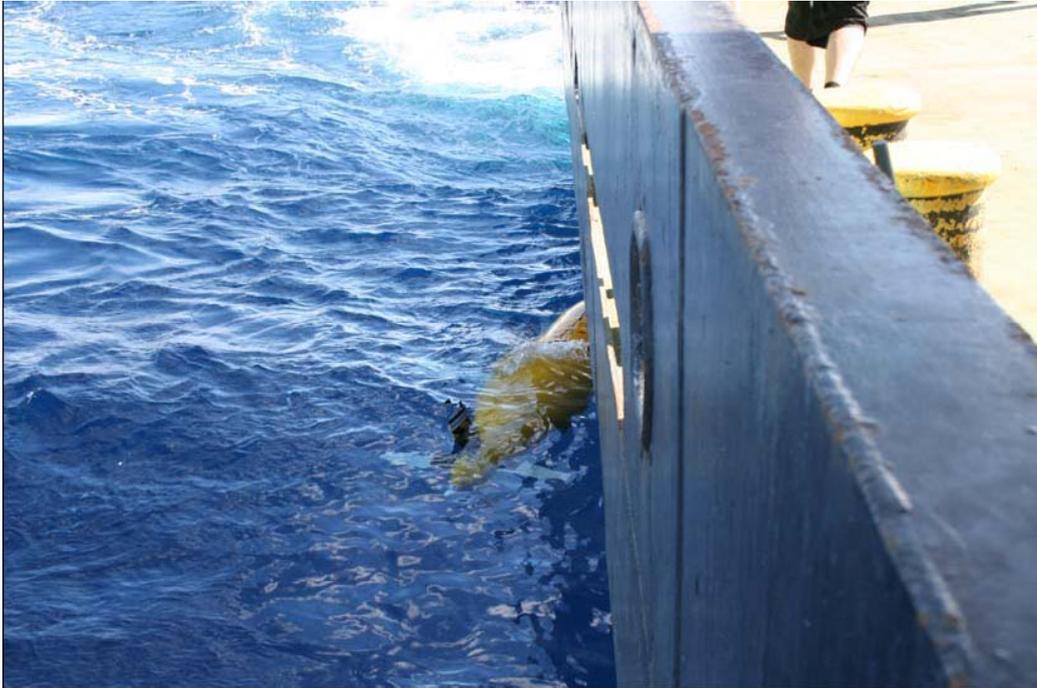
*Figure 7. Autosub LR disappearing under Discovery's starboard quarter. The command to stop the ships propeller was issued*

The AUV was launched as usual from the starboard side, but difficulties with release of the sea catch (it taking several attempts over several seconds) , meant that the AUV was not orientated ideally (at right angles to the ship , or slightly forward pointing), when it entered the water. In addition the tail handling line was released before the sea catch, hence we lost control of the AUV orientation at that point.

With the AUV drifting towards the starboard quarter, the ships side attempted to swing the ships head to starboard with starboard rudder and moderate propeller RPM. Unfortunately , with the AUV now close to the ship, this only had the effect of sucking the AUV under the counter and towards the propeller. At this point the request was made by the PSO to stop the ship's main propeller. This (fortunately) was executed almost immediately, preventing much more serious damage to the AUV.

The AUV surfaced on the starboard side. Initially the severity of the damage was not noticed. Following recovery, however, it was noticed that the propeller motor end cap assembly had been hit partially off, and the only thing preventing the propeller assembly being lost was the magnetic coupler

attraction. Flooding of the motor assembly destroyed that system, and consequential to that, voltage from the main power bus were able to short circuit onto the I2C bus, causing irreparable damage also to the sternplane and rudder controllers.

We had enough spares to effect repairs, and the vehicle was operational 2 days later.
