Mooring cruise report *JR 140*

Peter Enderlein

WCP performance/replacement of connectors/installing of new firm ware and new insulation board:

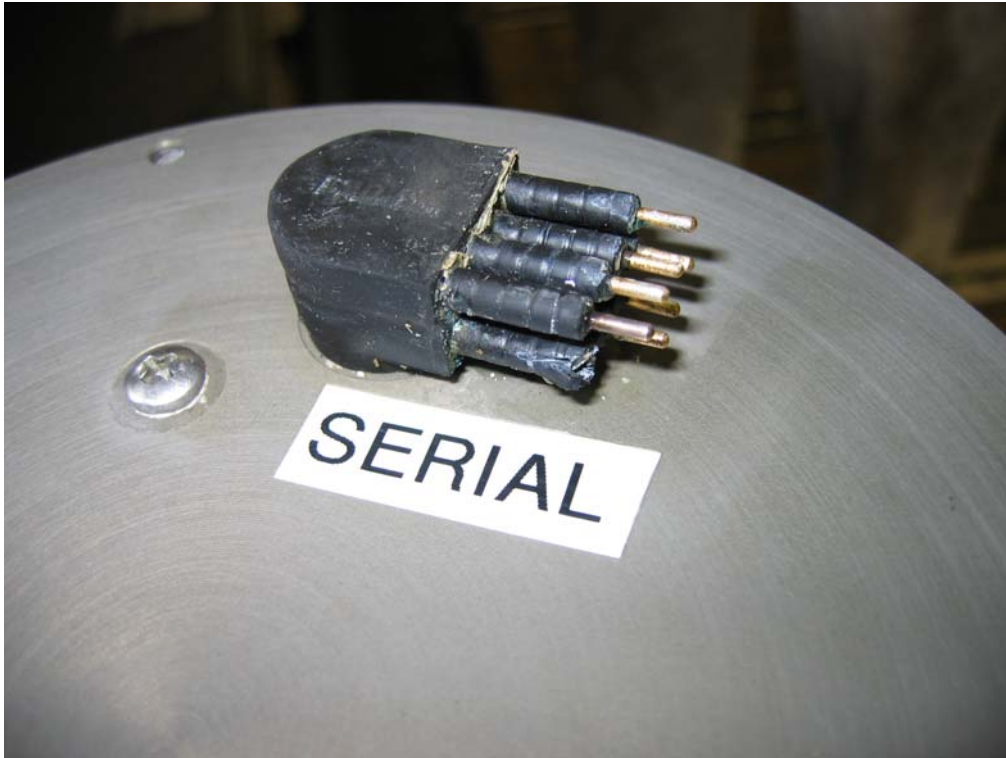
On the 31.12.05 the work started on WCP 1004: The pin on the serial port was fully disintegrated now. The O-Ring on the purge plug was also disintegrated. Also there was corrosion found around the O-ring where the screw hits the face plate (pic. 1). When the serial connector was replaced corrosion was also found around the connector where again the connector hits the face plate. On the long term this is something we have to look into a bit more, it will come to a point where the corrosion will become so heavy corroded that the area around the purge plug and the two connectors will become not longer water tide. During the replacement of the connector we could not find any connector for the ribbon cable so all cable were soldered instead. After the replacement of the connector and the installation of the new insulation board the unit was power

Pic. 1: corroded connector on WCP 1004

ASL provided us with a new connectors, a new firm ware and a new developed insulation board to repair and upgrade both units, after the corrosion problems we encountered after the deployment after last.

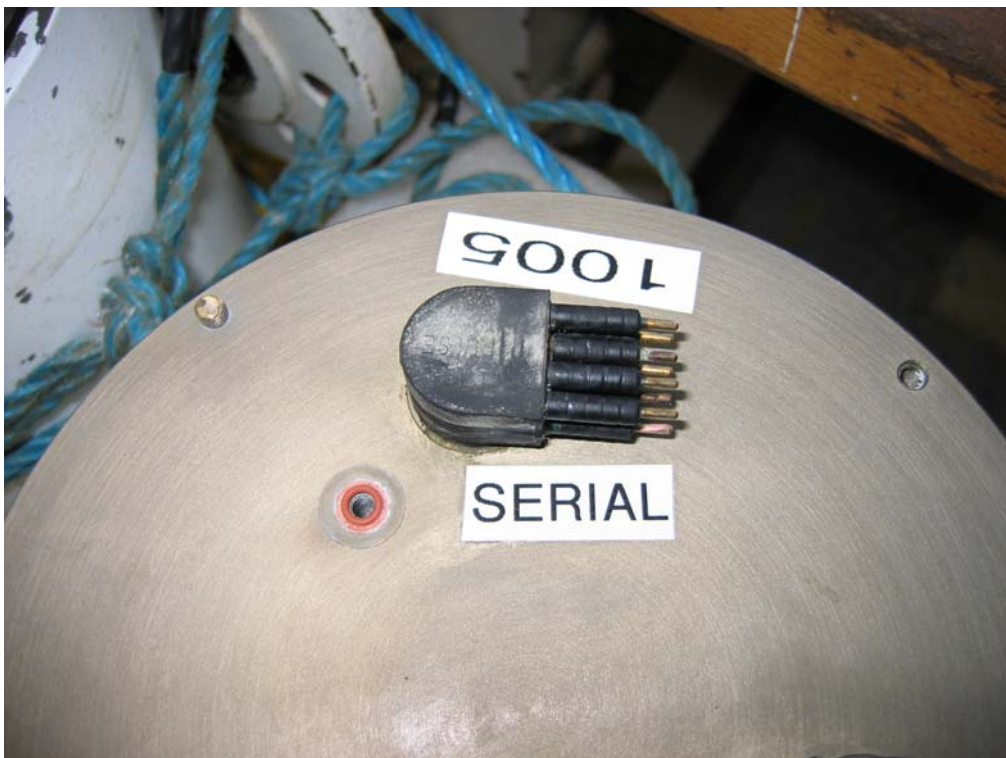
Thereafter the unit WCP 1005 was checked. Because there were no data on the unit 004 we decided to try to connect to the unit before taken it apart to avoid any possible influence due to the work carried out on the unit. The pin on the serial port was corroded but it was possible to establish connection to the unit. The internal clock showed: 02/09/30 17:17. The check afterwards for data revealed that the unit 005 did not had work either, as there was no file on the unit (pic 6). All this work on unit 005 was done without external power and before opening the unit! The removal of the purge plug and the serial connector showed the same corrosion like on unit 004. So something must be done to stop the corrosion otherwise it will come to a point when on of the six O-ring will not longer seal and water will get into the units (pictures 2,3,4,5).

Pic 2: less corroded connector on WCP 1005 with purge plug removed showing disintegrated O-ring and corrosion around

The replacement of the connector and the new board was done afterwards and an other check for a file on the unit conducted, but without any success.

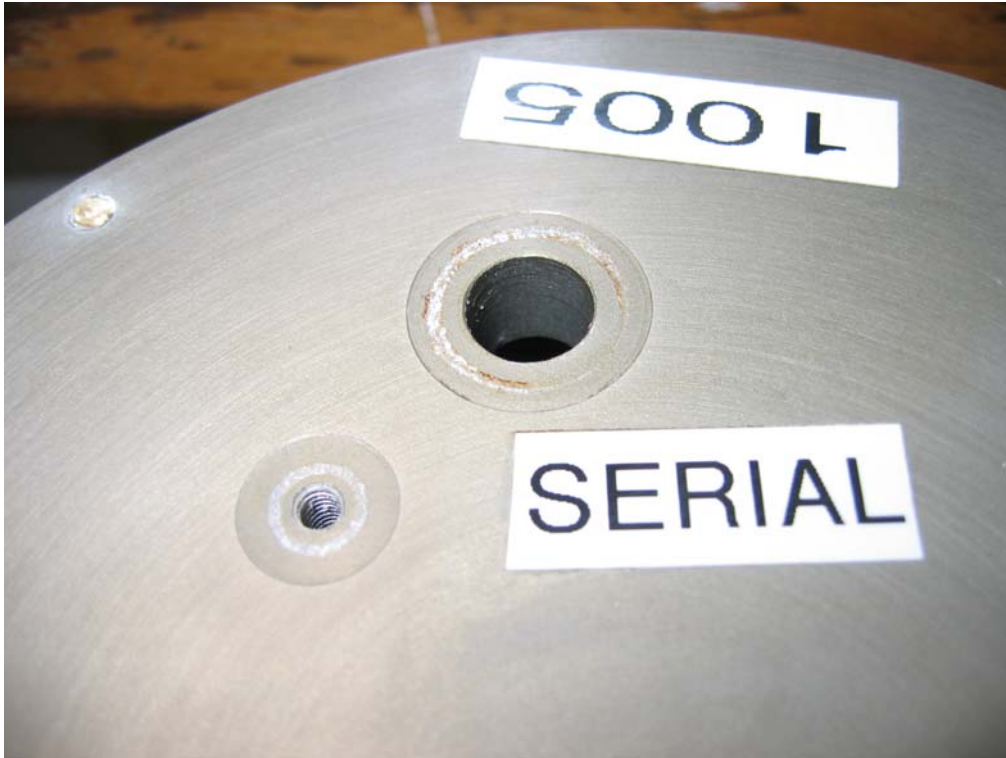
Pic 3: corrosion found around serial port and purge plug on WCP 1005

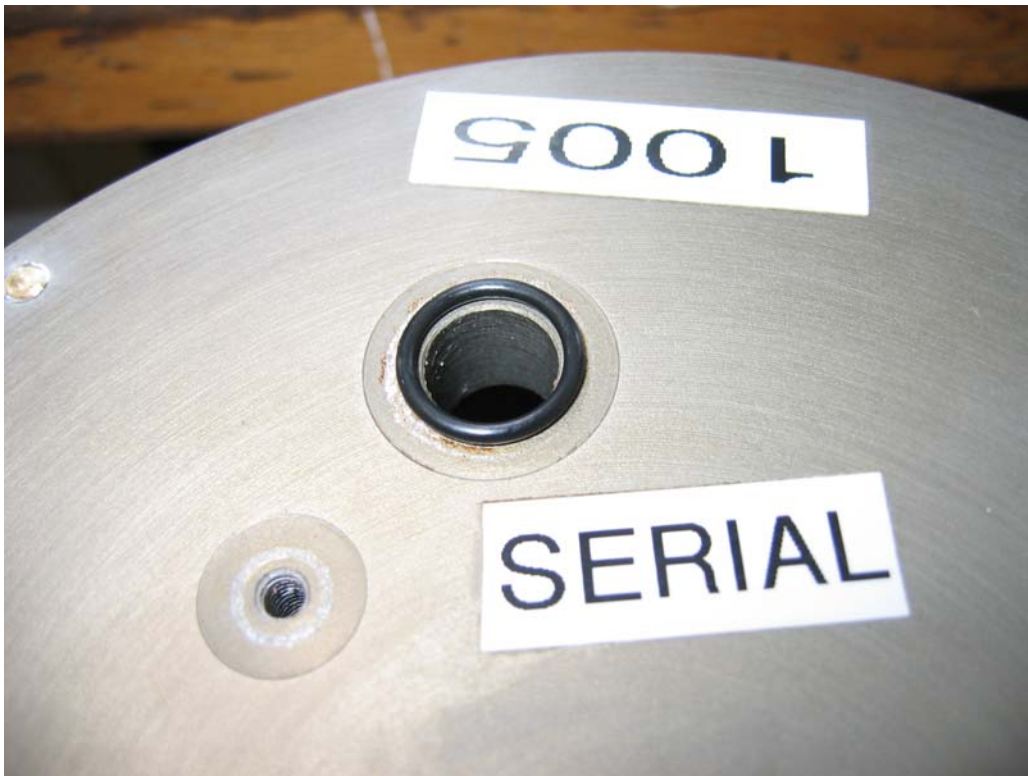
Pic 4: corrosion compared to location of O-ring of serial connector

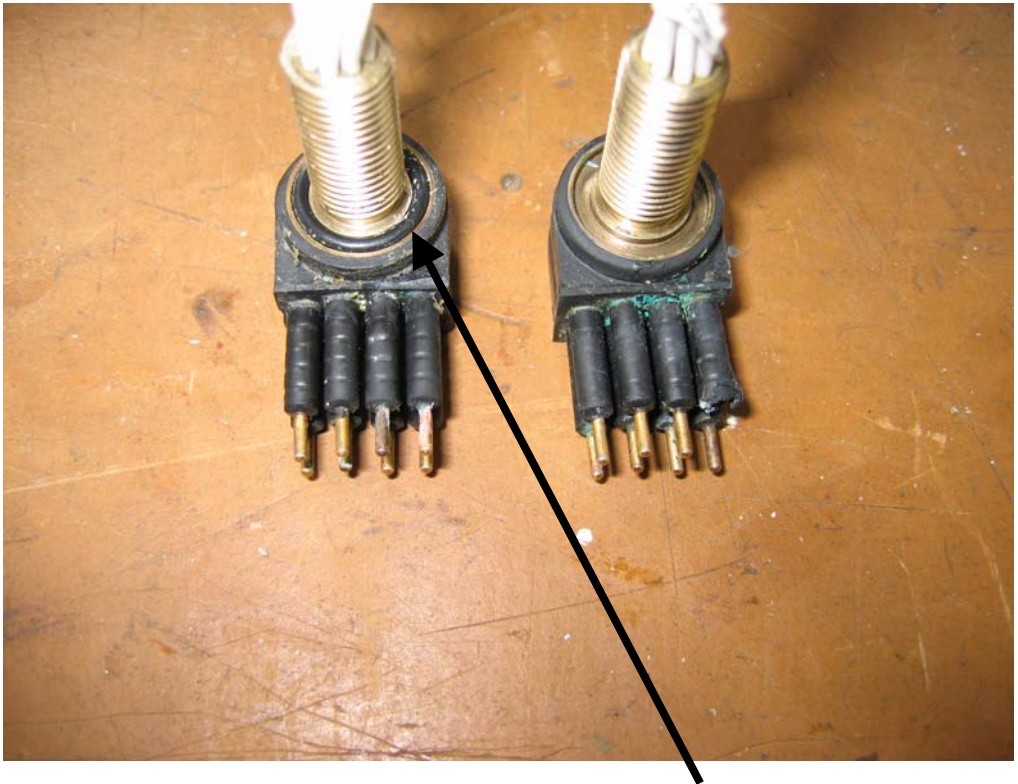
Pic 5: both removed serial connectors showing the brass? which caused the corrosion

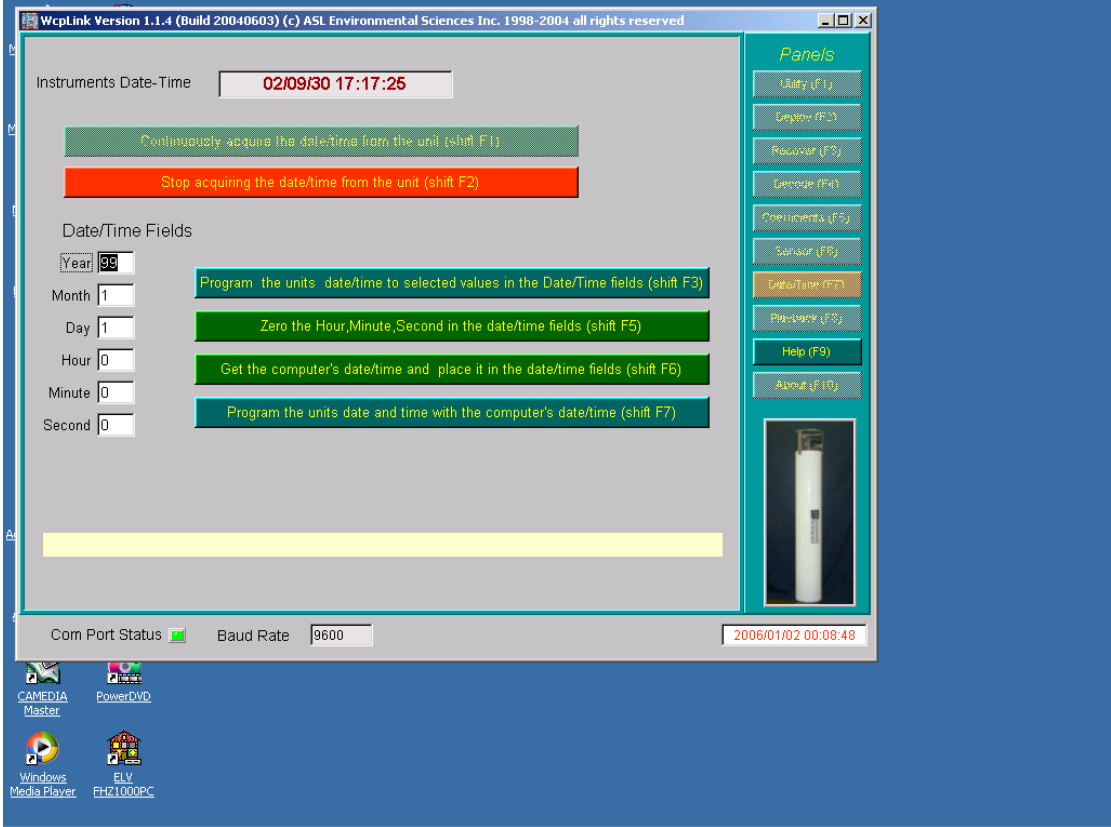
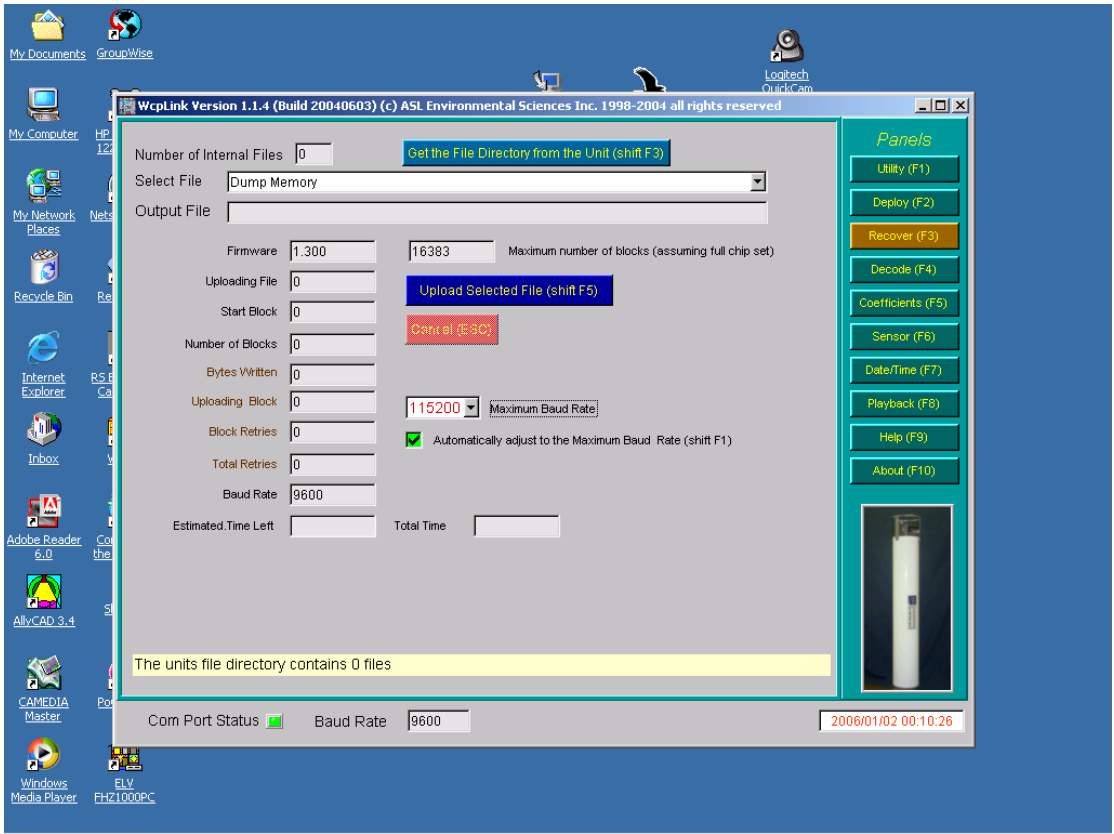
Pic 6: screen dumps of the time and the file directory of WCP 1005

Therefore decision was made to replace the firm ware, the clock battery and the main battery and to deploy unit 004 for a short test deployment in Rosita harbour prior to the ships hull echo sounder calibration. The unit work fine, but we had problems picking up the pings with a radio on 600 – 900 kHz, no real signal was detect. Also the Excel file provided a total wrong time stamp, but that is probably an Excel problem the file cam out as: 06/01/2001 instead of 01/01/2006. Both units were than programmed and deployed on the two moorings.
