# **RRS James Clark Ross**

## **JR99 Cruise Report**

**Cruise JR99**

**Equipment trials (swath bathymetry, TOPAS sub-bottom profiling, SSU,  
magnetometers)**

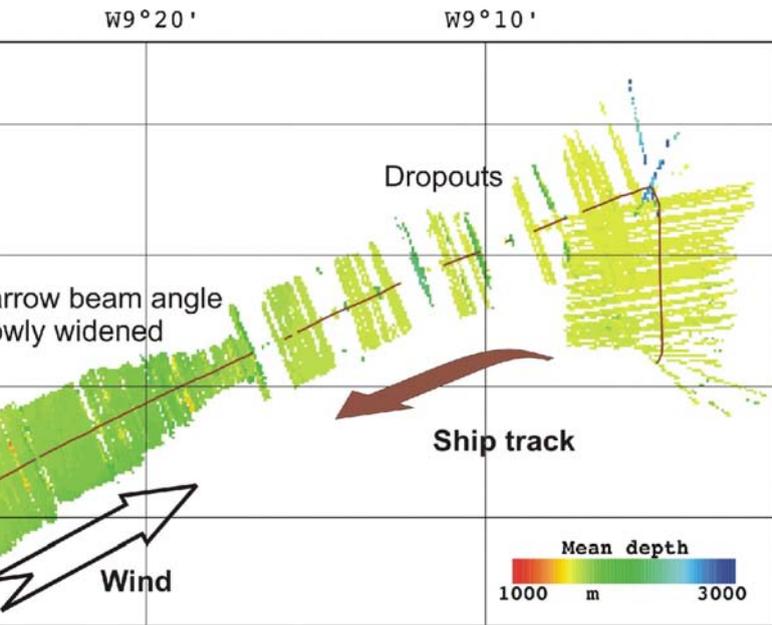
Figure 2. Poor-quality swath data acquired while the ship was head to wind in a gale. Frequent dropouts occurred in very gusty wind conditions and a short, steep sea. As conditions improved slightly we were able to widen the beam angle from 20° to 50° and obtain acceptable data.

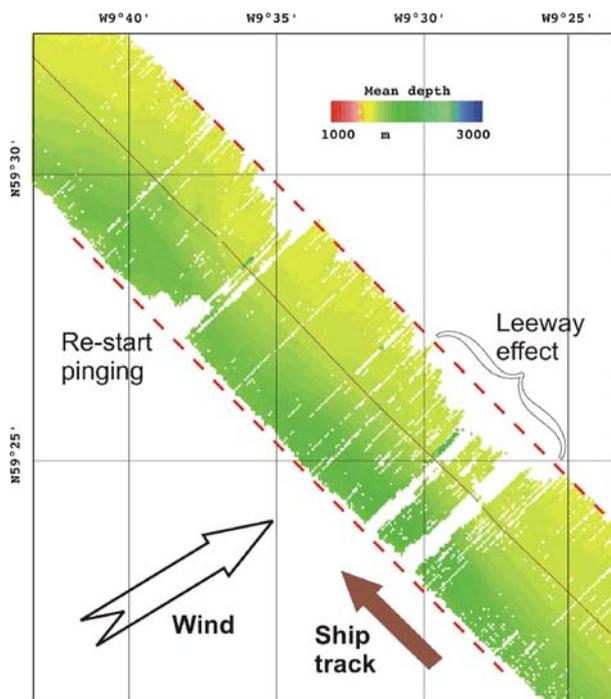
Figure 3. Effect of leeway on quality of swath data. In only a moderate wind on the beam, low ship speed (4 knots) results in 6-7° of leeway and frequent dropouts. At 6 knots and 3° of leeway, loss of signal is observed on the downwind side.

At 8-10 knots and negligible leeway, data quality is good.

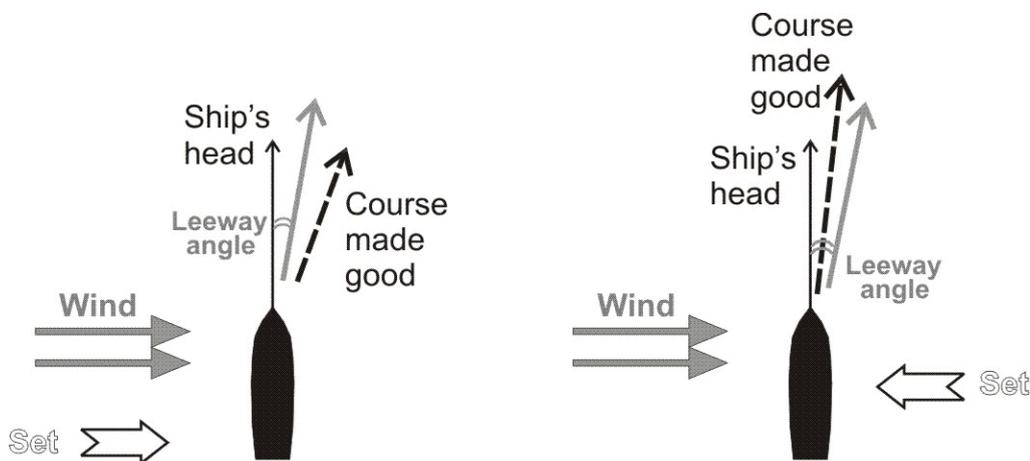
Fig. 7. Leeway affects the EM120 when the ship is pushed sideways through the water by the wind. GPS displays include the ship’s heading and the course made good. The ship can also be set sideways by a current. If set and wind are in the same direction, the leeway is less than the difference between heading and CMG, i.e. the data are degraded less badly than you might expect. Conversely if the set is pushing the ship up into the wind things will be worse.

The problem is also worse the slower the ship is going, e.g. if required to steam at 4-5 knots towing seismic equipment. In sea states of 5 or more it is advisable to choose courses which run up- or downwind. For example during JR99 we obtained 13 hours’ worth of acceptable data on August 21-22 while the ship was steaming at 5 knots head to wind in a gale. If up-wind or downwind courses take the ship away from the work area, you may as well stop until the weather improves.

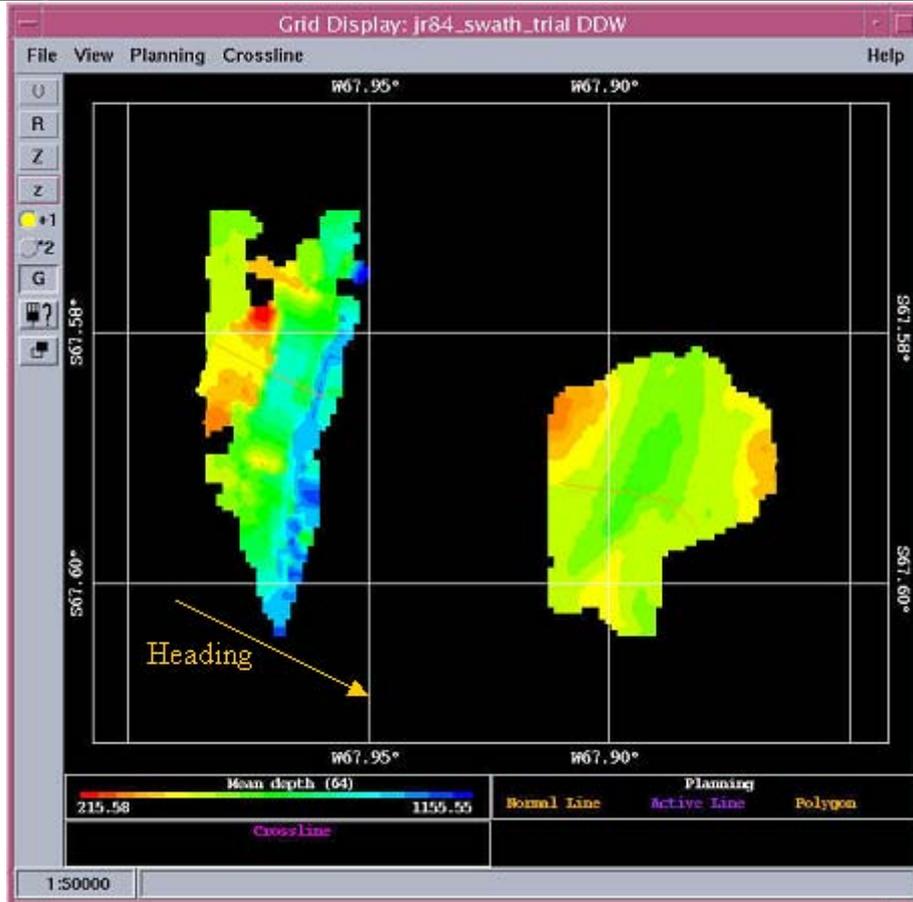
Good response from the EA500 in these conditions when in normal ping mode and active. EM120 lost signal.
