# Terschelling (Autosub / Simpson) 2006 Cruise Report

Steve McPhail, Maaten Furlong, James Perrett, Andy Webb, Dave White.

23<sup>rd</sup> July 2006

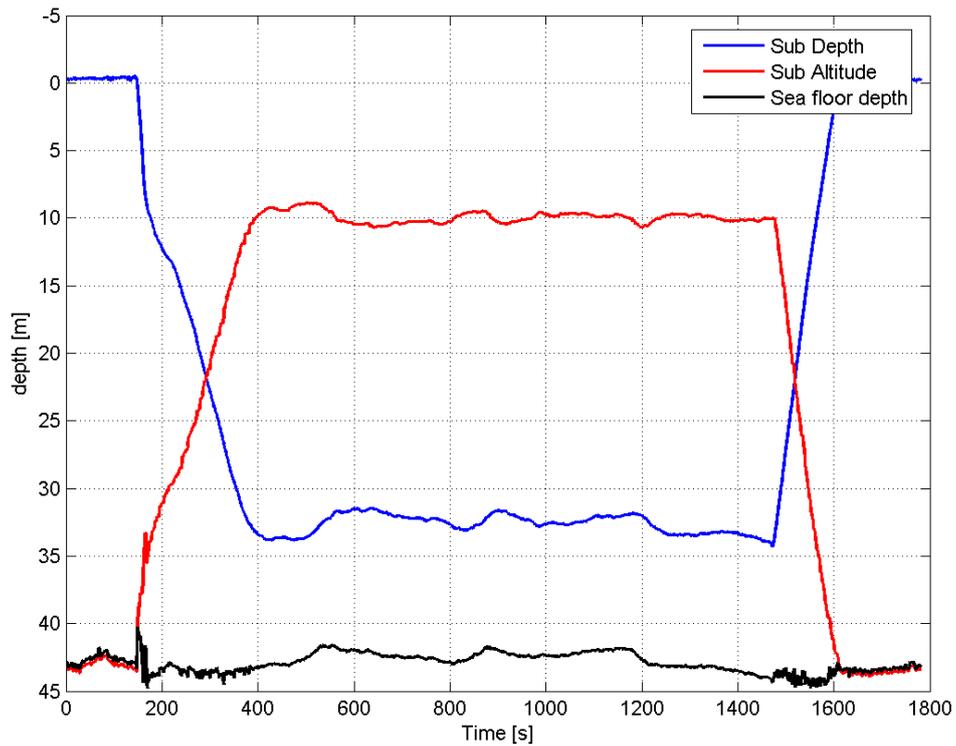
Figure 1. Depth Profile for Mission 405 (TRIAL). The vehicle was run at constant altitude mode (10 m), as a test that close to seabed altitude control would be safe for the later missions.

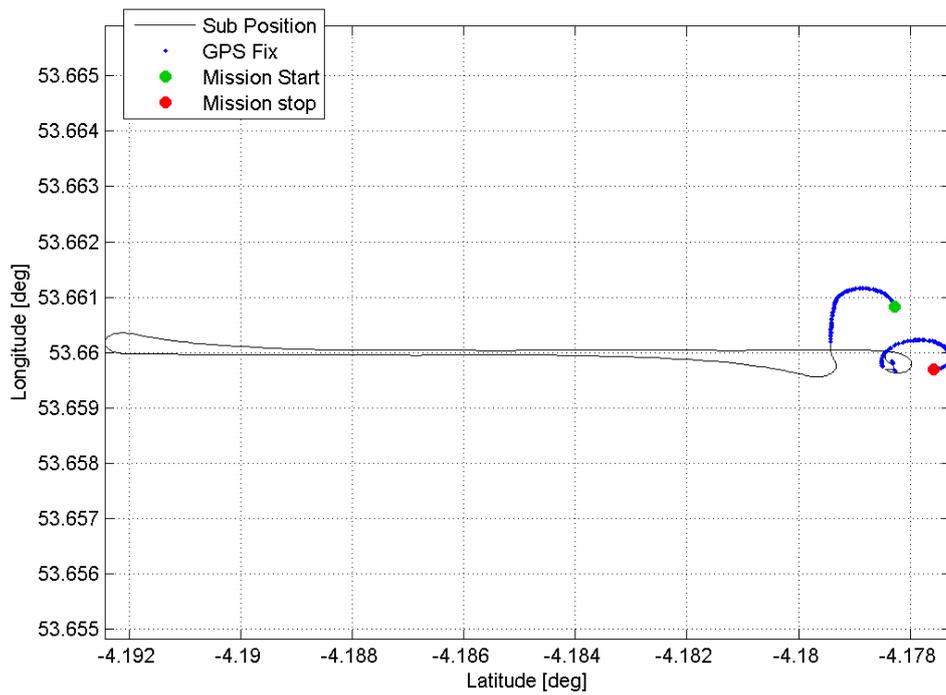
Figure 2. Navigation plot for Mission 405 (TRIAL). The navigation is raw (uncorrected), hence the small jump in position at the end of the mission.

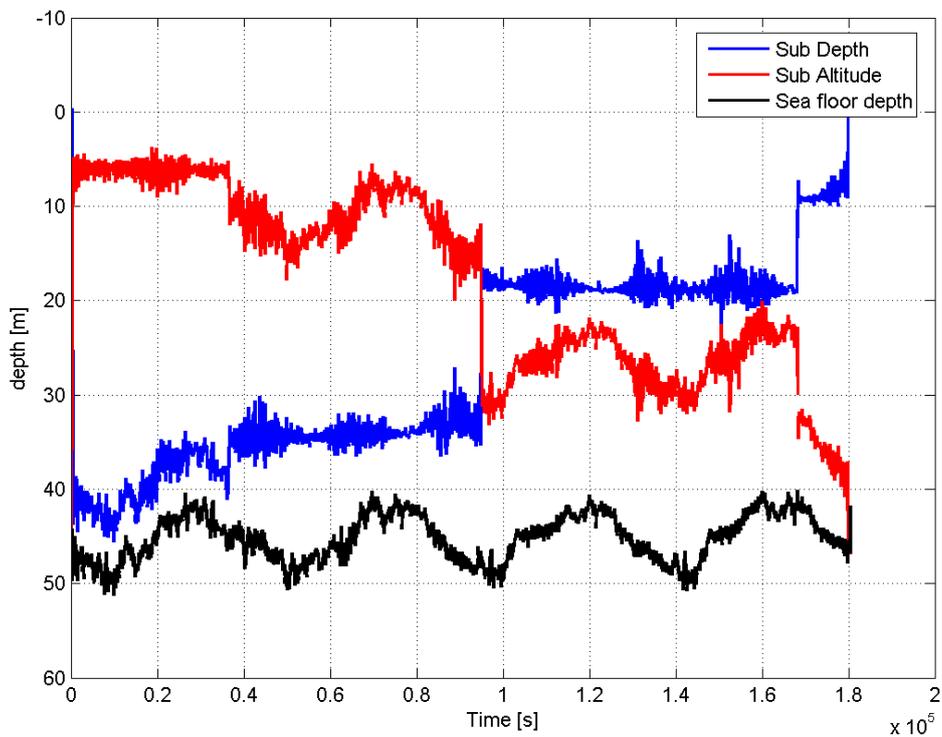
Figure 3. Depth profile for mission 406 (MLB). Minimum altitude was set to 6m for the first leg. The variations in depth seem to be correlated with the state of the tidal flow, and presumably turbulence. The 7 m variation in water depth due to the tidal range is clear (black trace).

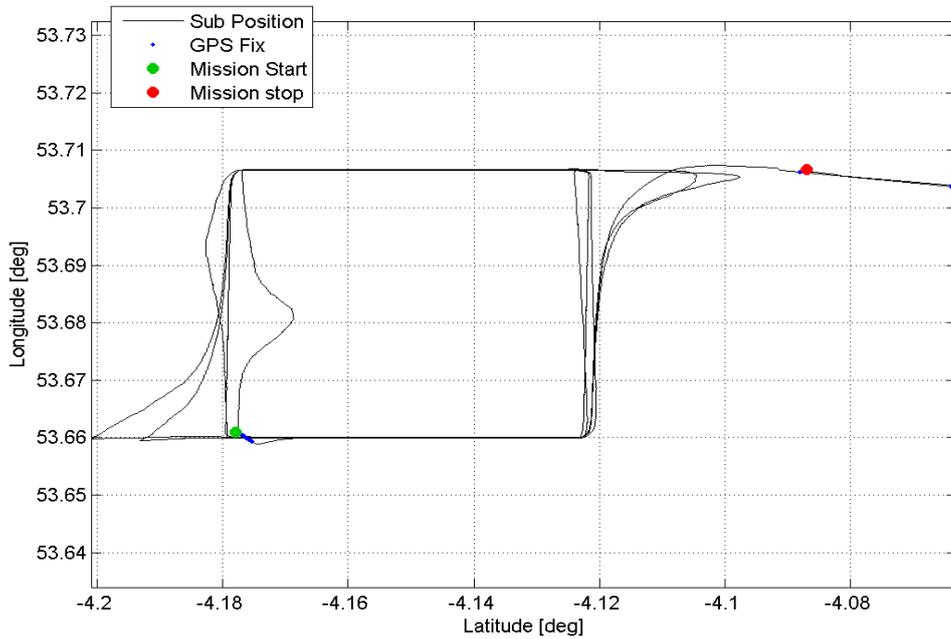
Figure 4. Navigation plot for mission 406 (MLB). Note the large excursions from the planned track due to currents. The mission ran anti clockwise starting from south west waypoint (heading east). The large apparent excursion in the North East corner was due to a single outlier GPS fix at the end of the mission.

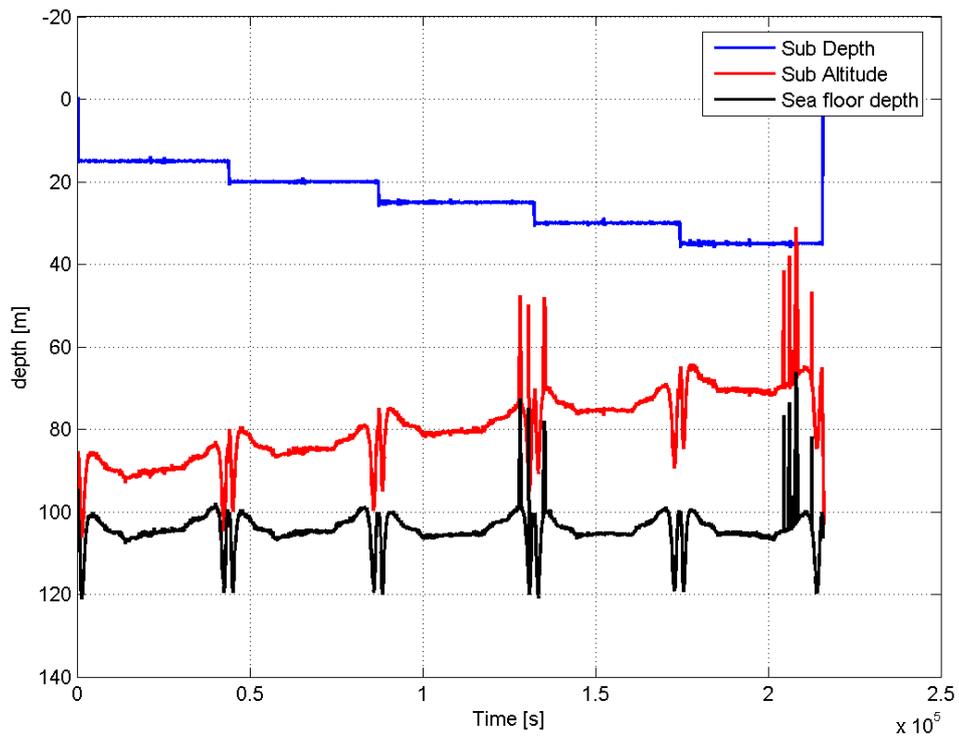
Figure 5. Depth profile for mission 407 (SWIS). The excursions of altitude and water depth at the depth changes are artefacts due to the changing pitch of the vehicle at depth changes. Note the much improved depth control compared to the previous mission.
