SOUTHAMPTON OCEANOGRAPHY CENTRE

Internal Document No. 62

CTD Data Quality on Discovery Cruise D242

September-October 1999

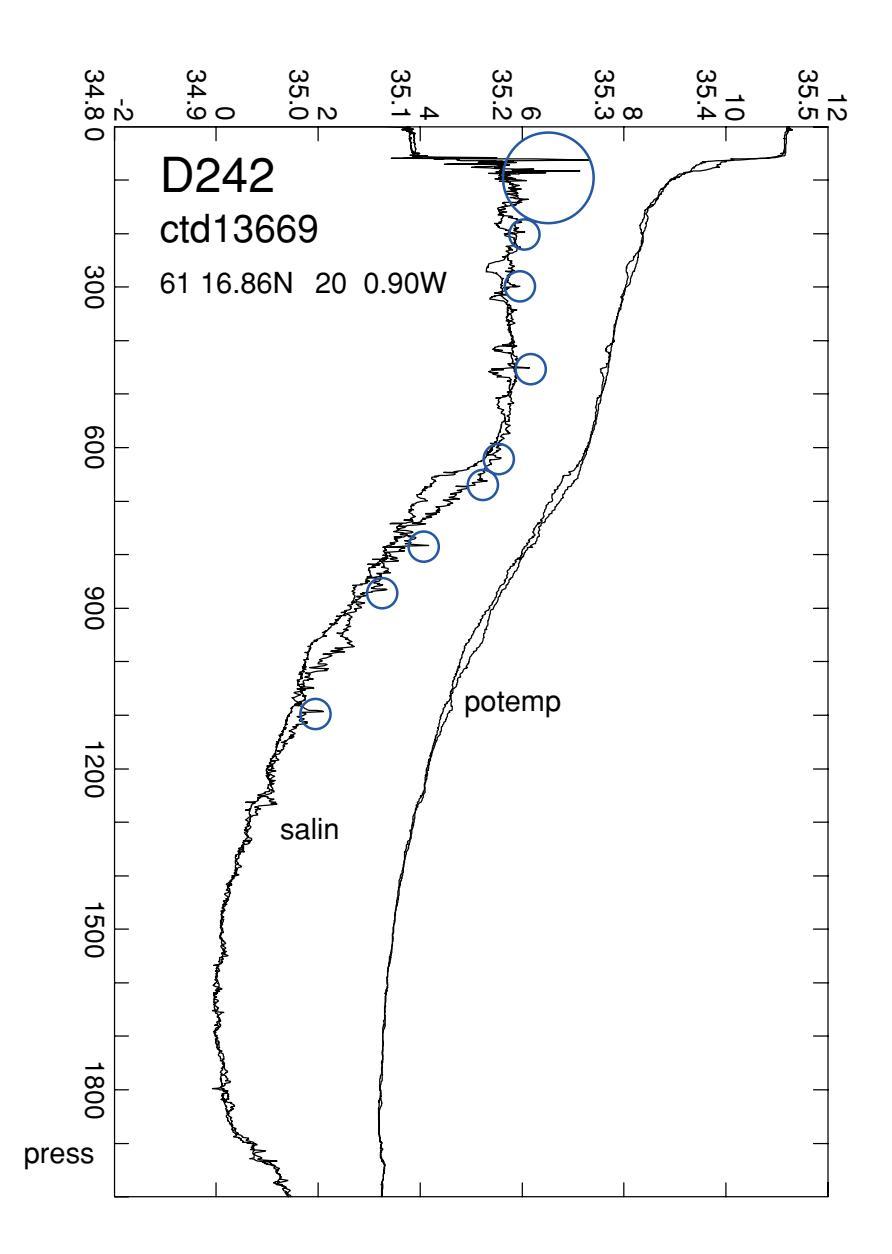
than the up-casts, and the spikes towards higher salinity were larger in regions of stronger vertical temperature gradients. Visual comparison of the 1hz data from a CTD station near 61° 20'N, 20°W (D242 station 13669) with nearby stations occupied on D230 (FOUREX station 118, Bacon 1998) and D233 (CHAOS station 13507, Smythe-Wright, 1999) showed that the D242 stations exhibited substantially more and larger spikes in salinity than the previous cruises (Figure 1). The spikes were generally of order 0.005-0.01 but reached up to 0.05 in high salinity and temperature gradients. Figure 2 contains Temperature-Salinity plots which illustrate the problem well; Figure 2a shows an example from the high gradient water in the Faroe Bank Channel, with decreased amount of spiking on up-casts compared to the down-casts at the same station. It is clear that averaging that down-cast profile would cause the data to be anomalously salty compared to the up-cast. Figure 2b shows the relatively few spikes and similar down- and up-casts from D230.

Figure 1 -Temperature and Salinity profiles from 3 cruises in approximately the same location. Data shown are 1hz data from up and down-casts; a) D242 Station 13669 with examples of spikes highlighted by circles.

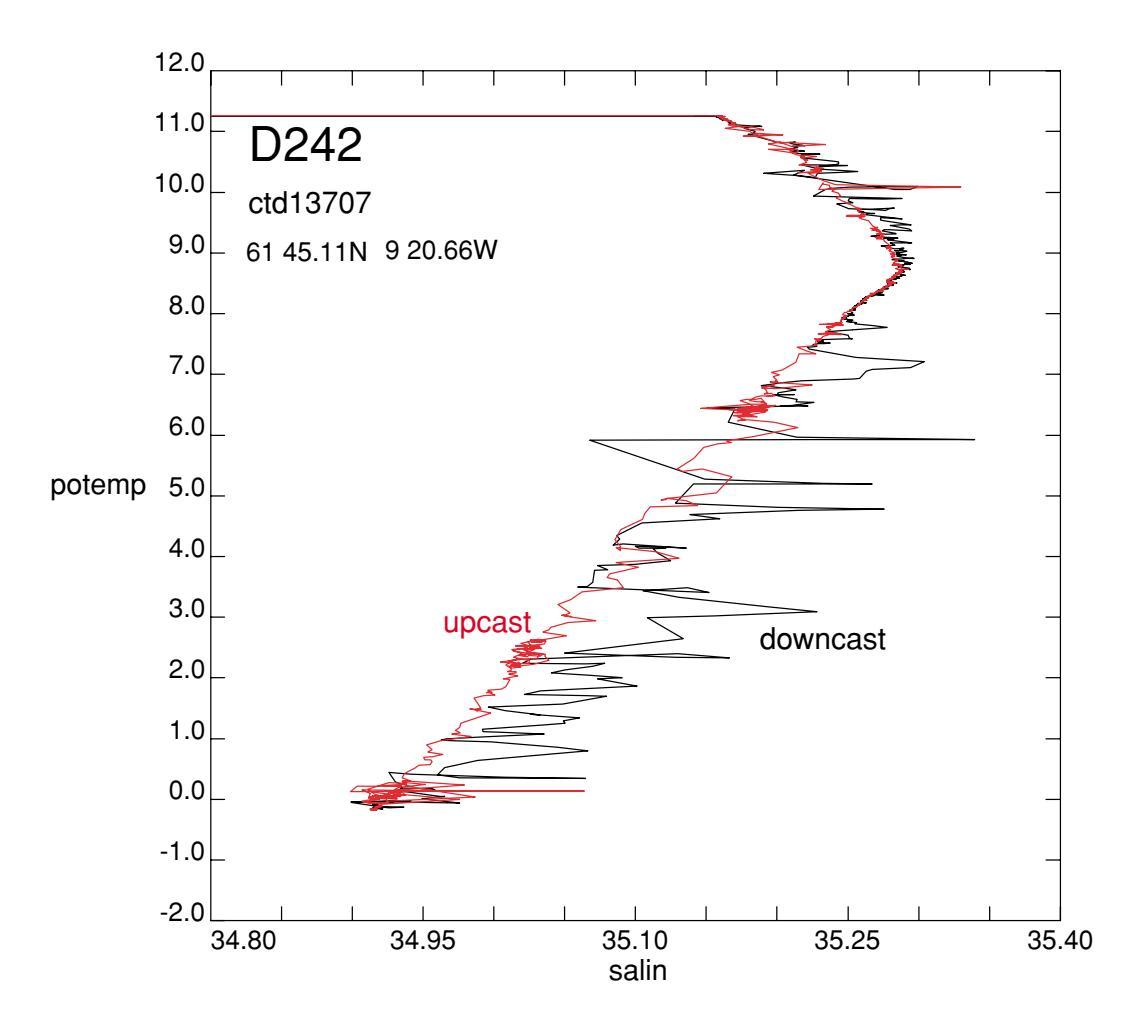
Figure 2a - Temperature-salinity plot for D242 station 13707 in the Faroe Bank Channel with very strong salinity and temperature gradient producing very bad spiking in the deep water. Data shown are 1hz; down-cast is in black, up-cast in red.

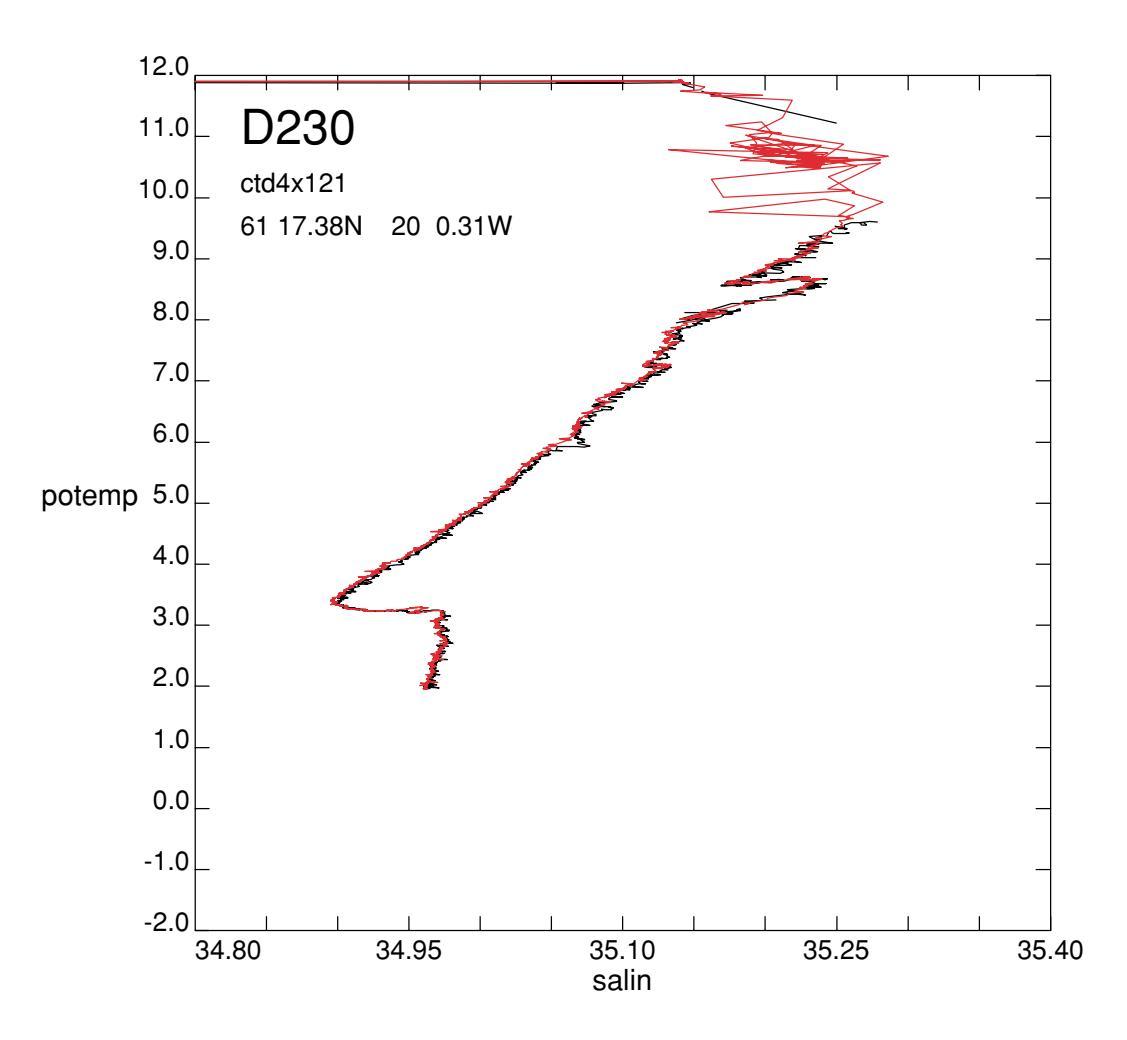
Figure 2 - Continued b) FOUREX Station 118. Data shown are 1hz; down-cast is in black, up-cast in red.

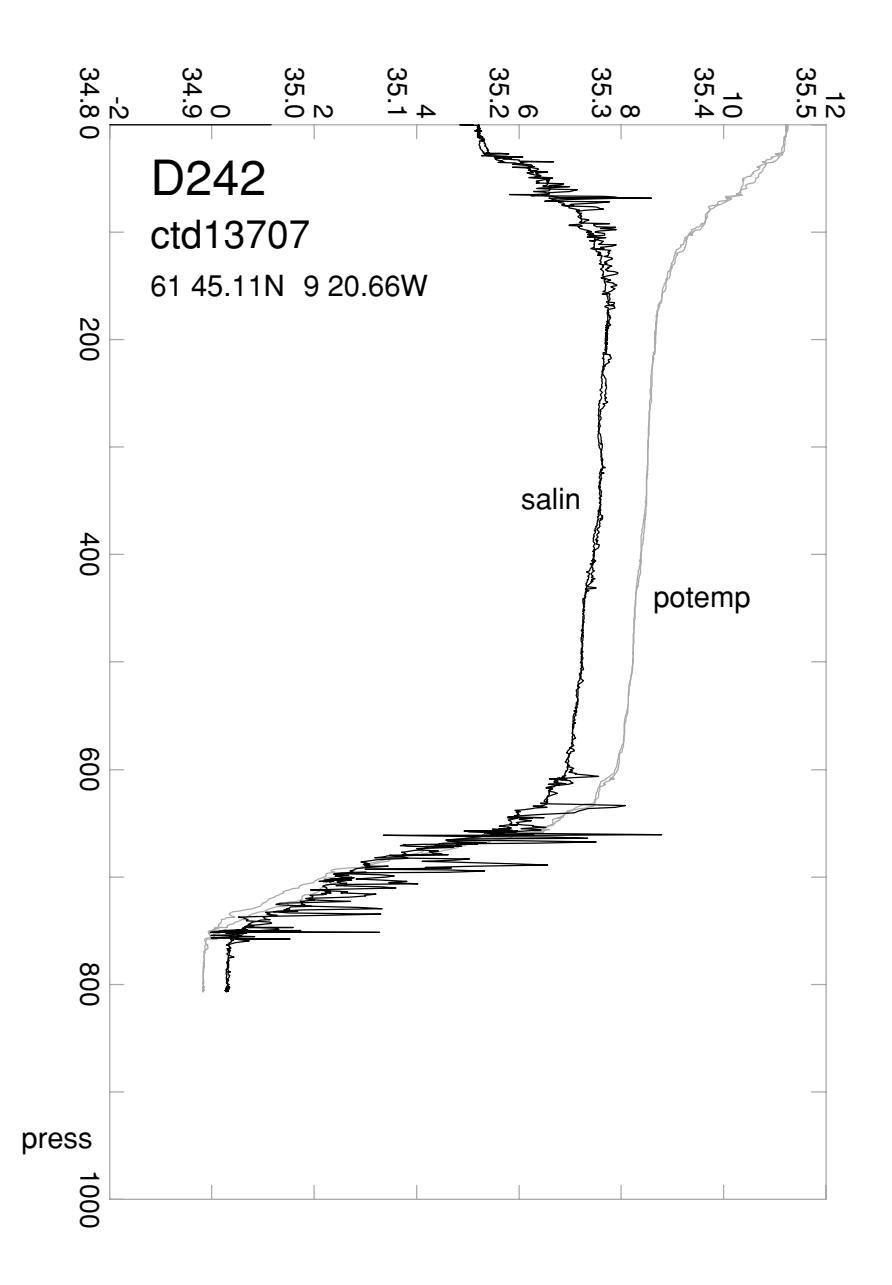
During D242 some difficulties were experienced with the operation of the Lowered ADCP (see Cunningham 2000) and 3 different instrument/frame set-ups were used. Most stations were completed with the borrowed WHOI 30° LADCP which has a relatively short pressure case (e.g. 13707), one was completed with no LADCP in the frame (13732), and one with the usual SOC 20° LADCP used on D230 and D233 (13738). The difference between these 3 profiles in similar locations is very striking; the worst spiking is in ctd13707, it is reduced at ctd13738, and ctd13732 shows very peculiar oscillating spikes (Figure 3). These remarkable changes associated with the LADCP case changes suggested that the instrument set-up in the frame may have been contributing to the noise problem.

a) 13707 with the WHOI 30° LADCP (used on most D242 stations).

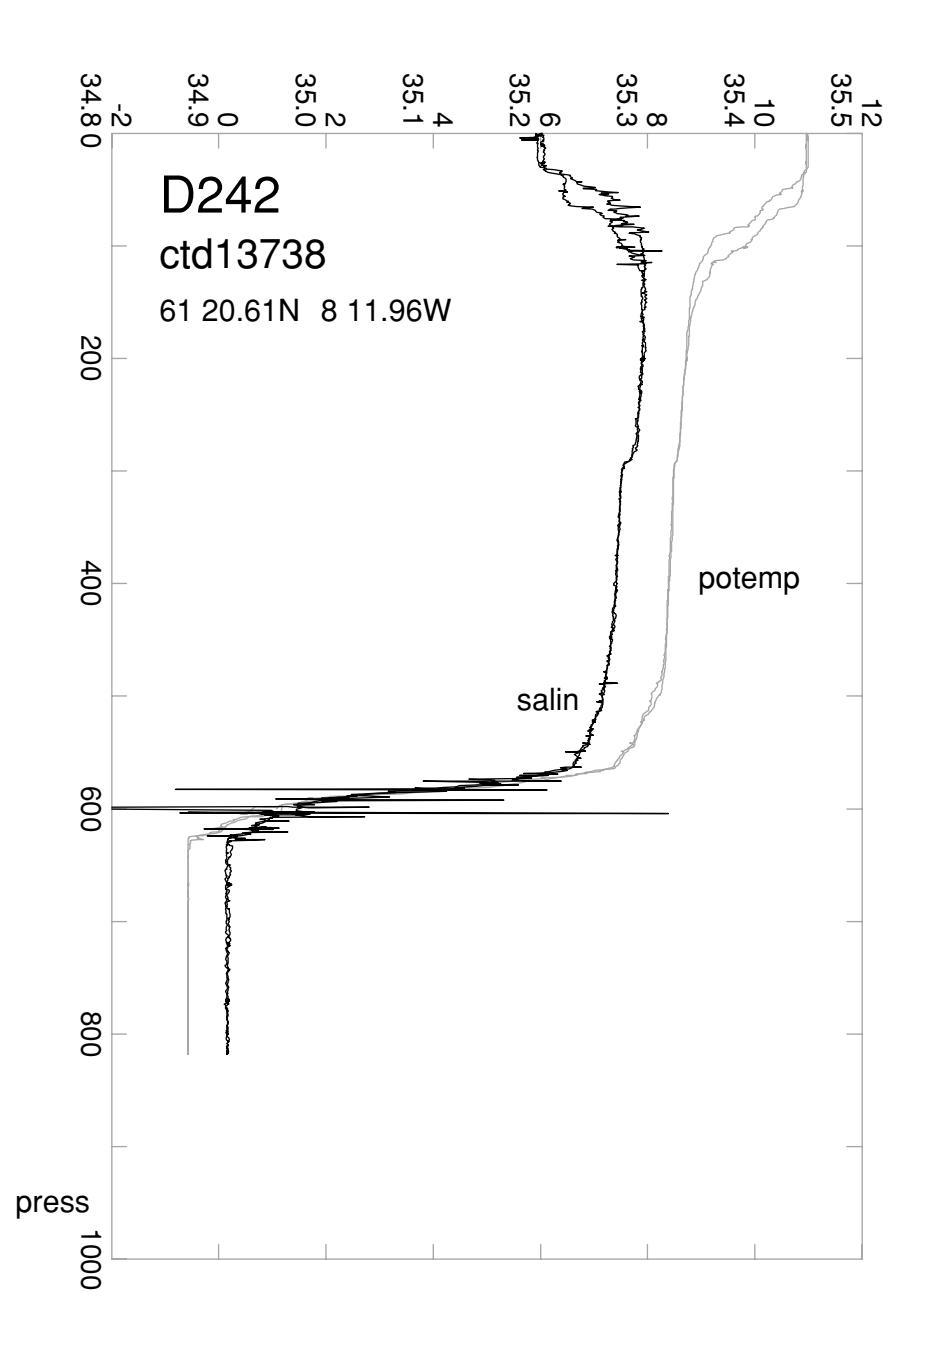
Figure 3 Continued b) 13738 with the SOC 20° LADCP

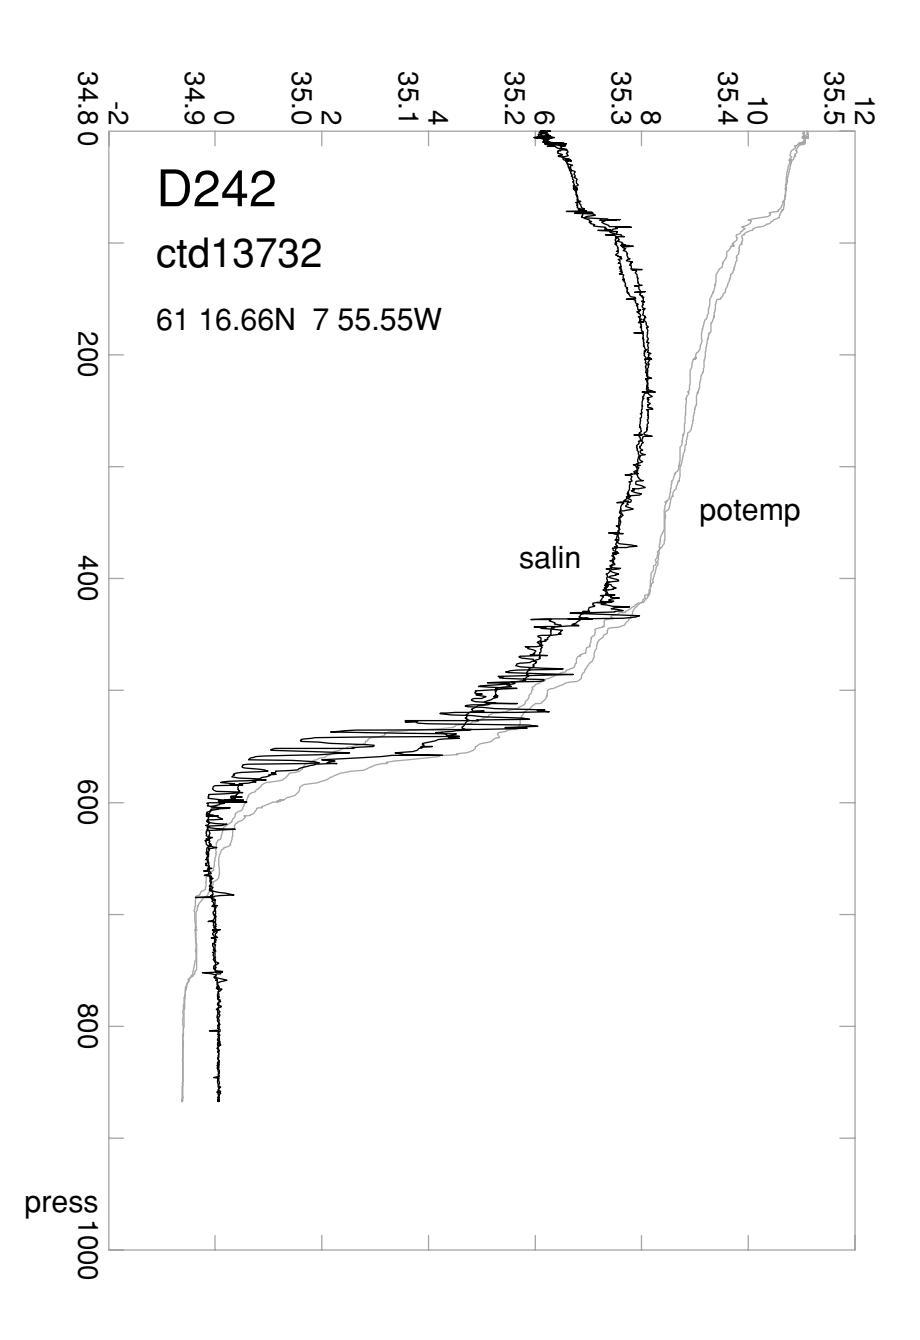
Figure 3 Continued c) 13732 with no LADCP in the frame

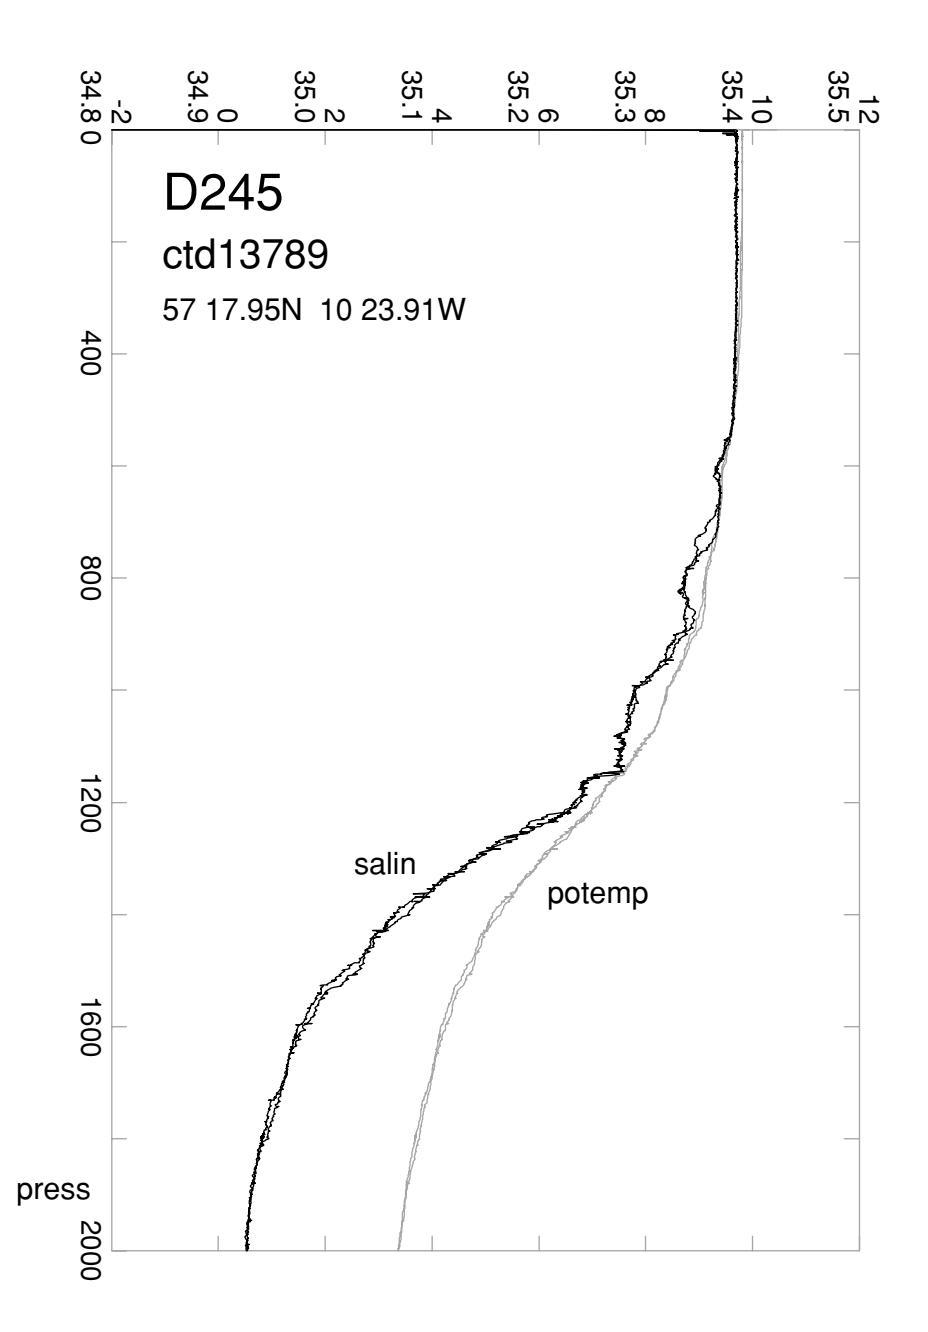
Cruise D245 in January/February 2000 (Holliday and Griffiths 2000) deployed the modified rosette frame in conjunction with the longer SOC LADCP. Figure 4 shows the absence of salinity spikes in the D245 data, suggesting that the frame modification had improved the quality of the data.

Figure 4 - Temperature and Salinity for D245 station 13789 showing the clean up and down profiles collected with the modified CTD frame and long LADCP.

Ideally the CTD should be positioned below any flat horizontal metal plates so that the temperature and conductivity sensors sample nearly undisturbed waters at a level commensurate with the LADCP transducers. Because of the design of the current CTD frame and the increasing number of instruments attached to it, this is not a practical solution for the present rosette frame. However, after D242 it was possible to remove part of the flat bar nearest the CTD to reduce the generation of wake vortices.

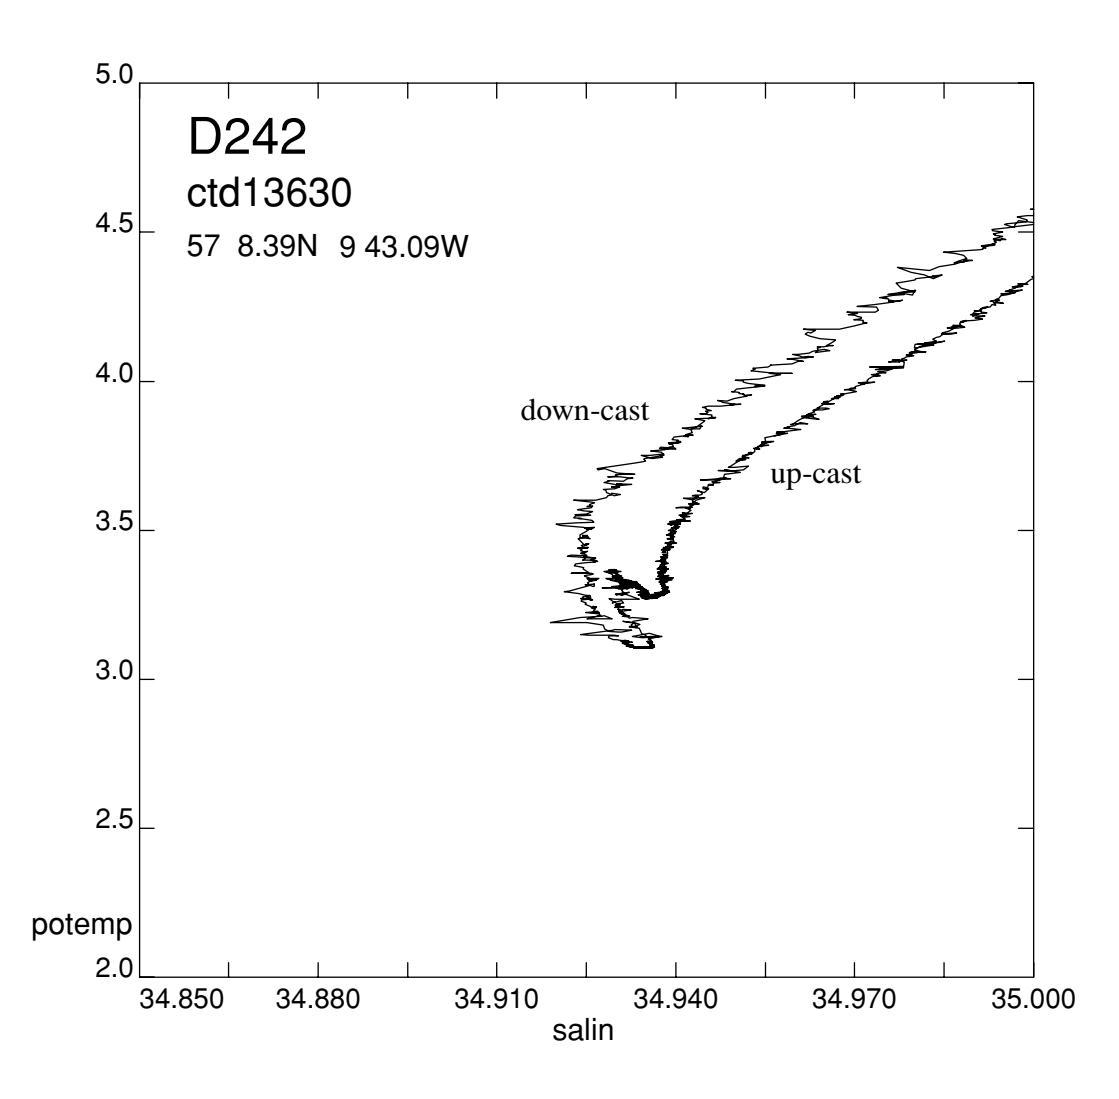
Figure 5 - D242 Station 13630, the test station, showing two jumps to higher salinity; at the bottom of the cast, and during an extended winch-stopped period.

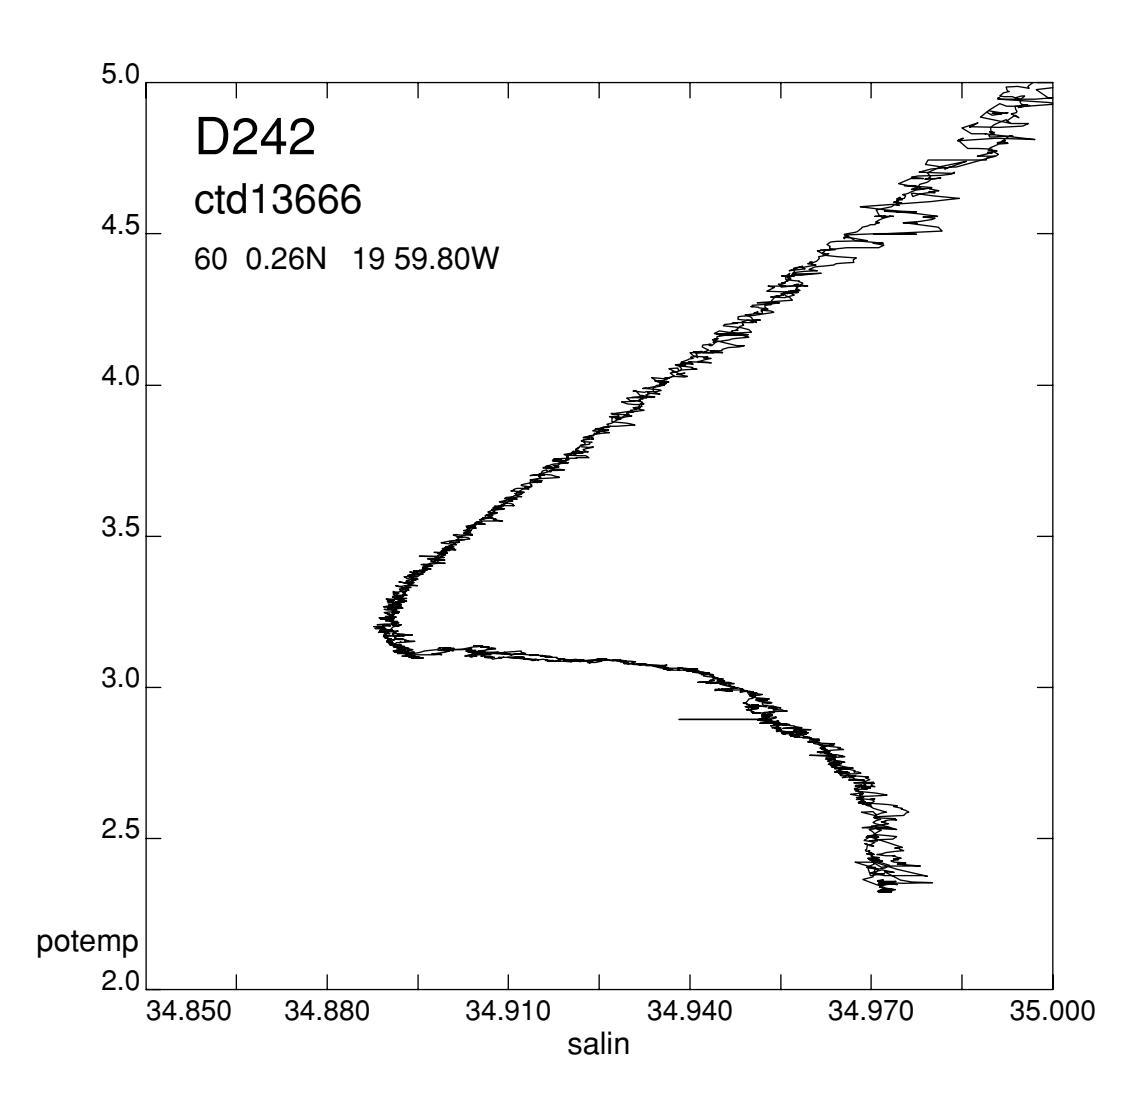
Figure 8 - D242 Station 13666, using DEEP03 and showing no hysteresis.

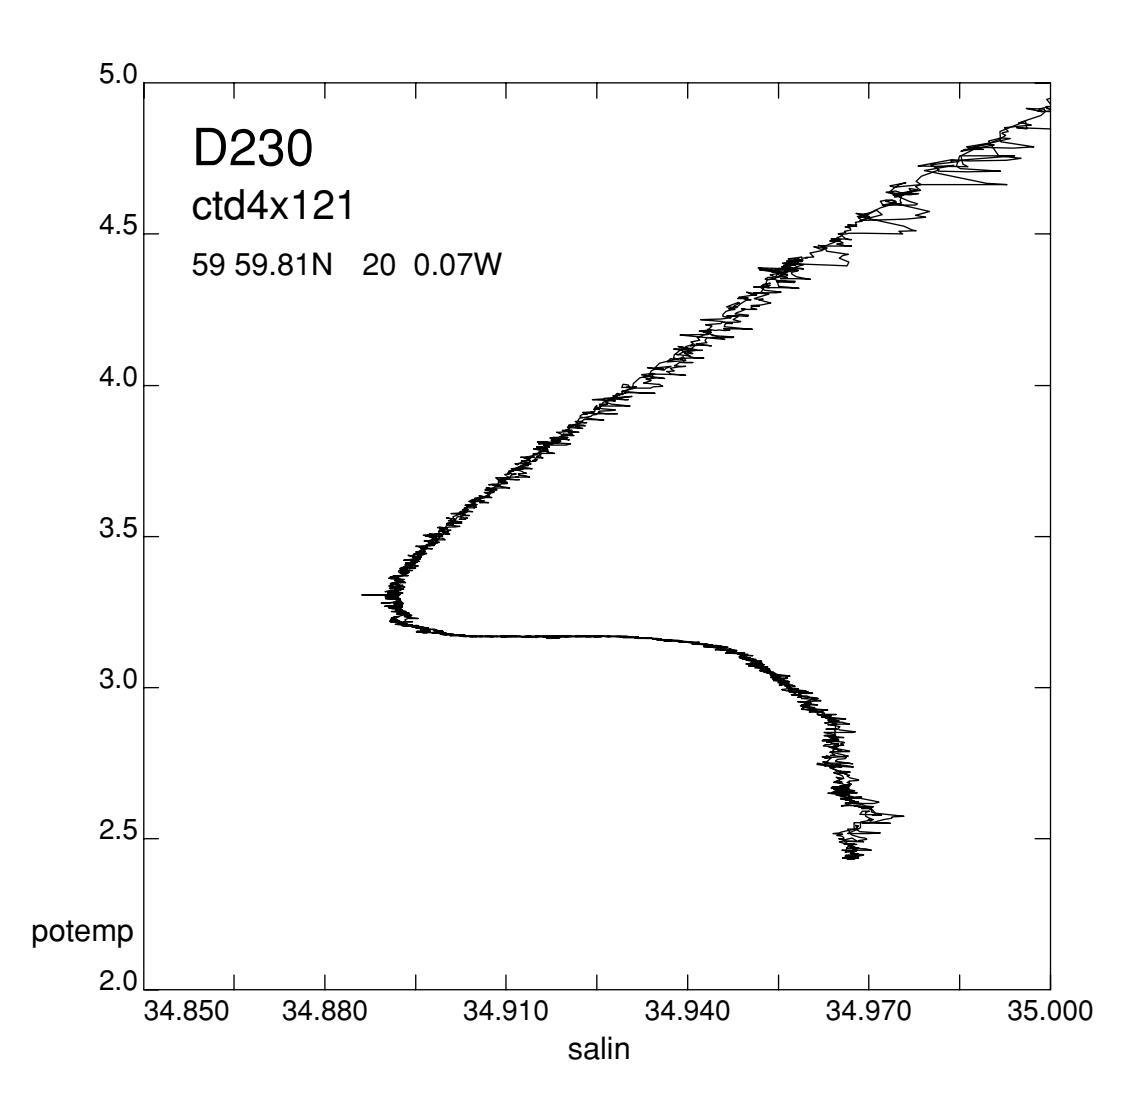
After cruise D242, the 1Hz profiles from previous cruise were inspected to assess how bad the problem was. It was obvious that the data from DEEP03 were markedly more consistent between down- and up-casts, but how did they compare to historical data? Figure 9 shows data from cruise D230 (FOUREX, Bacon 1998) for which another SOC CTD, DEEP01, was used and no hysteresis was present. Figure 10 shows data from cruise D233 in May 1998(CHAOS, Smythe-Wright 1999) when DEEP04 was used, and some hysteresis was clearly present in those data. The hysteresis problem with DEEP04 had therefore existed at least since 1998 and it is unfortunate that it had gone unnoticed during that cruise.

Figure 9 - D230 Station 121 using DEEP01 and showing no hysteresis.

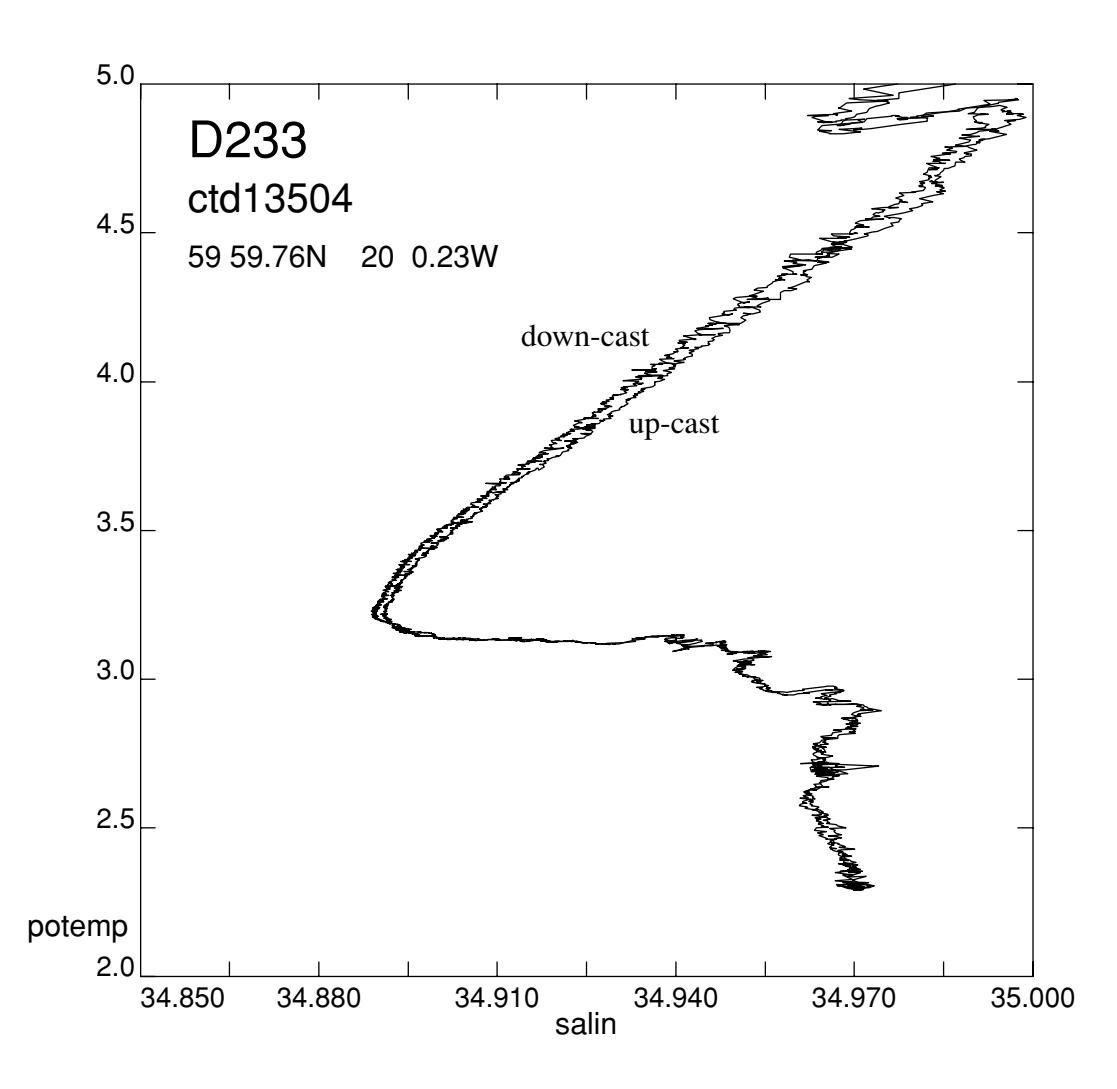
Figure 10 - D233 Station 13504 using DEEP04 in May 1998, showing some hysteresis.

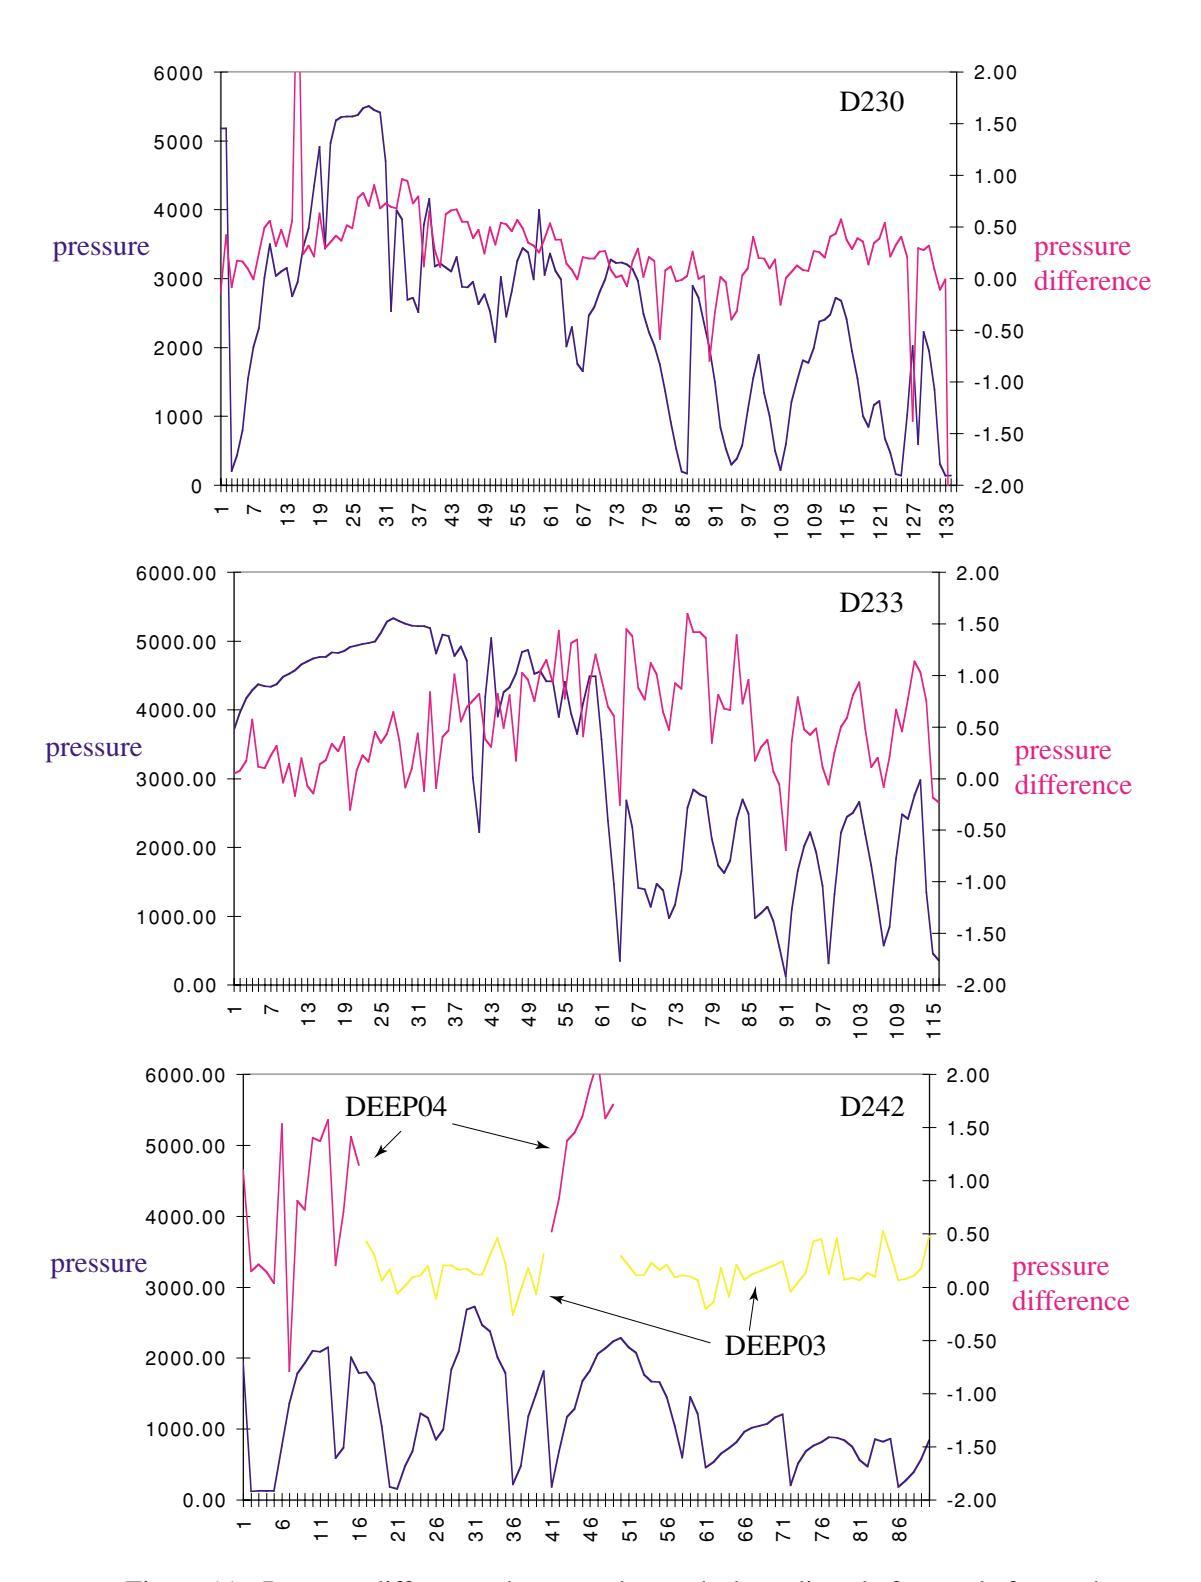
Figure 11 - Pressure differences between the on-deck readings before and after each cast on D230 (DEEP01, pressure corrected for hysteresis), D233 (DEEP04) and D242 (DEEP03 and DEEP04). Maximum pressure of each cast is also shown in blue.

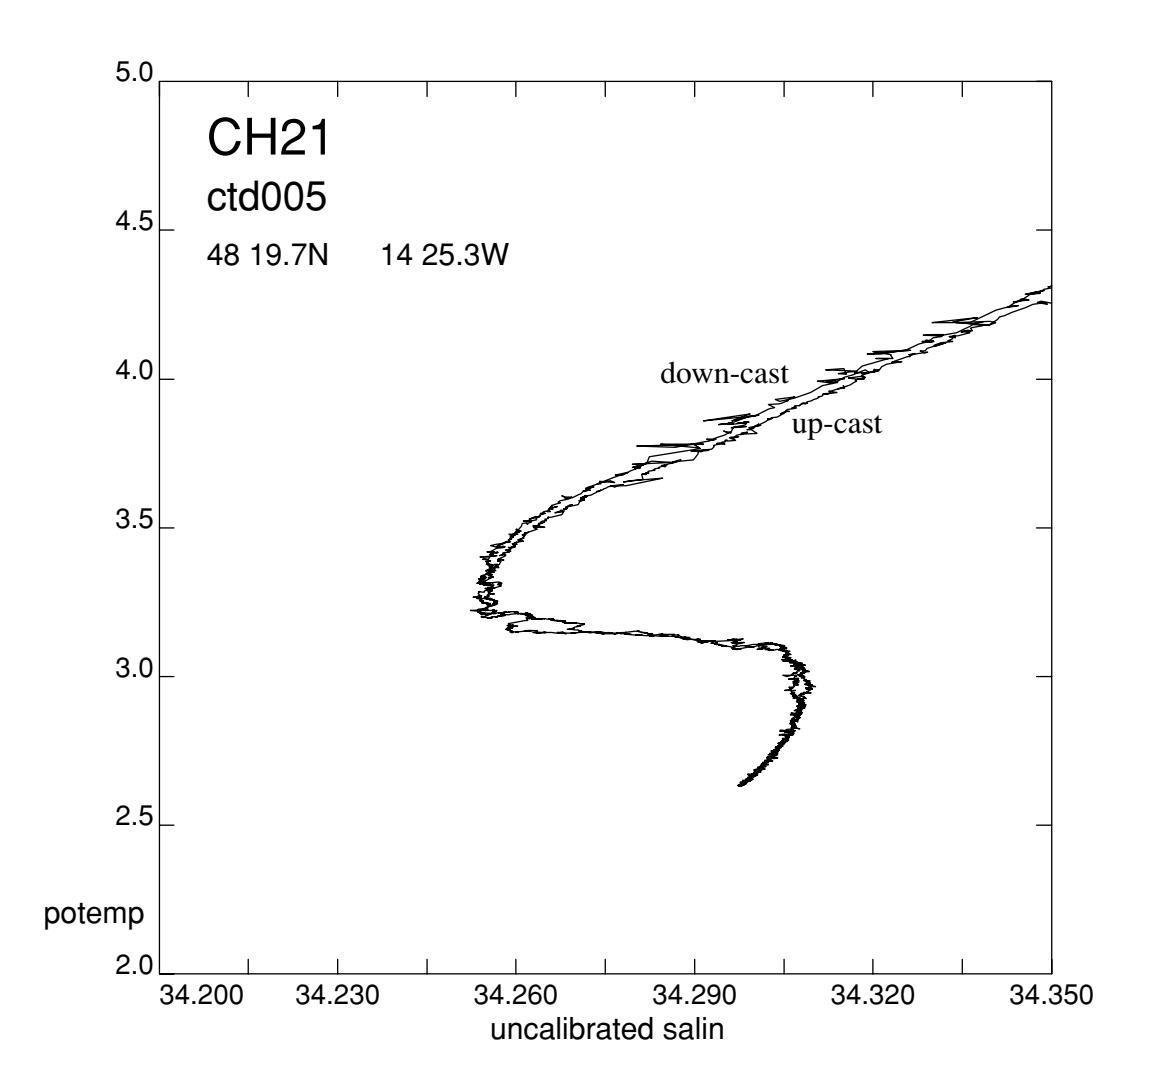
The problems on D242 persisted despite twice changing the conductivity cell, suggesting that the sensor was not the source of the problem. However it is generally thought that production tests for new conductivity cells were not as stringent as they had been in the past, and it was always possible that the two new cells were both faulty. To test whether the fault lies with the conductivity cell, the working cell originally used in DEEP03 for D242 (and D245) was transferred to DEEP04 and deployed on an RVS trials cruise in April 2000 (Charles Clayson). The resulting profile is shown in Figure 12 and clearly shows the hysteresis persisting. The conclusion from this experiment is that the conductivity cells are not the cause of the hysteresis.

Figure 12 - CH21 Station 005 using DEEP04 with the conductivity cell used in DEEP03 on Station 13666 (Fig. 8) and throughout D242.

In conclusion the source of the salinity hysteresis still needs to be identified. In the meantime it is suggested that DEEP04 be used as a backup instrument on hydrographic cruises, and not used as the main CTD.
