RRS James Clarke Ross Scotia Sea and Falkland Trough Marine Geology February 1995 - March 1995

Cruise Report

Cruise JCR09B February to March 1995

Marine Geology Scotia Sea and Falkland Trough

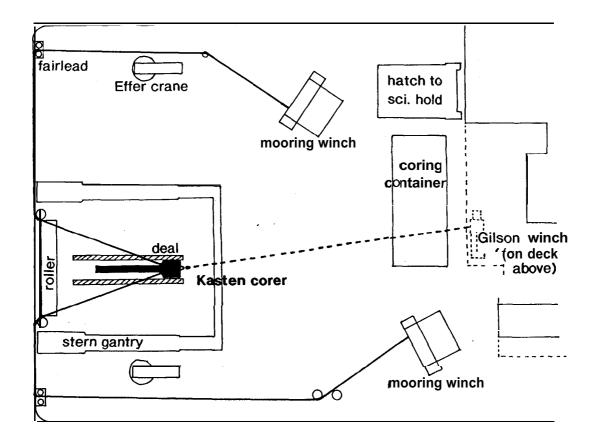
On recovery the pinger was removed, the core head brought to the stem roller and the Gilson wire attached. The Gilson winch was used to drag the corer in over the roller on to the deck, with the deals guiding it into position. Both the mooring winches and Gilson winch tended to be jerky in their operation, not being designed for precise control. The core head was damaged on one deployment because it was dragged sideways and one of the wire strops tore through a piece of stainless steel sheet. Otherwise the system worked.

Figure 1. Arrangement of jury rig for deploying and recovering Kasten corer.
