RAPID cruise report for Cruise DY129

8 December 2020 - 26 January 2021
RRS *Discovery* Cruise DY129

Cruise report 72

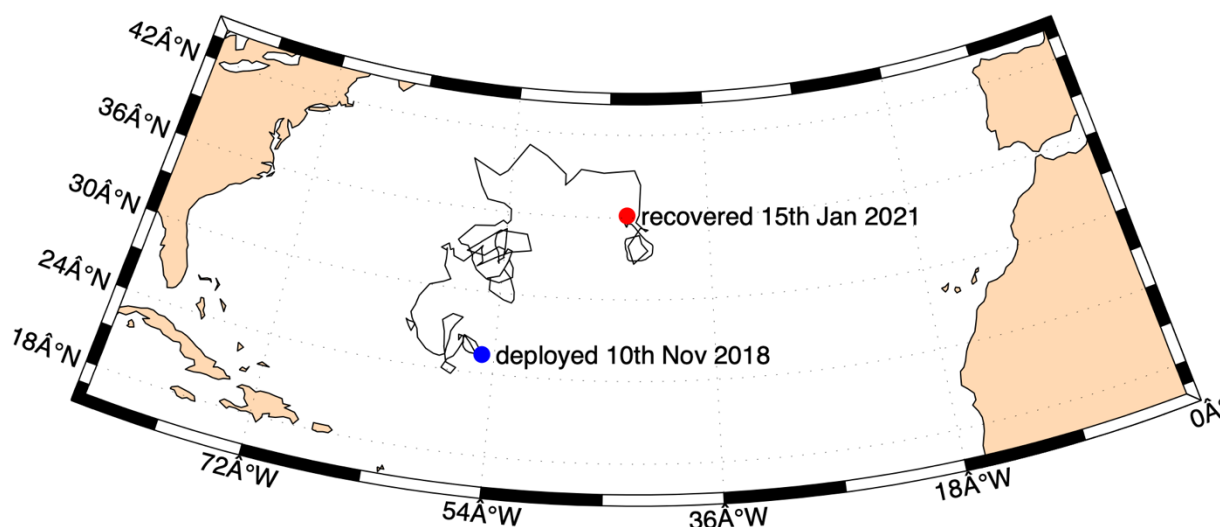
Deep Argo float s/n 25 was recovered on the 15th January 2021 at a position of 36° 12.68N, 43° 18.75 W. The float was deployed on JC174 in 2018 and developed a leak soon afterwards. It had been drifting on the surface since deployment.

Figure 9.1 Trajectory of recovered deep Argo float #25.

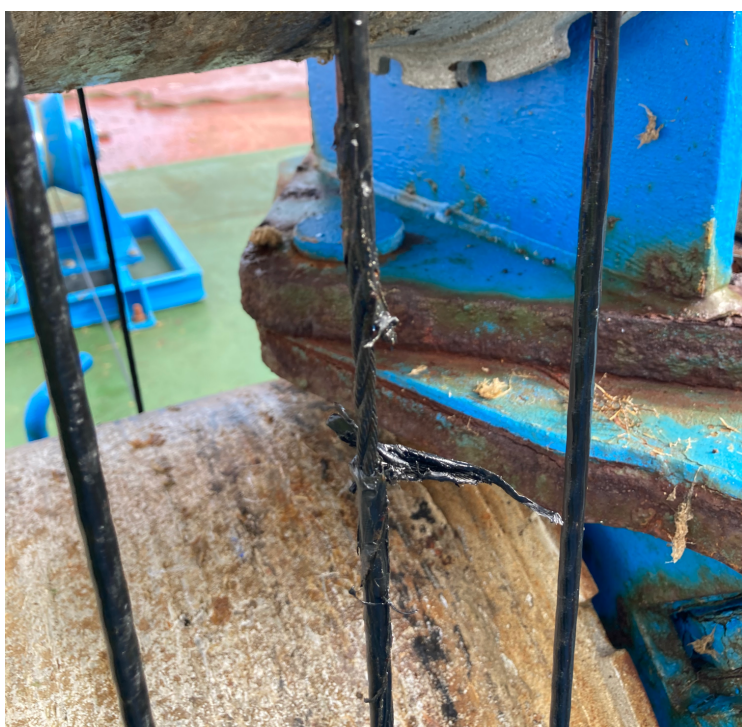
- WB2 had some instances of shredding on the plastic jacket of the wire (around 200m). Figure 17.2.

Figure 17.2 Showing shredding of the plastic jacket on the wire at WB2 around 200m.

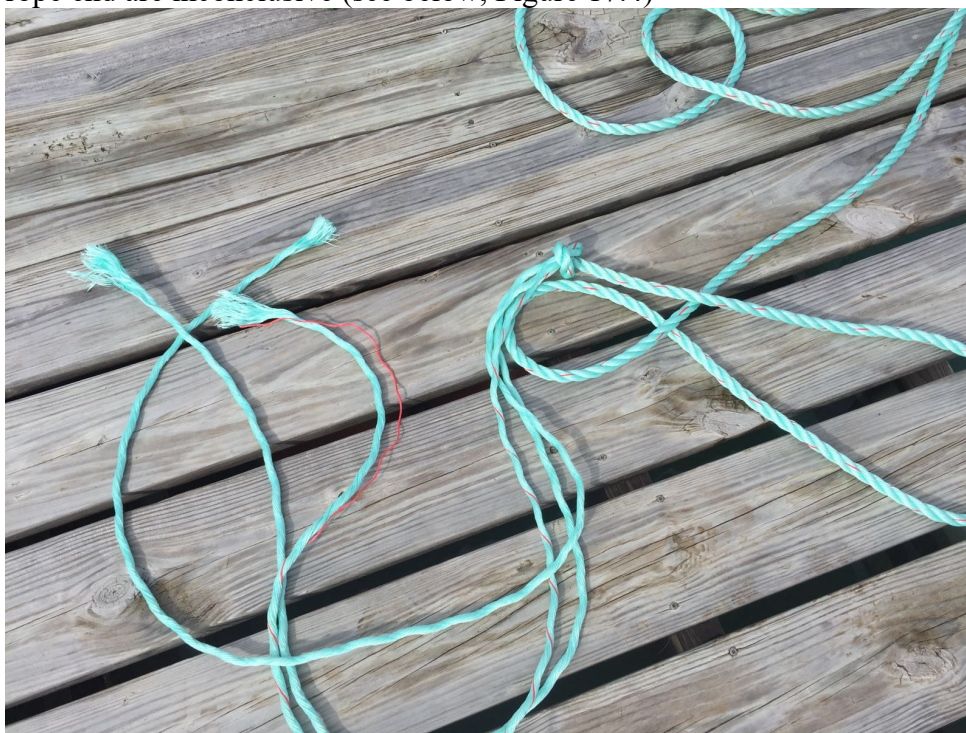
WBAL6 – The buoyancy from the lander surfaced two months after deployment. The frame was confirmed to still be at the deployment position on the subsequent cruise. Photos of the recovered rope end are inconclusive (see below, Figure 17.4)

Figure 17.4 Recovered rope end from WBAL6.

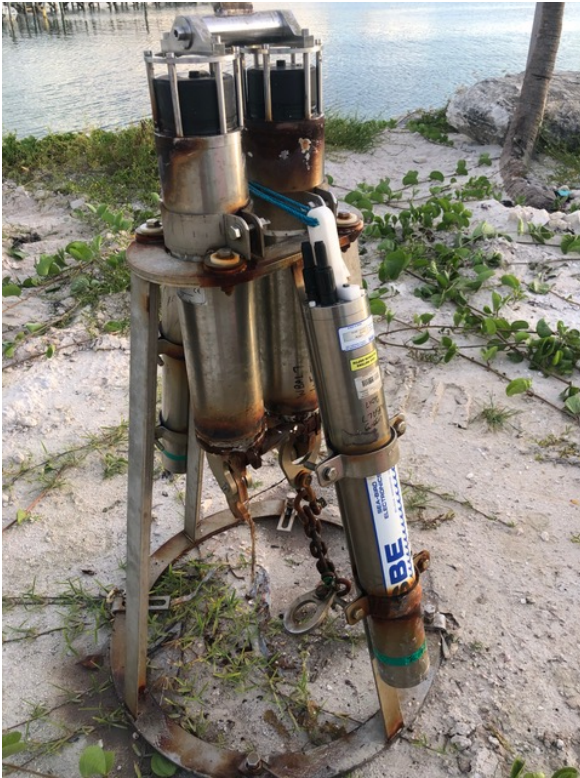
WBAL7 – the whole lander (buoyancy and frame) was recovered to Abaco by small boat. Photos appear to show one of the releases has been triggered (see photo below, Figure 17.5). The cause of the release was down to release s/n 822 moving $\frac{1}{4}$ turn and releasing the lander from the ocean floor. The releases did not respond when tested on board the ship. And further testing will be conducted back at NOC. There were no messages from the Argos beacon but the lander was found adrift by a passing fishing boat near the Pelican Sea Reserve off Abaco.

Figure 17.5 Photo of WBAL7 lander frame as recovered by a University of Miami professor.
