CRUISE REPORT 4/86

R V "G A REAY" 18.6.86 - 29.6.86

ATTEMPTS TO LAY POP-UP CURRENT METER RIGS FROM R.V. G.A.

REAY CRUISE 4/86

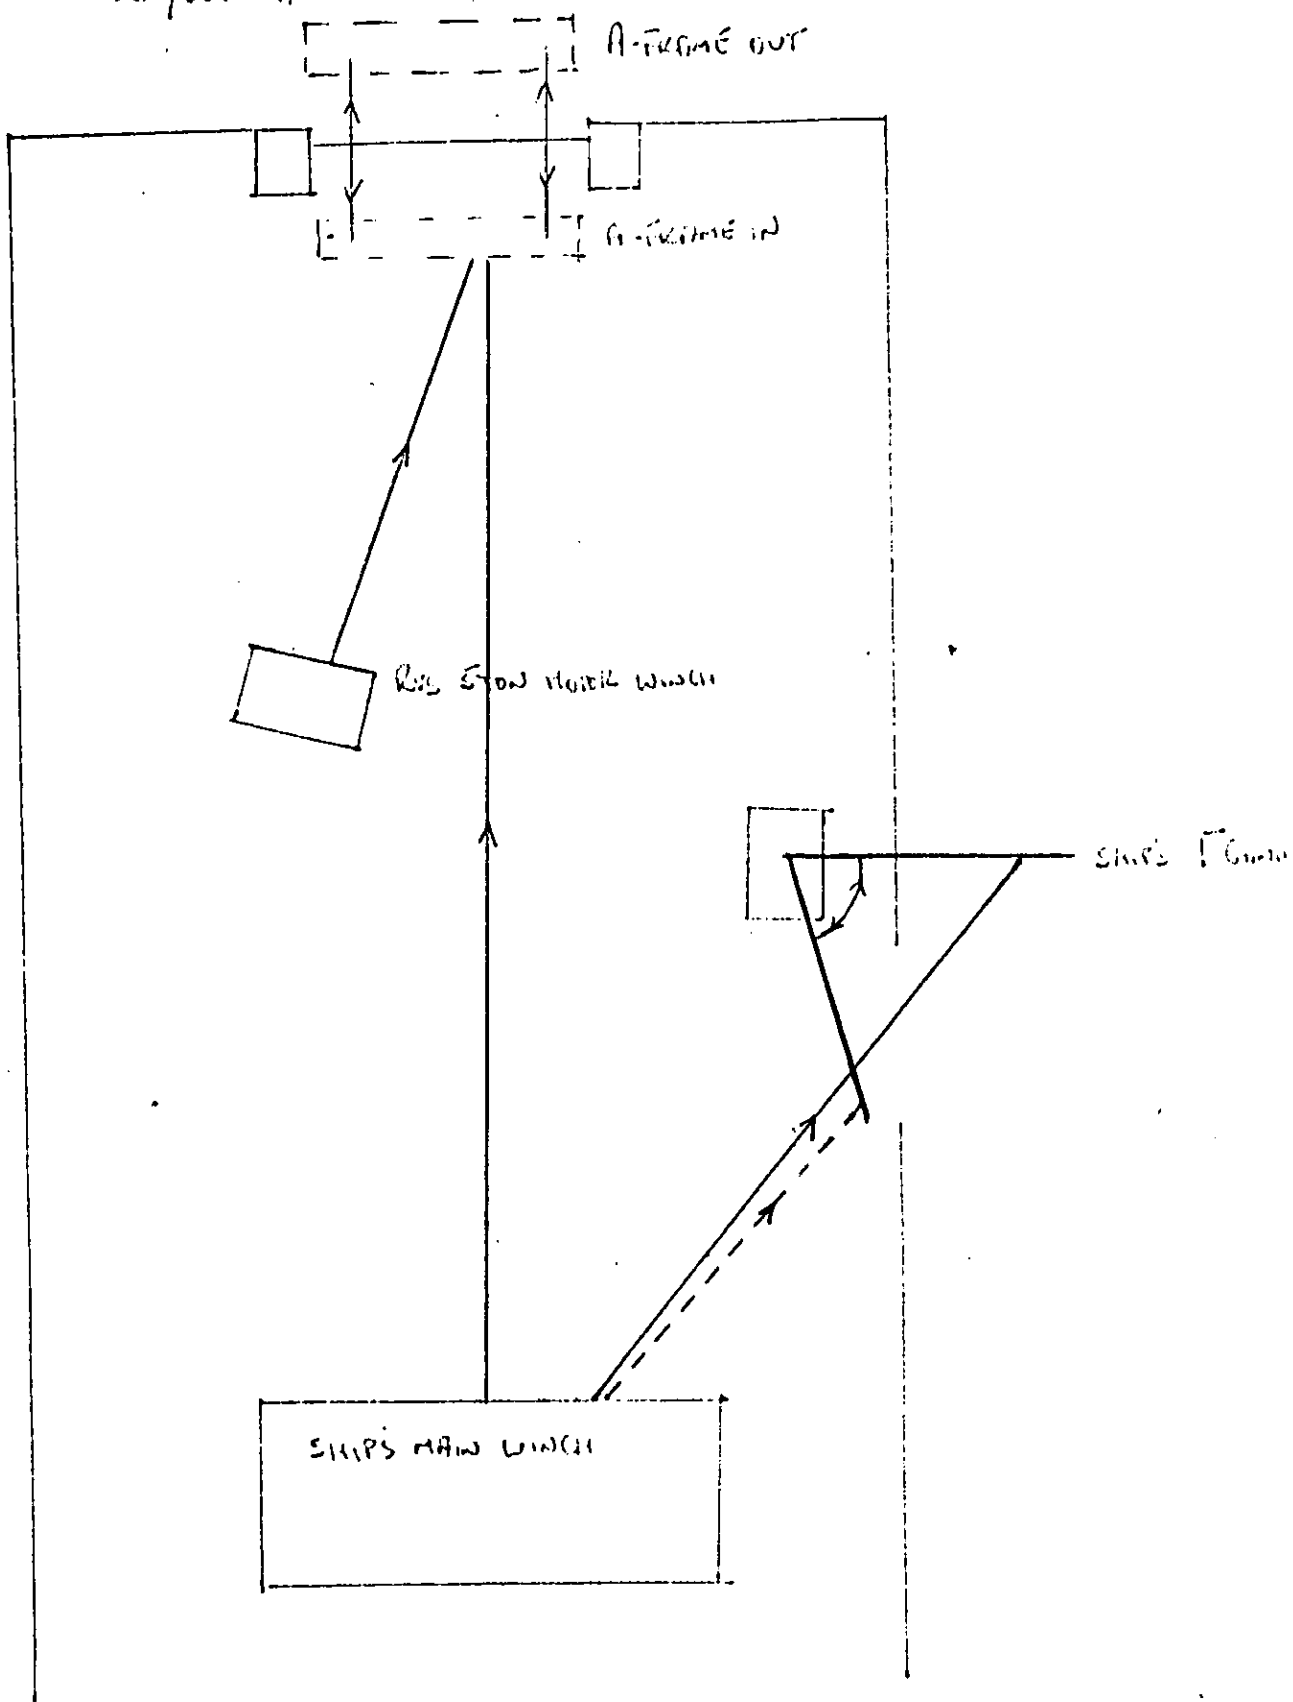
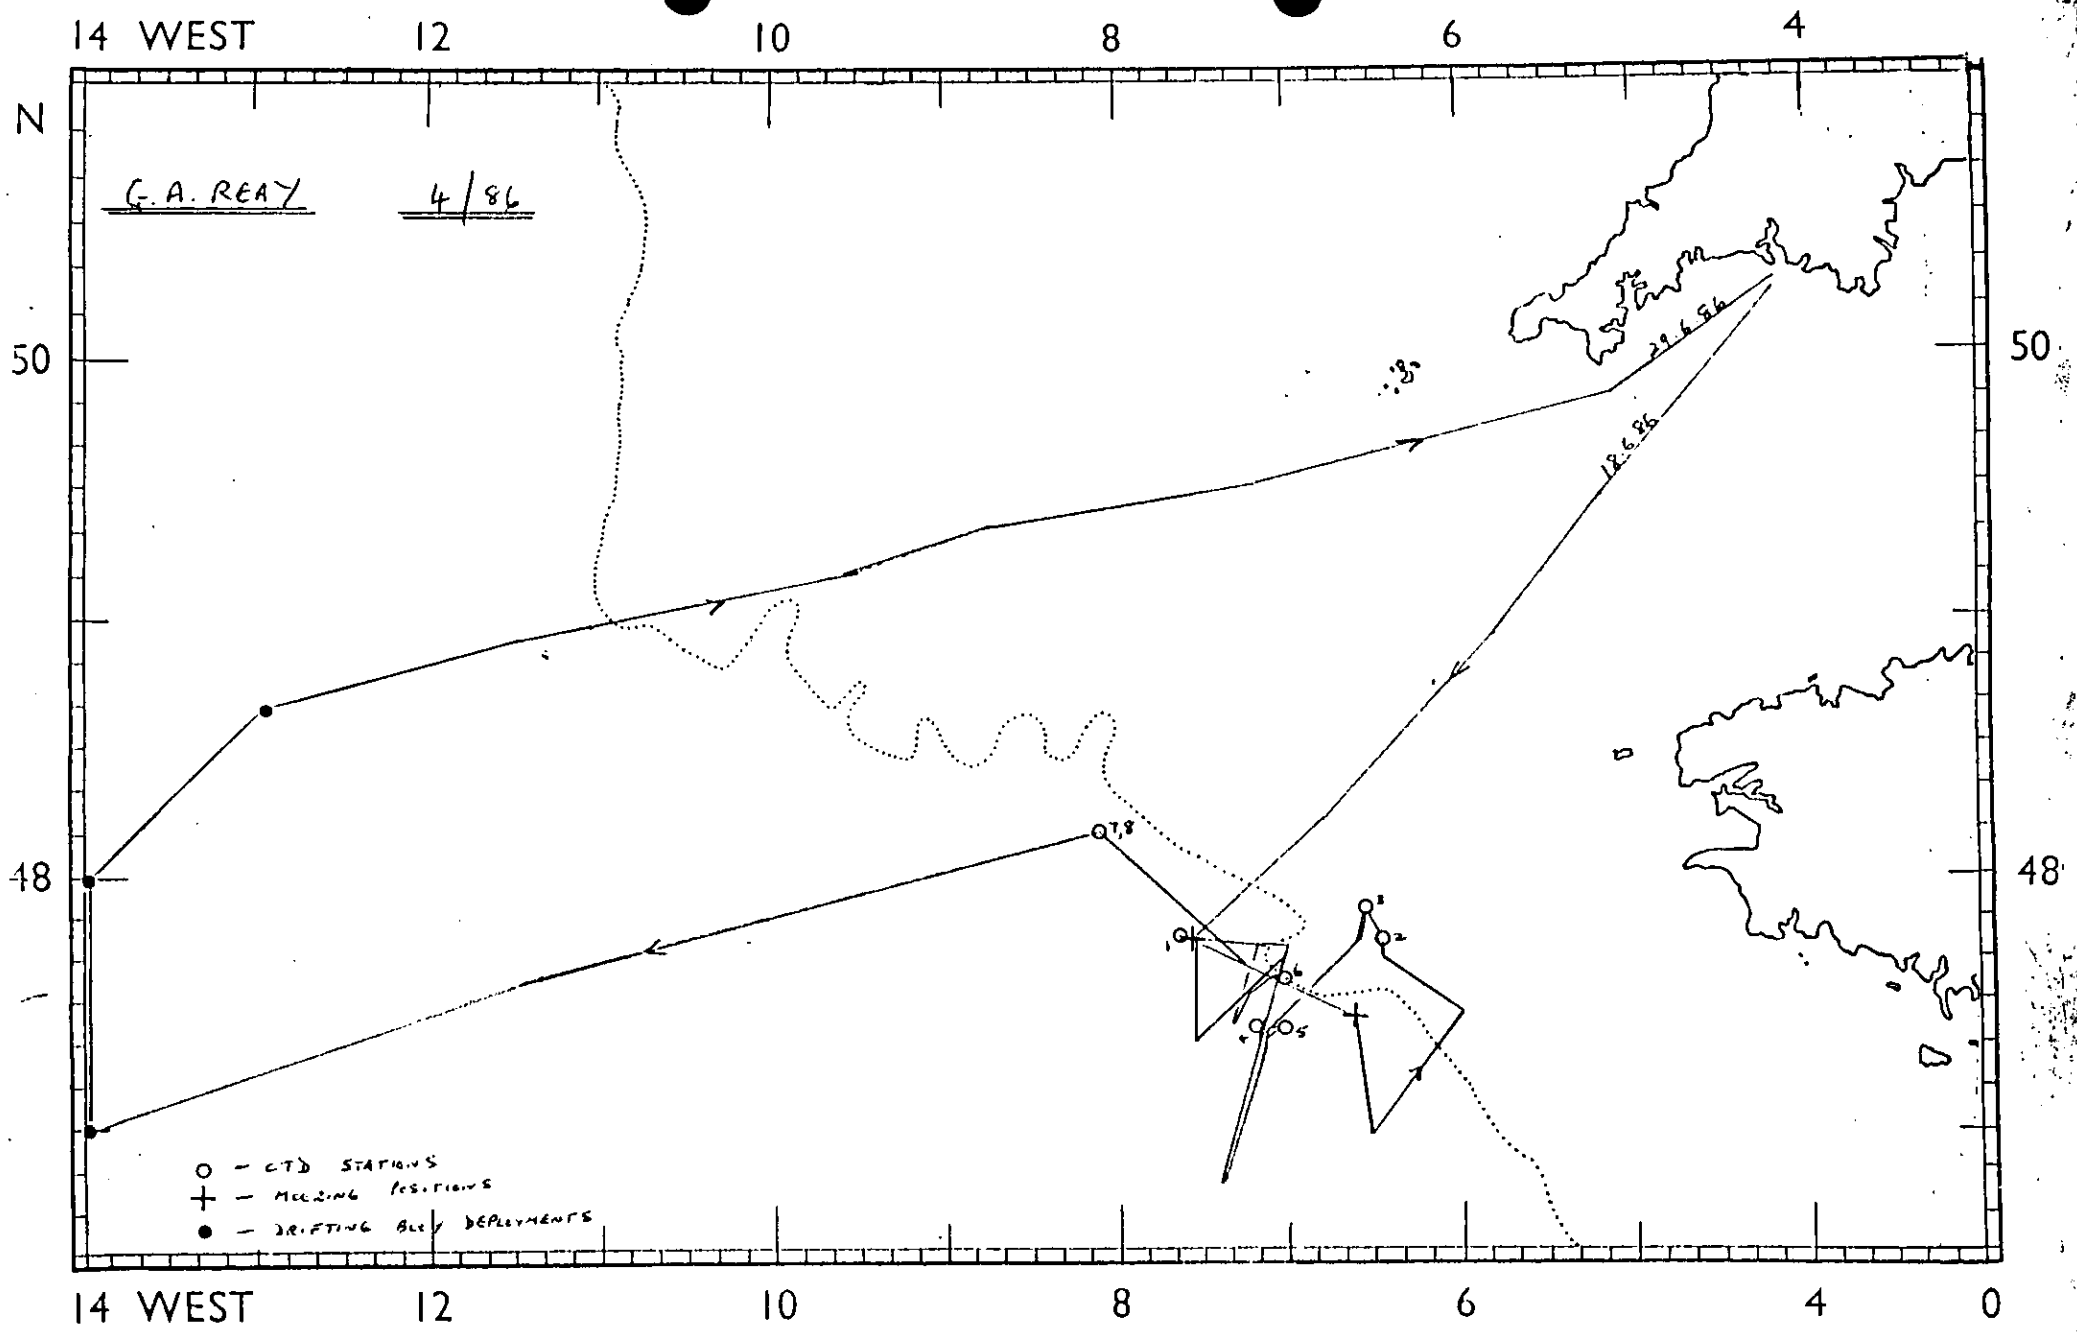
LAYOUT AND LEADS ON R.V. 'G.H. REEDY'

Prefired in air as soon as the full weight of the clump came on wire. It was now thought that the cause was the ship's own vibration, transmitted and amplified by the A-frame.

Prefired at 36m. depth. The wire was vibrating strongly during this deployment. It was noted that the plastic coated wire had some freedom to move sideways on the sheave. Ship's

staff say (this is unconfirmed!) that they have seen successful deployments of these releases before, when special sheaves were used -- wide enough to let shackles through, but equipped with a deep narrow central groove to restrain the wire.

If a grooved block is available, it could be tested on cruise 6/86, and used if successful. Otherwise all future rigs of this type should be laid buoy first, cutting free the clump last and allowing it to free-fall to the bottom.
