**UK-SOLAS Cruise Report: RRS *Discovery* Cruise  
D313, 07 November - 06 December, 2006:  
DOGEE-SOLAS and SEASAW; high wind gas and  
aerosol fluxes in the North East Atlantic Ocean**

**Principal Scientist:  
Rob Upstill-Goddard  
Ocean Research Group  
School of Marine Science and Technology,  
University of Newcastle upon Tyne  
NE1 7RU**

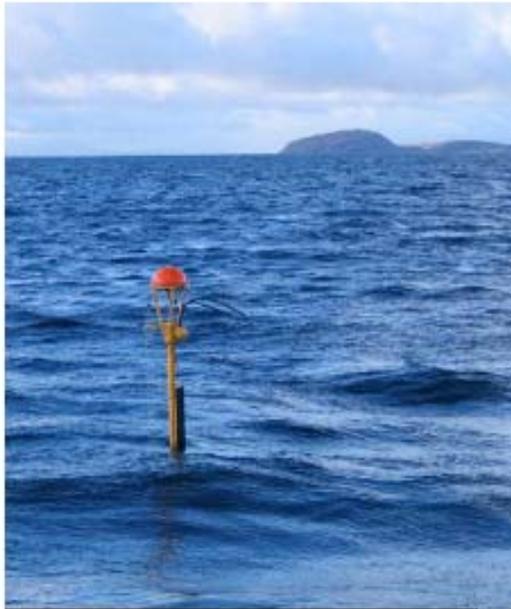
Figure 35 a) The wave buoy deployed in the Mull of Kintyre during day 312 and b) the configuration of the three wave wires (looking from above).

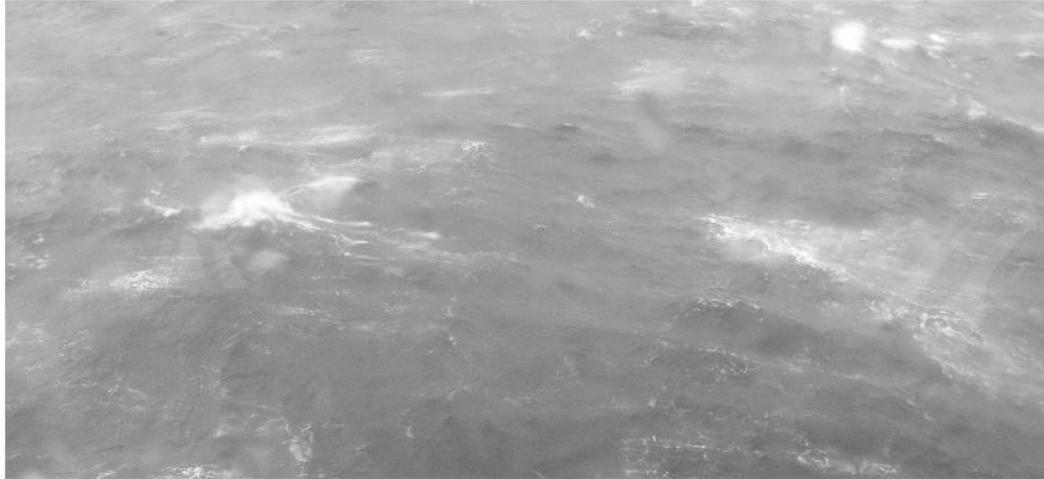
**Figure 39.** a) An image of the sea surface taken by the forward bridge camera during day 315 and b) the corresponding processed white cap image.

Matlab scripts were used to process 1000 images over a wind speed range of 10 to 20 ms<sup>-1</sup> from Camera 1 during day 324. Unfortunately, the horizon was included in the images when the ship rolled. This effect and the waves produced by the ship moving through the water were removed by selecting a horizontal strip (85% of the image height) across the middle of the image. A moving threshold based on the rate of change of the intensity of each image was selected to identify the white cap coverage from the background sea surface. Even with a downwelling shortwave of less than 200 W/m<sup>2</sup> Sun glint corrupting the image proved to be a major problem. As every image cannot be inspected for sun glint and it was partially removed from the data by only selecting white cap coverage below 25 %. Further work will be performed post cruise to remove the remaining sun glint from the images and determine the whitecap fraction.

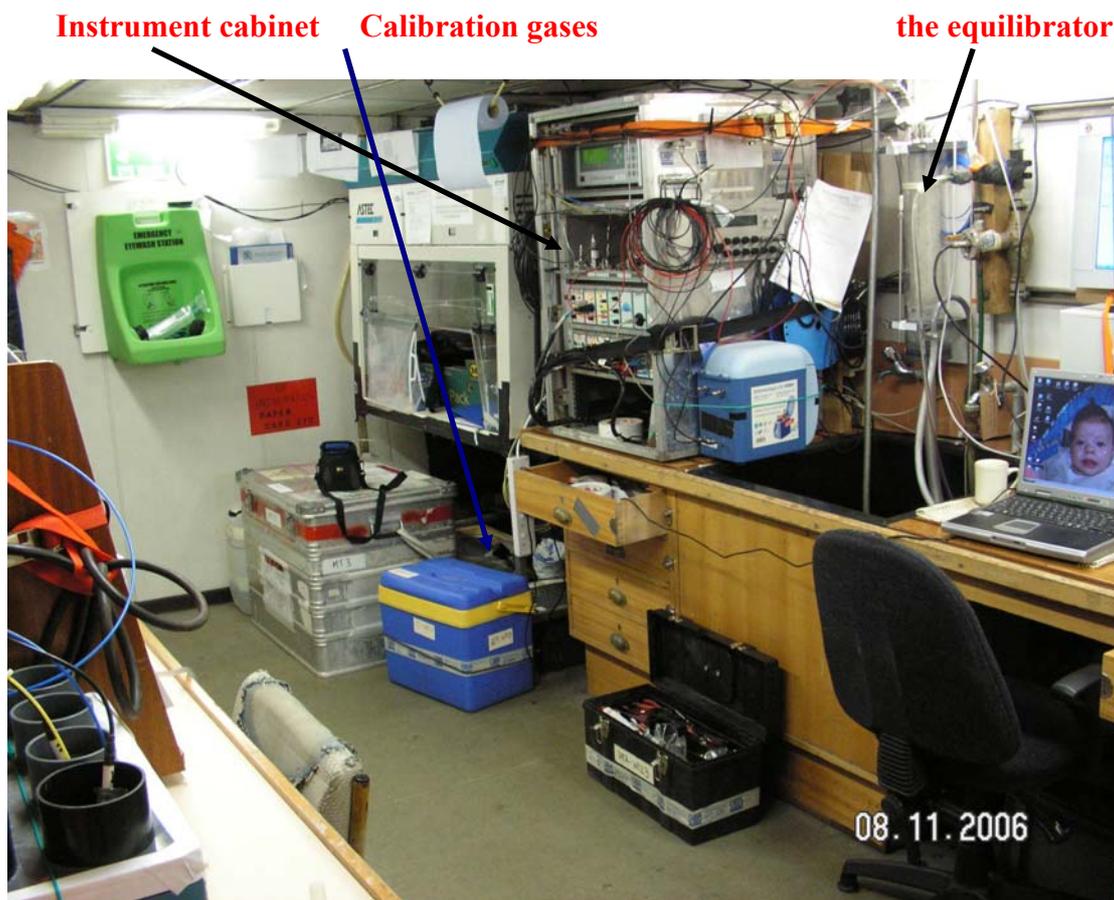
**Figure 40.** The CO<sub>2</sub> instrumentation as installed during D313.

Tubing and electrical cables connect the components of the instrument.

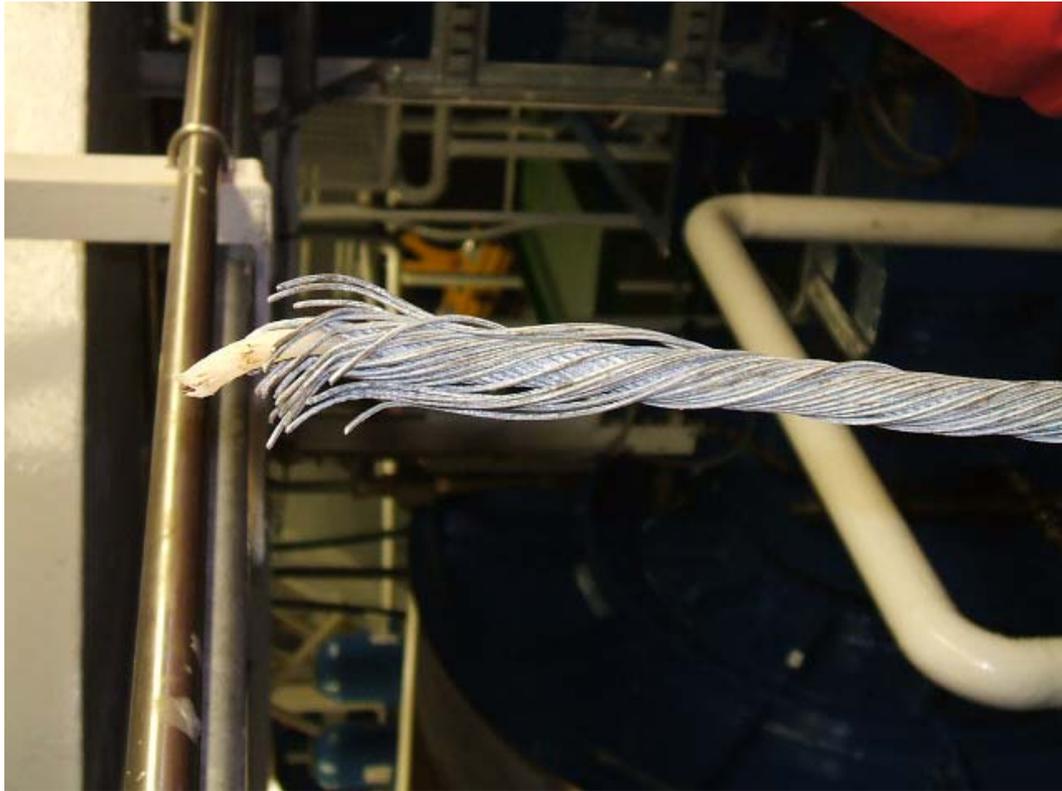
**Cable break**

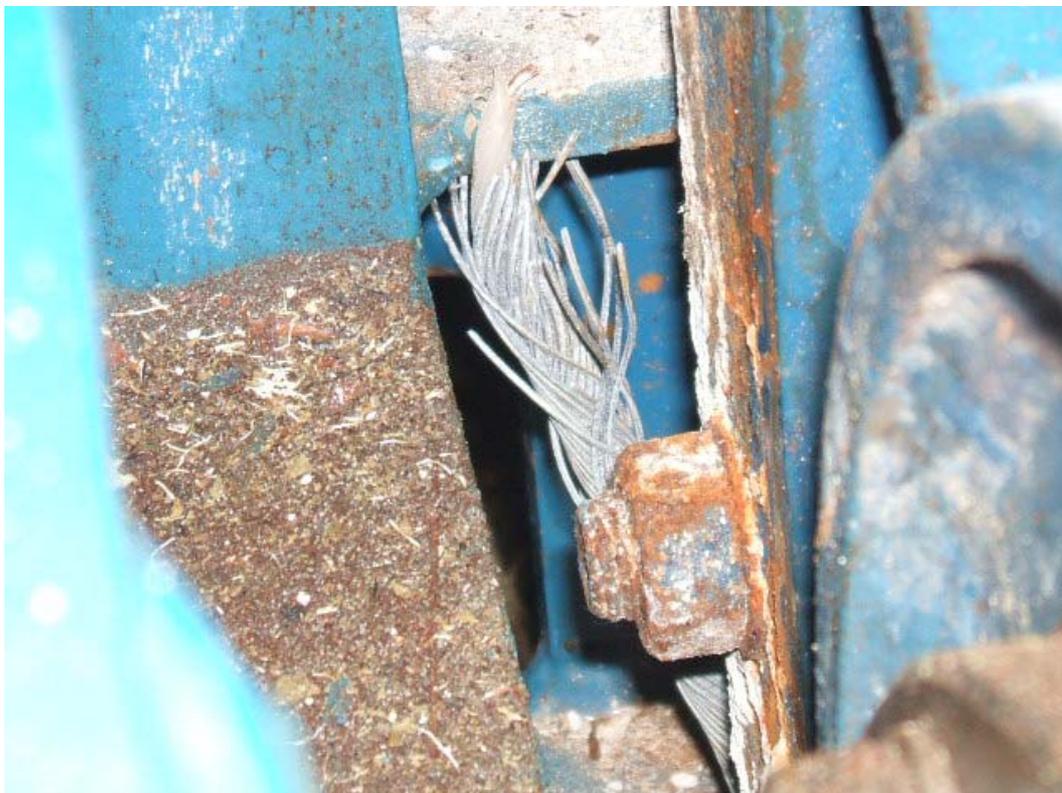
**Cable break, in situ**

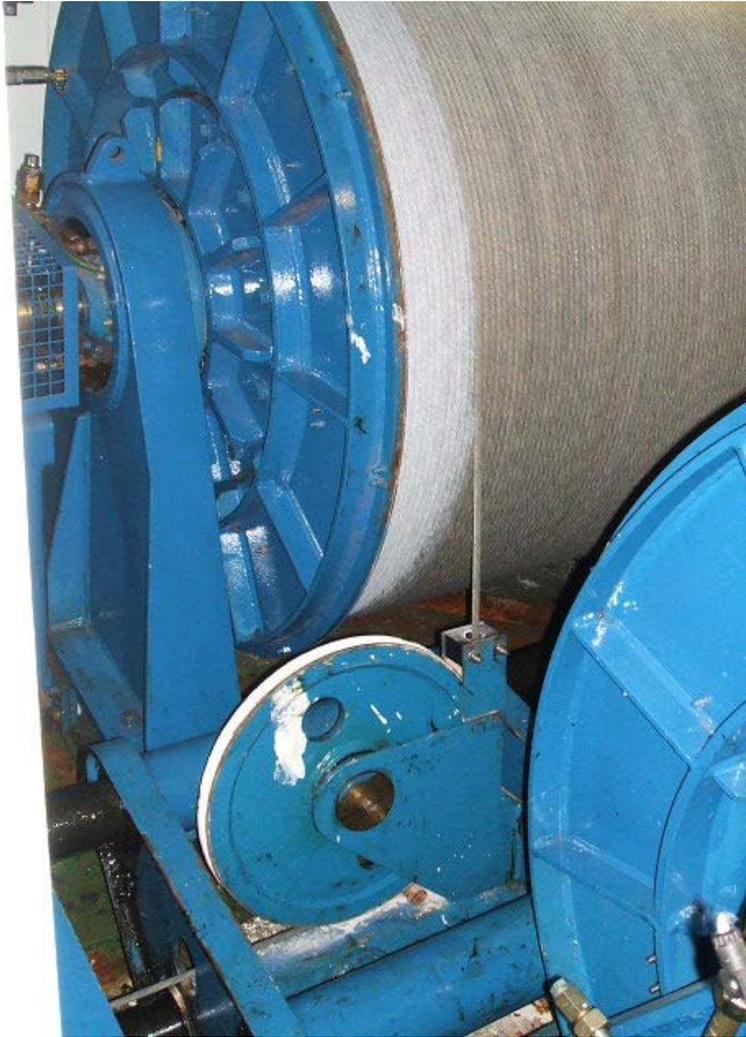
**Detail of wire on drum**

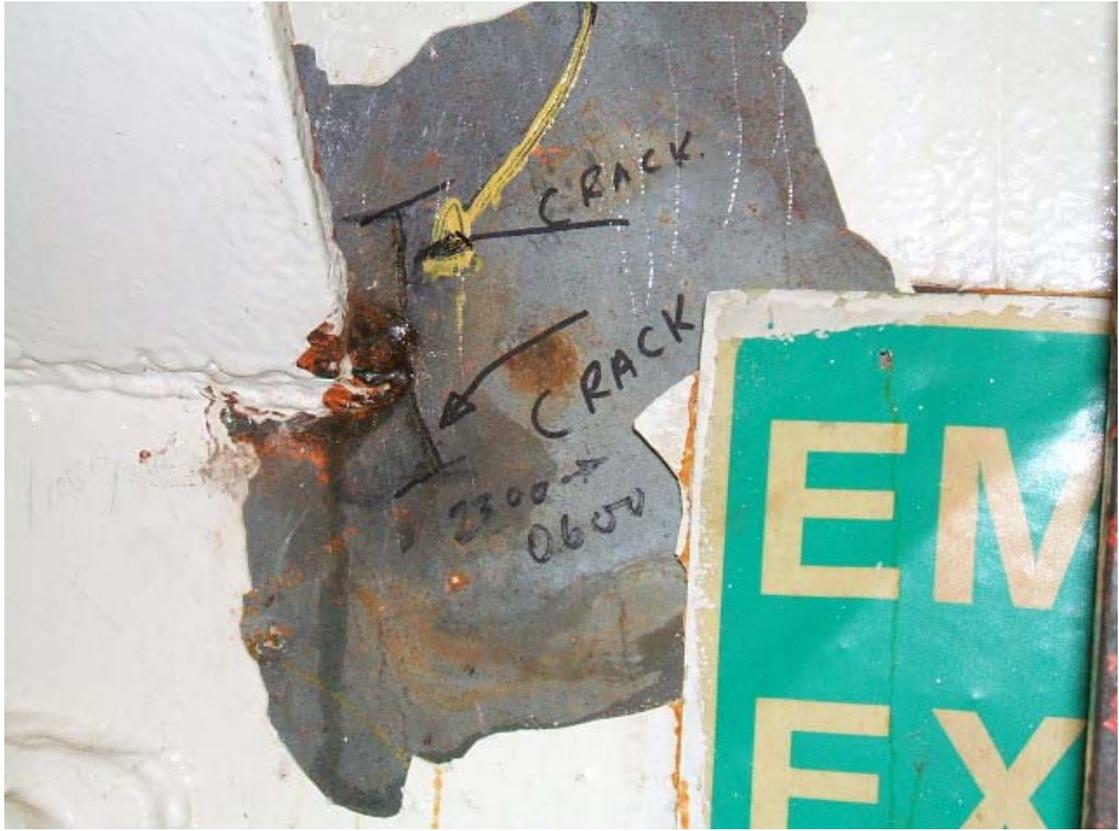
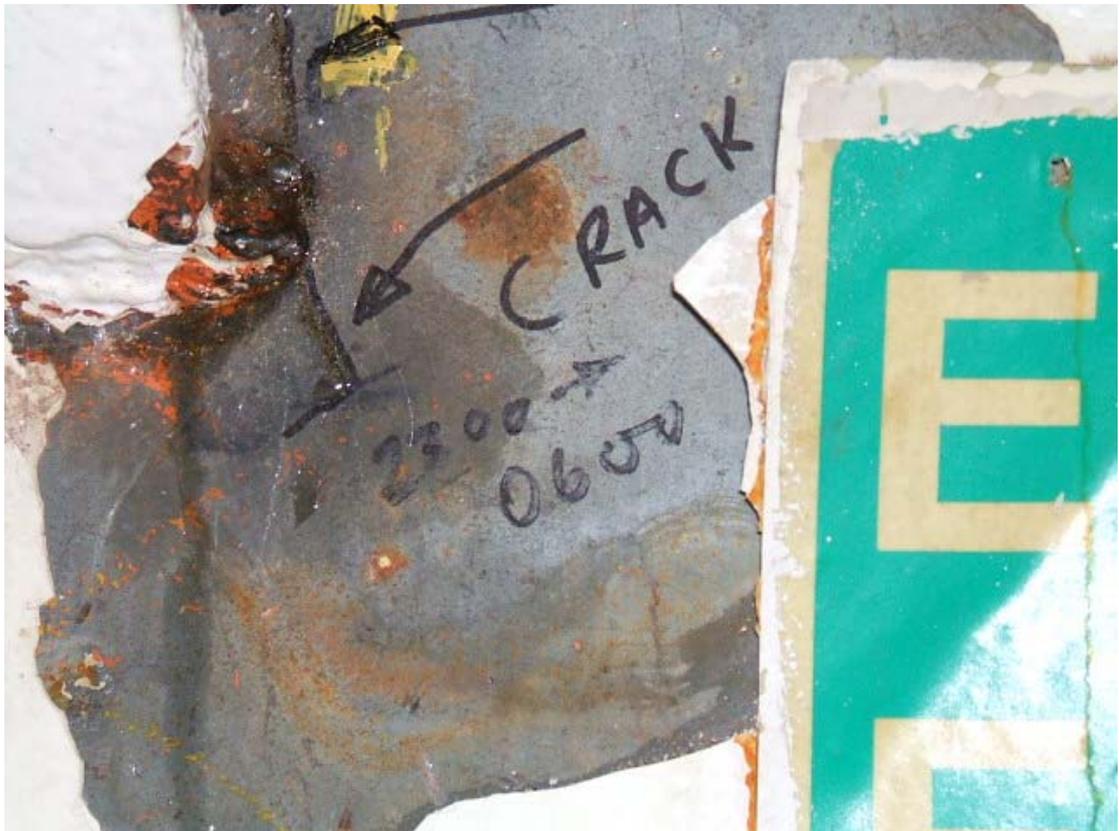
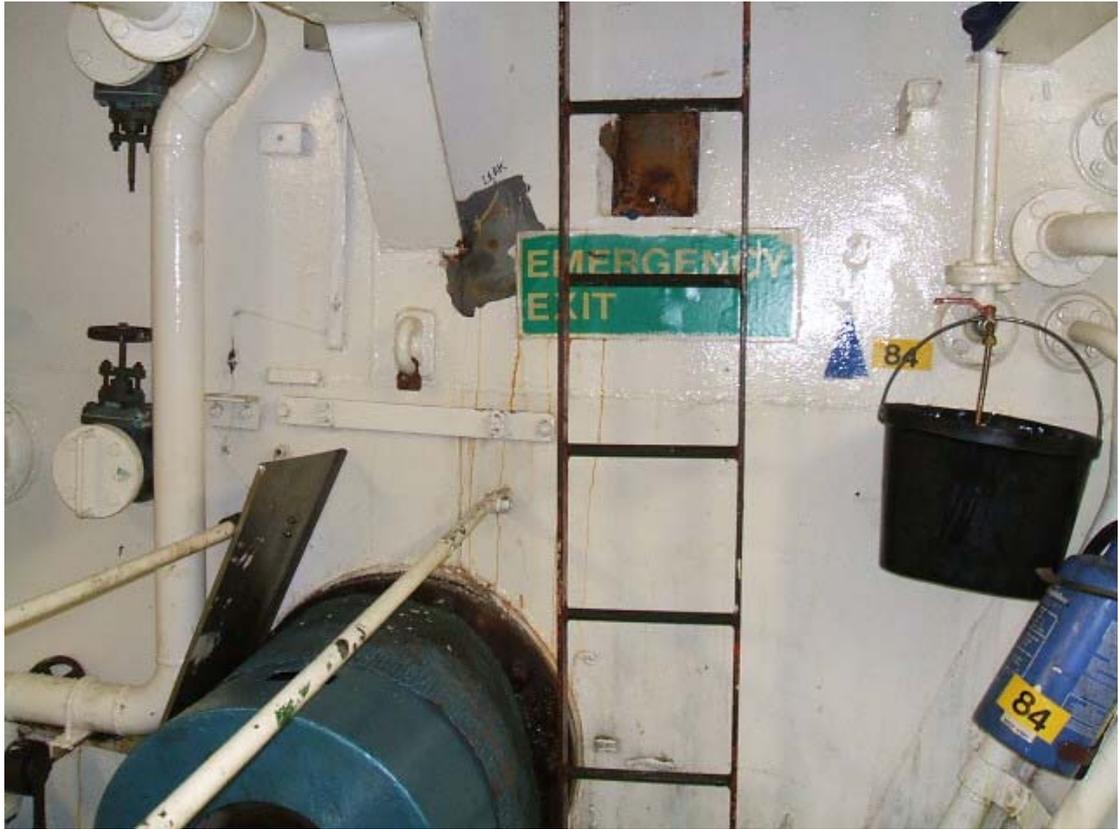
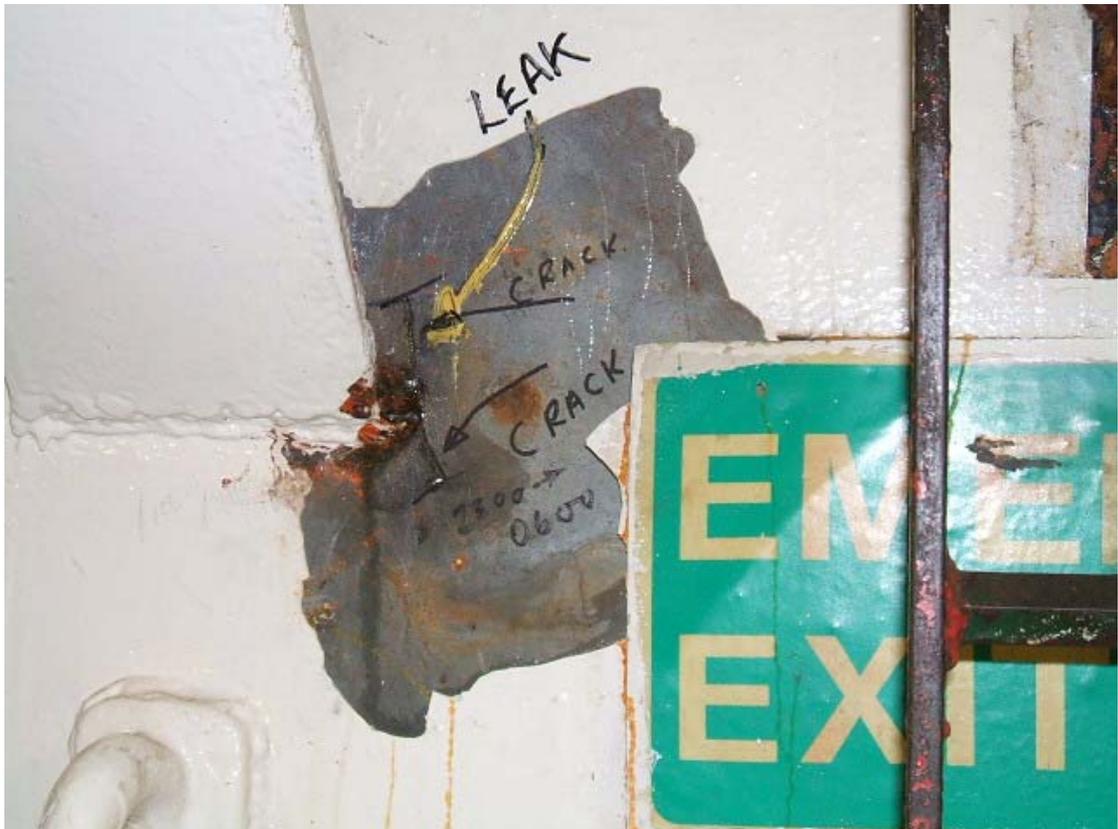
## Appendix 4: Chief Engineers report on aft collision bulkhead

At this mornings inspection it was found that the original crack had progressed from 6 mm to around 50 mm. Also another crack has now appeared running 135 degrees from the weld. The area concerned is directly above the stern tube seal and is highlighted in the attached images. It is causing us some concern due to the appearance of the second crack overnight. Also to bear in mind that there is a lot of vibration in the vicinity, under seaway and the inclement weather is pulsing the area around the stern tube. Please also refer to the General Arrangement plan sheet 1(Des 28851) - Frame No 9. However this plan does not show the longitudinal girder under the seismic compressor flat. Also to note, as this is a collision bulkhead, it is affected by class (Lloyd's)

Later that evening (Sunday 12<sup>th</sup> November) the duty engineer, during his routine inspections of the machinery spaces, noticed a wet patch on the aft collision bulkhead. The cause was a 6 mm crack, which had progressed to 50mm by breakfast time on Monday 13<sup>th</sup> with another crack running away from it. This, combined with worsening weather, forced us to make for port at Stornoway, arriving approximately 10am on Tuesday 14<sup>th</sup>, for the fault to be repaired. UKORS arranged despatch of a replacement CTD winch and additional CTD spares (bottles) for delivery to Greenock. Rakia Meister left the cruise in Stornoway for personal reasons on 15<sup>th</sup> November.
