# D333: Multidisciplinary Equipment TRIals Cruise (METriC)

*14-23 October 2008, Canary Islands*

*Cruise report*

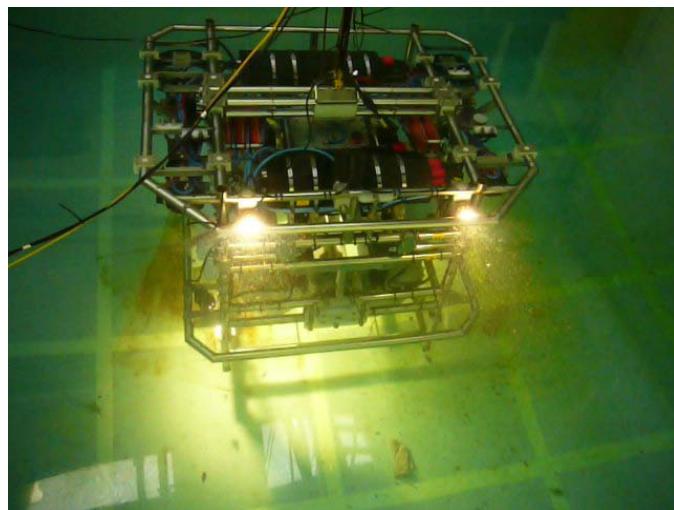
HyBIS is an RO-TVG (Remotely Operated TV-Grab) that is designed to be a versatile, easy-to-use platform for seafloor survey, intervention and instrument package deployment.

**Figure 11** HyBIS vehicle in NOC acoustic test tank

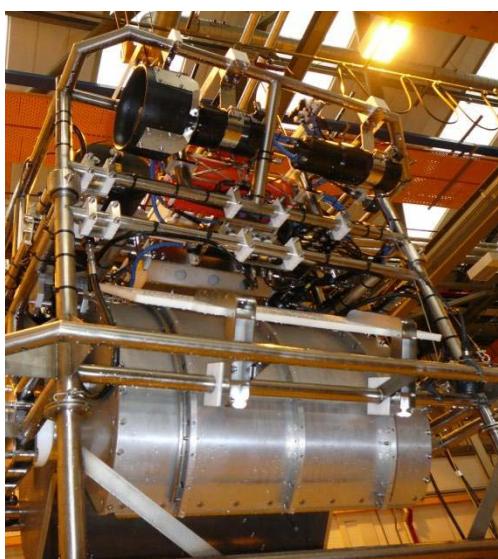
HyBIS has a command module for power, lights, and telemetry, and a swappable tool module for sampling. The command module has twin colour cameras and over 1000W of lights - all rated to 6000m. The command module also has hydraulic power packs, 140Bar water pump and electric thrusters producing 100 kg of thrust. The sampling module currently comprises a 0.3 cubic meter clam-shell grab.

The modules are separated by hydraulic release pins, enabling the tool module to be jettisoned or a pay-load to be deployed. In the future, it can be tooled with manipulators, push-cores, a slurp-gun or a rotary drill.

HyBIS currently has six serial channels and three colour video channels. It has enough hotel power to supply a CTD, chemical and optical sensors and a variety of sonars. It is powered through the standard NMFD fibre-optic-electrical cable, delivering 7kvA at 1500V ac, with 5 KW available at the vehicle.

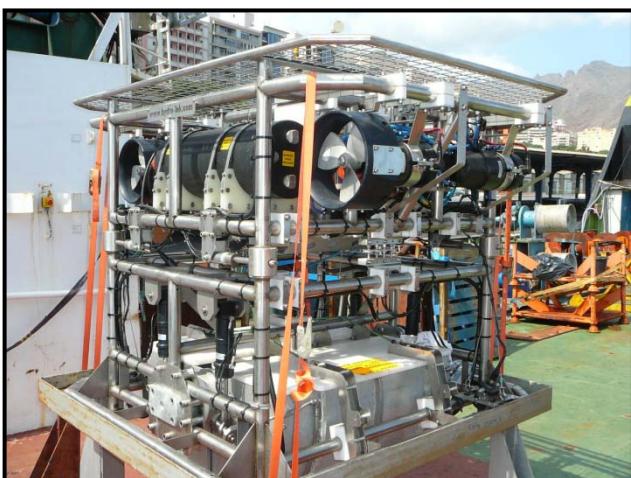
The RO-TVG 'HyBIS' was positioned on the after deck of the RRS Discovery and mounted on its deck frame which, in turn, was mounted to the screw fixture matrix on the ship's deck. The vehicle was attached via a termination bottle (supplied by NOCS' Deep Platforms Group) to a 4700m length of 17mm electrical fibre-optic umbilical cable wound on a portable winch. The winch (a Macartney portable electric winch) required 120Amps of 3 phase electrical supply plus a continuous flow of cooling water from the ship's non-toxic supply. All operations of the vehicle were done according to the procedures described in the risk assessment presented to the ship's master and operators prior to the start of the trials cruise.

Figure 13 The HyBIS vehicle mounted on its deck stand, on the after deck of the RS Discovery

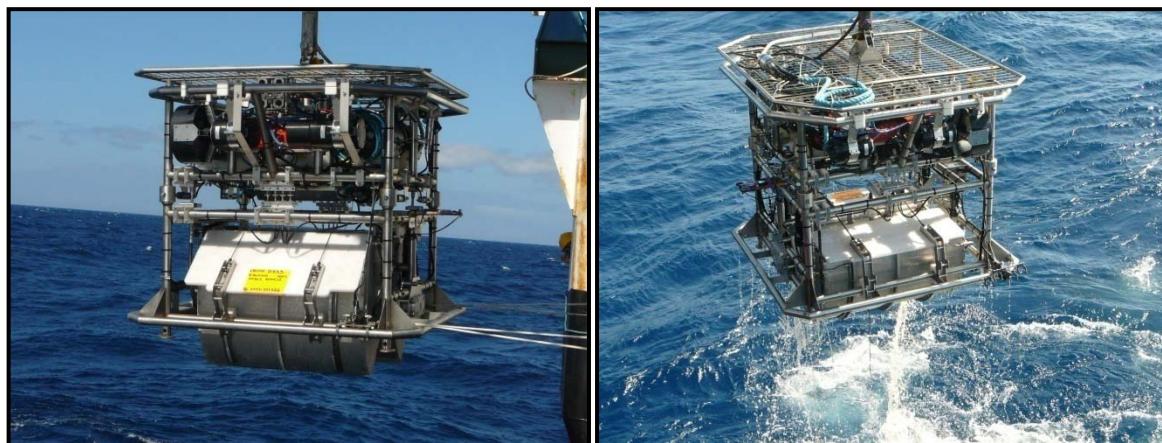
Figure 16 HyBIS launched (left) and recovered (right) over the stern of the RRS Discovery on its first trials dive.

At 1400 GMT HyBIS was launched and descended at 30 metres per minute. The vehicle was fitted with a Sonardine USBL beacon inside the vehicle's frame. At 1458 GMT the vehicle was at 1850m depth and in sight of the bottom. The sea floor was found to be extremely rugged with steep scarpas and rocky outcrops covered in coral. A sample of mixed dead and live was taken at 1351GMT and the vehicle returned to the surface at 40m/min.

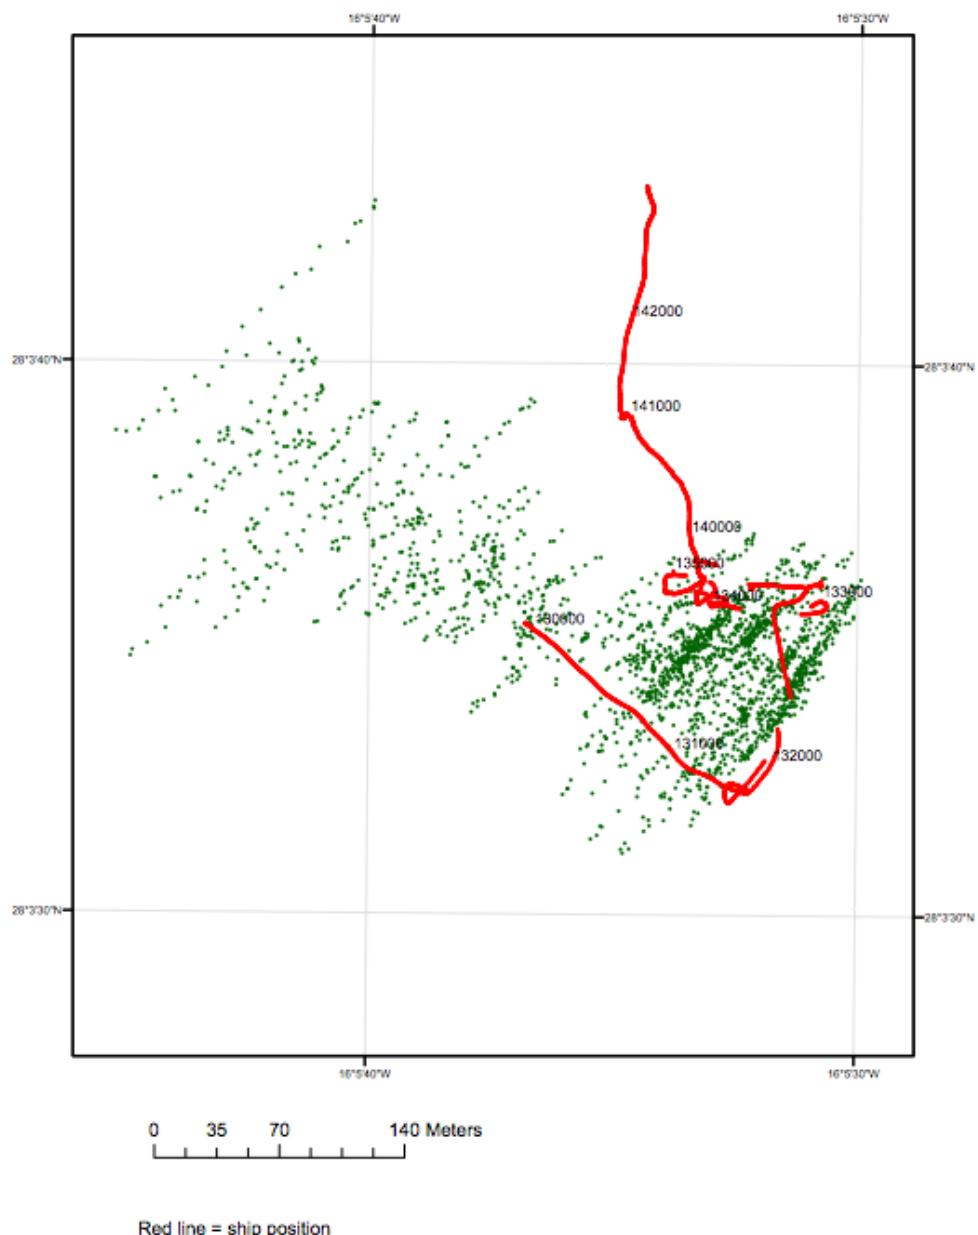
Figure 17 HyBIS dive site 1. Green dots are acoustic USBL navigation or HyBIS. The positions are poor due to a location of the beacon inside the vehicle causing interference

All systems functioned, although the USBL fixes were poor. Vehicle manoeuvrability was good, especially its yaw control with 3° per second lateral rotation. Both forward and reverse thrusters functioned well enabling a radius of manoeuvre of about 30-50m at a speed of 0.3 kts. Both forward and downward lights provided an even illumination with a viewing range of 10 to 20 m. It was difficult to see the contents of the grab when it closed due to sediment clouds inside the bucket. Once cleared, the sample was evenly illuminated and clearly visible. The vehicle suffered minor impact damage to its bottom frame from rocks and requires some form of impact protection.

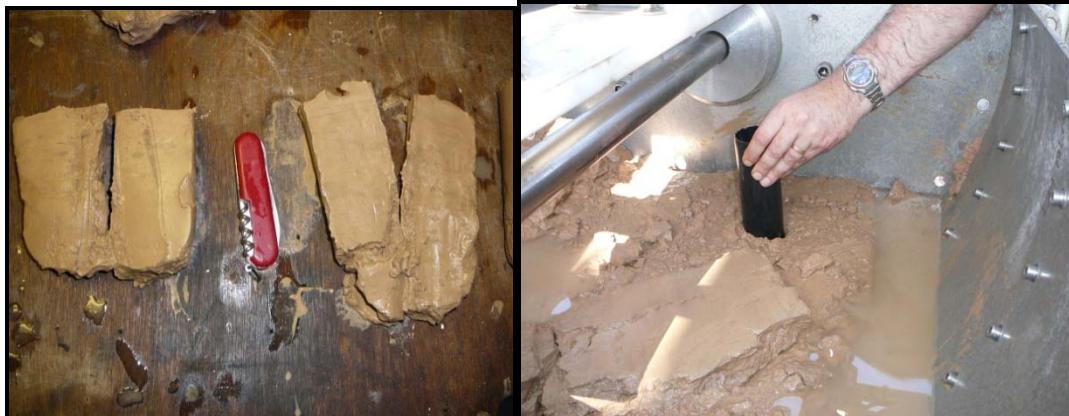
Figure 19 HyBIS Sediment sample taken using an improvised push core. Results of push cores: minimally disturbed sediment profiles.

All systems functioned, although the USBL fixes remained poor with an error of 50 to 100m at 2900m water depth. Vehicle manoeuvrability was good achieving a radius of manoeuvre of about 50m at a speed of 0.3 kts. The sample was cored using a push core at the surface, on deck. The cores was relatively homogeneous but not disturbed, although the surface of the sample was.

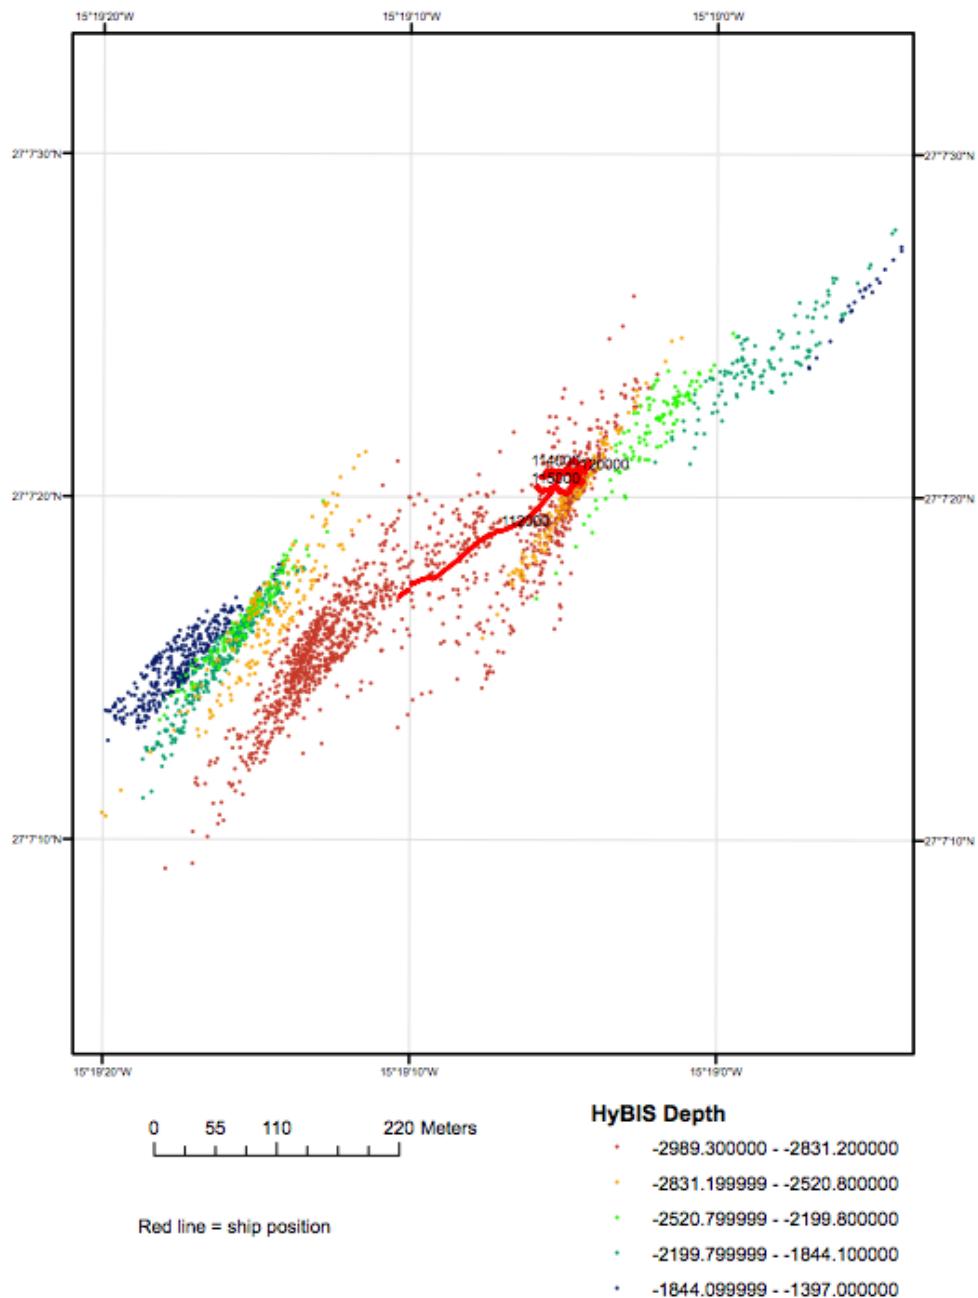
Figure 20 HyBIS dive 2 coloured dots are acoustic USBL navigation of HyBIS. The positions are poor due to a location of the beacon inside the vehicle causing interference.

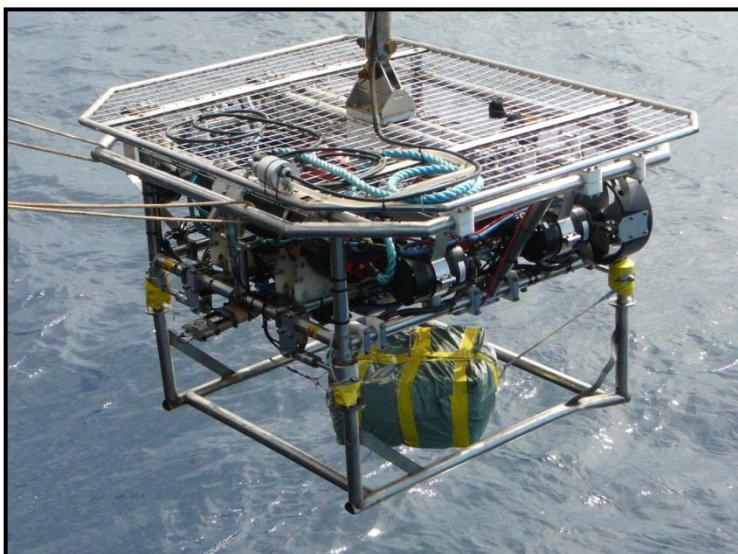
Figure 21 HyBIS configured as a payload delivery vehicle. A 50kg payload was slung under the vehicle and suspended on lines attached to the hydraulic release bolts.

At 1230 GMT HyBIS was launched and descended at 30 metres per minute. The vehicle was fitted with a Sonardine USBL beacon outside the vehicle's frame and another beacon 50m up on the umbilical wire. At 1333 GMT the vehicle was at 2325m depth and in sight of the bottom. The sea floor was found to be flat and covered in clay ooze. Vertical visibility was at least 18m. USBL position fixes were good from both vehicle and wire (error ±5m). At 1348 GMT the package was released, but one of the tag lines failed to let go. It was found to have been wrongly fastened.

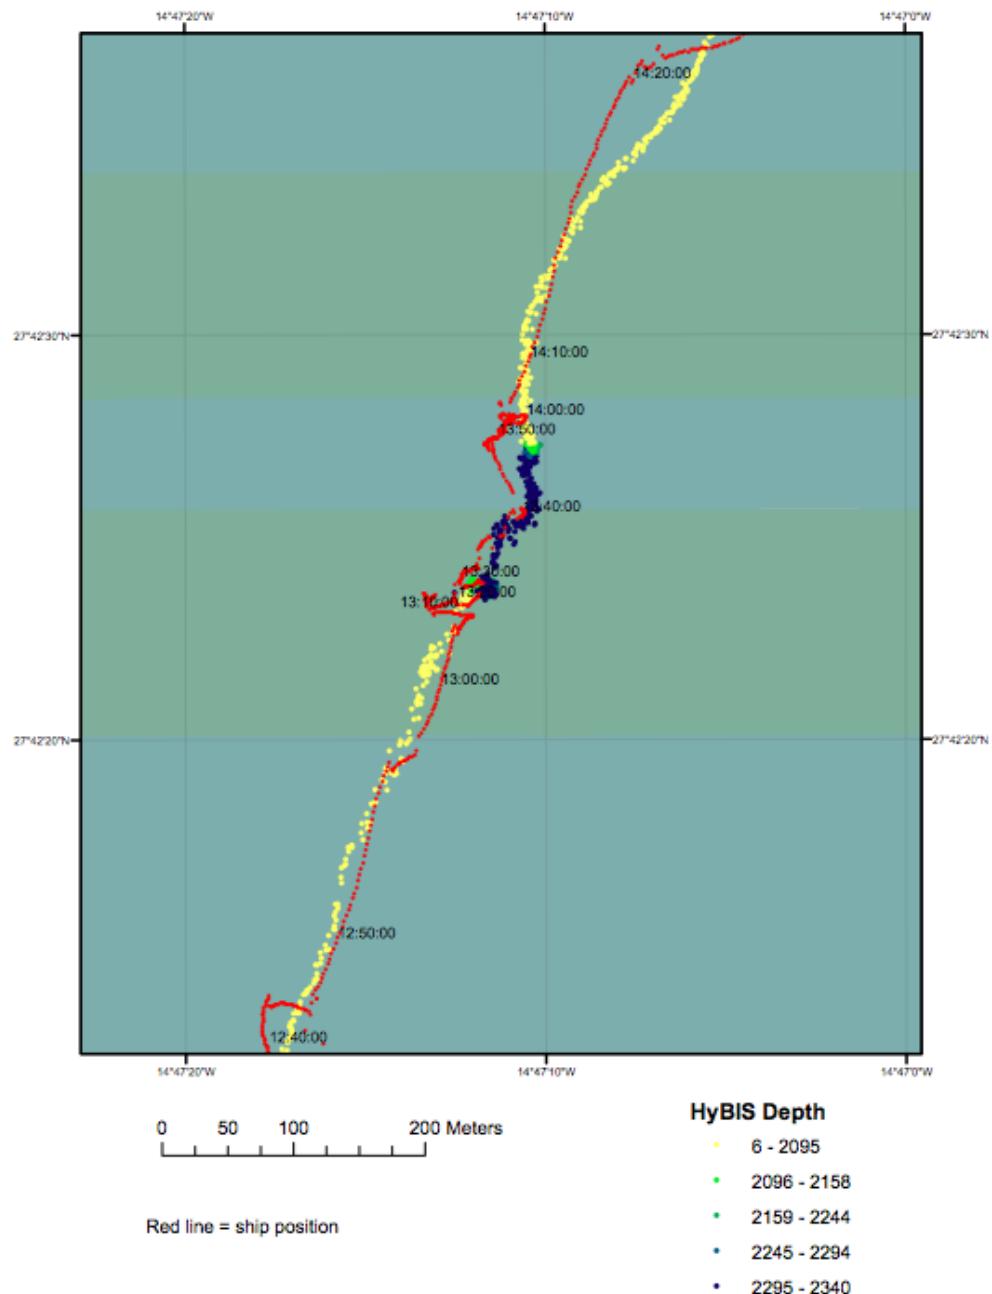
Figure 22 HyBIS dive site 3 depth coloured dots are acoustic USBL navigation or HyBIS. The positions are good to within  $\pm 3$ m due to a location of the beacon on the outside of the vehicle.

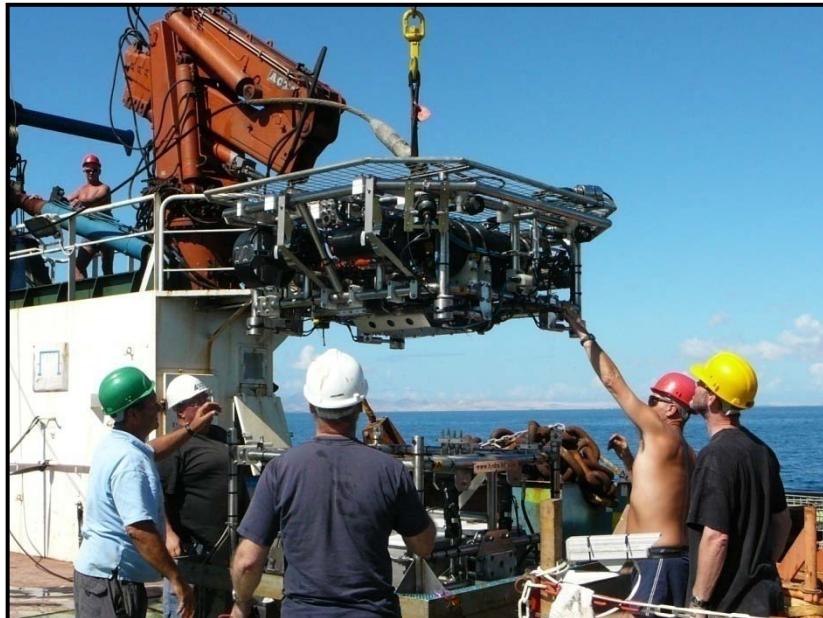
Figure 23 HyBIS being split in preparation for its configuration as a payload delivery vehicle. The command module readily pulls apart from the bottom sampler

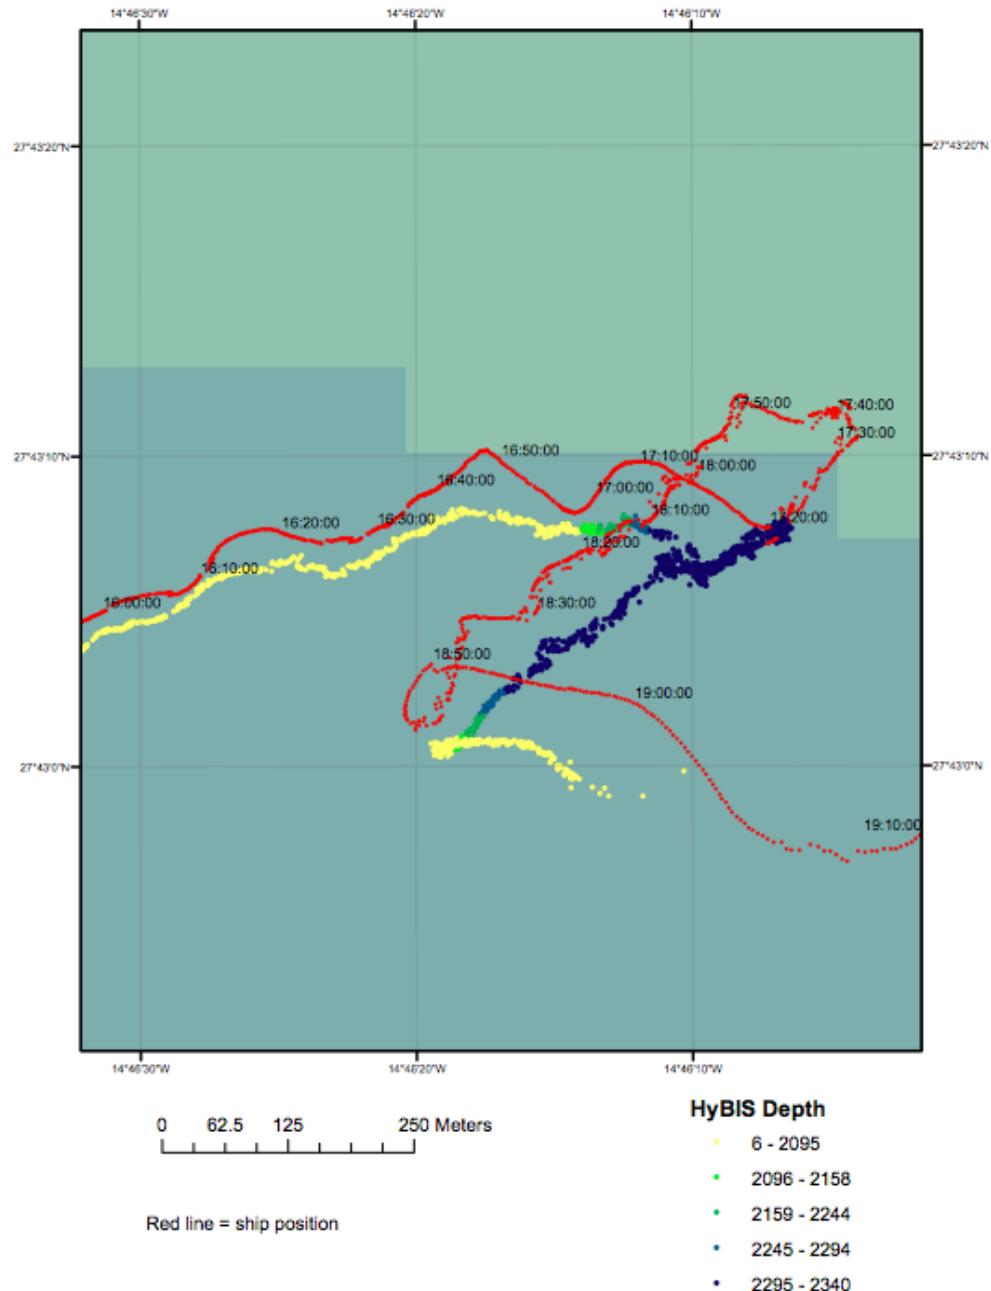
Figure 24 HyBIS dive site 4. Depth coloured dots are acoustic USBL navigation of HyBIS. The vehicle was able to manoeuvre within a 50-100 metres radius from the ship.

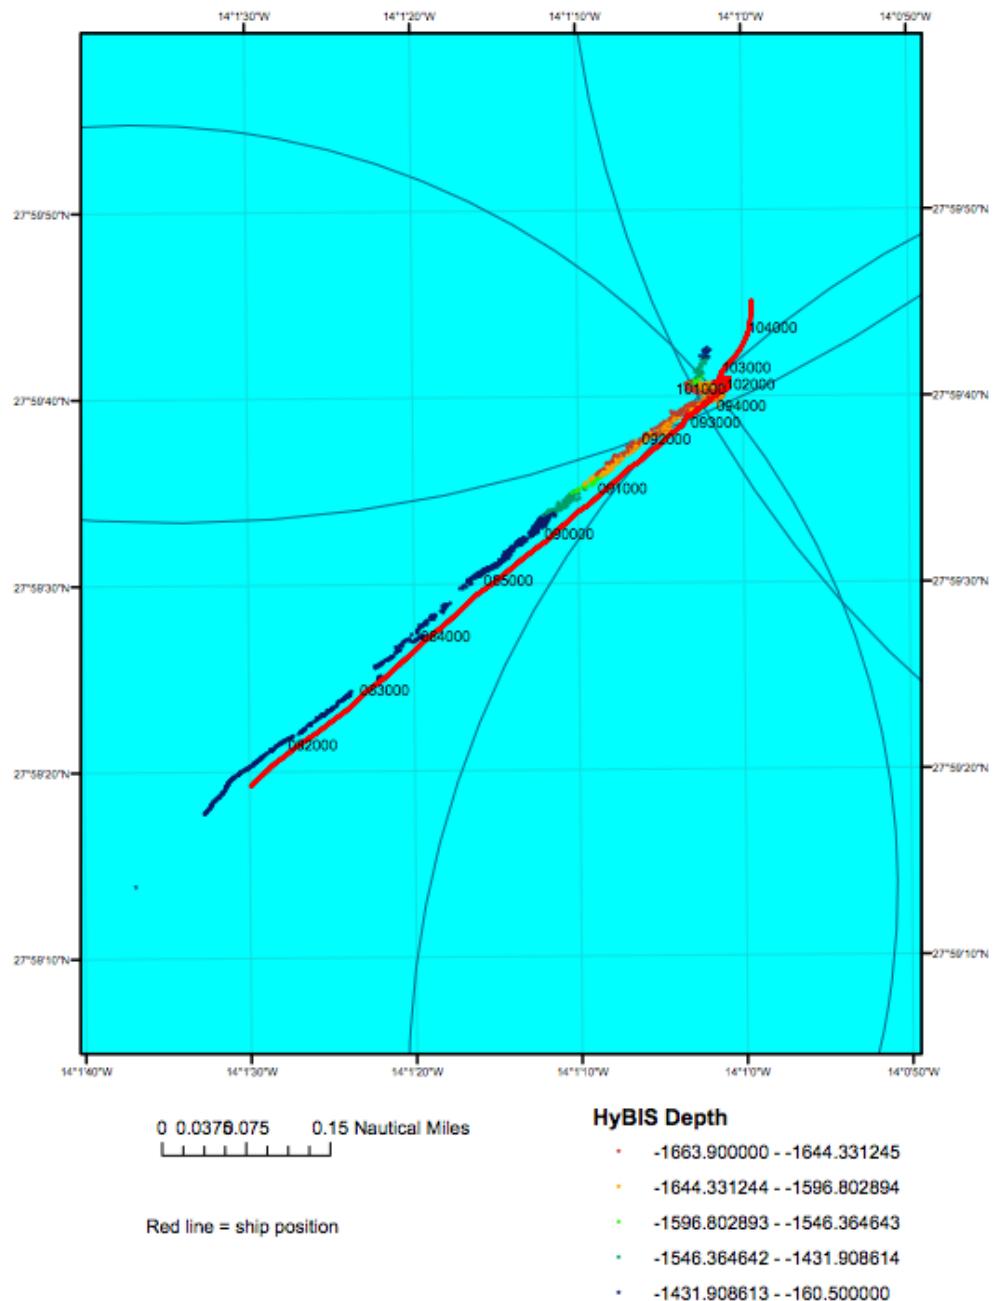
Figure 26 HyBIS dive site 5. Depth coloured dots are acoustic USBL navigation or HyBIS. The arcs describe the ranges to the POL lander made using its acoustic releases. The vehicle was able to manoeuvre within a 50 metres square, formed by the intersection of the arcs

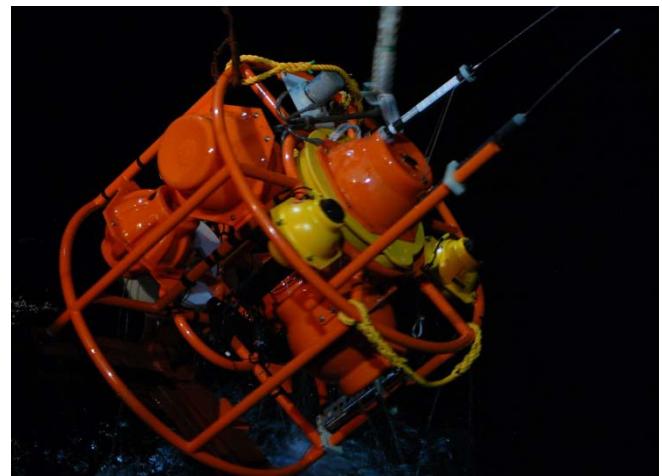
**Figure 28** HyBIS and the POL lander recovered to the surface and lifted clear of the water at the end of the search and rescue mission

The vehicle proved its capability to relocate a target, attach a line and recover a heavy and large payload. The method of deploying a grapple on a 10m rope below the vehicle was not optimal and would have been better loosely secured to a boom extending to the front of the vehicle. This would have enabled better control and visibility of the grapple. The method of securing the line to the grab bucket, enabling an emergency release of the payload was successful.

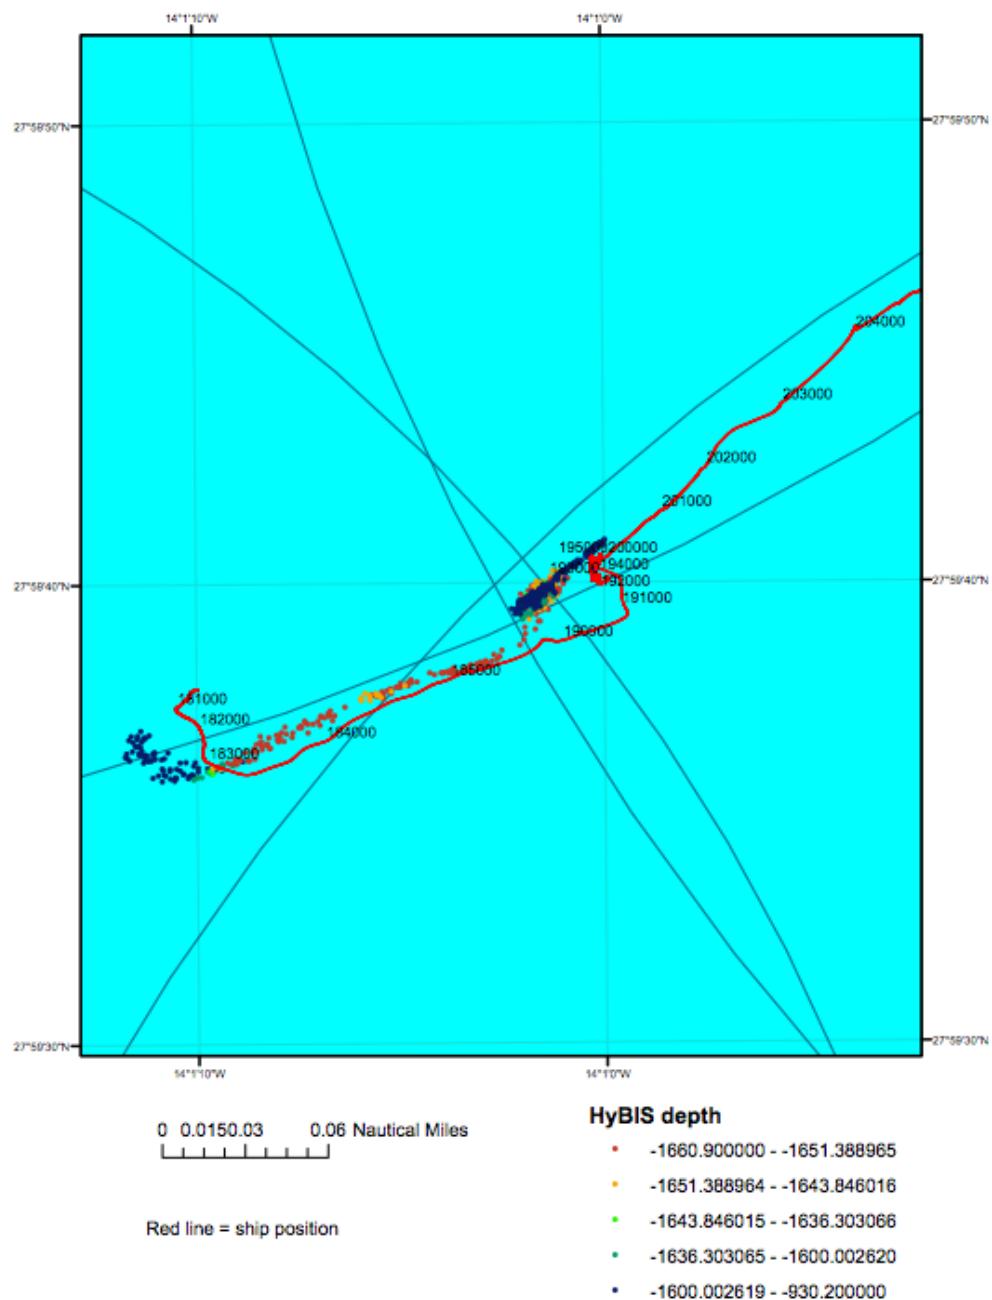
Figure 29 HyBIS dive site 6. Depth coloured dots are acoustic USBL navigation or HyBIS. The arcs describe the ranges to the POL lander made using its acoustic releases. The vehicle was able to locate and recover the lander

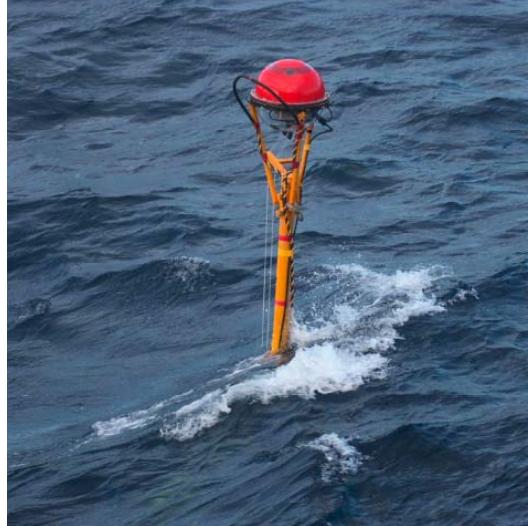
Figure 30 A breaking wave passing through the spar buoy (left) and configuration of the three wave wires

The spar buoy is 11 m in length and constructed of Aluminium to save weight. The buoy floated vertically in the water and uses specially aligned weights to orientate the buoy into the wind (Figure 1a). Two 12 V batteries are located at the base of the buoy and were used to power the instruments and logging systems. The buoy was ballasted by a 40 kg weight deployed 10 m below its base for all deployments (Table 2). Three 4m wave wires stretched along most of the top yellow section and were used to measure the wave height relative to the buoy. The three wave wires are perpendicular to each other and separated by a distance of 0.14 m (Figure 1b). The orange dome contained the wave wire electronics, a digital video recorder and a stills camera to record the images of the waves and identify breaking waves.

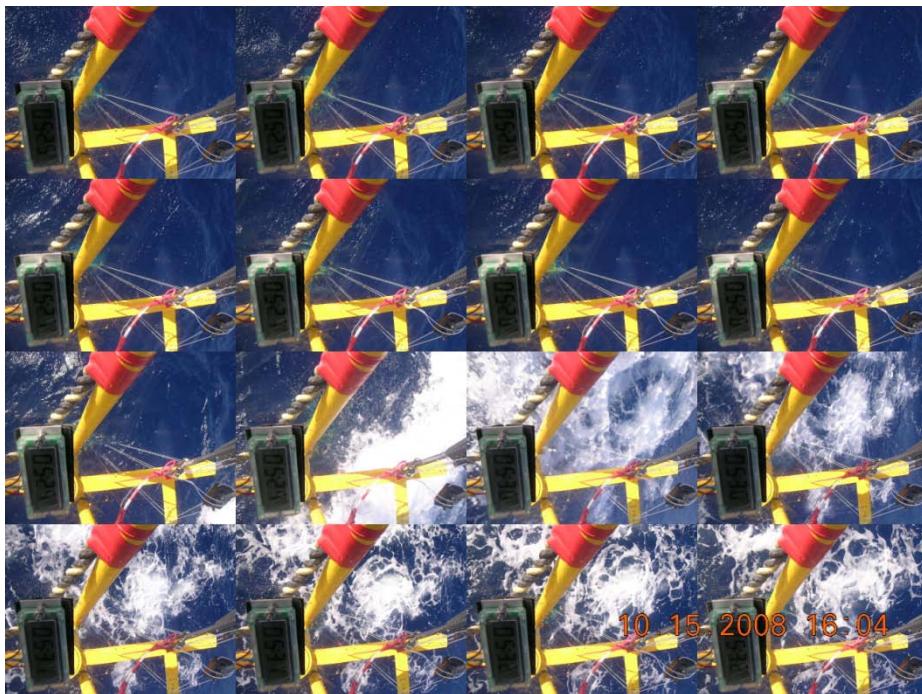
Figure 31 Spar Buoy Images from the stills camera showing the breaking wave shown in Figure 23 A breaking wave passing through the spar buoy (left) and configuration of the three wave wiresFigure 23. Each image is taken at approximately 0.5 seconds intervals.

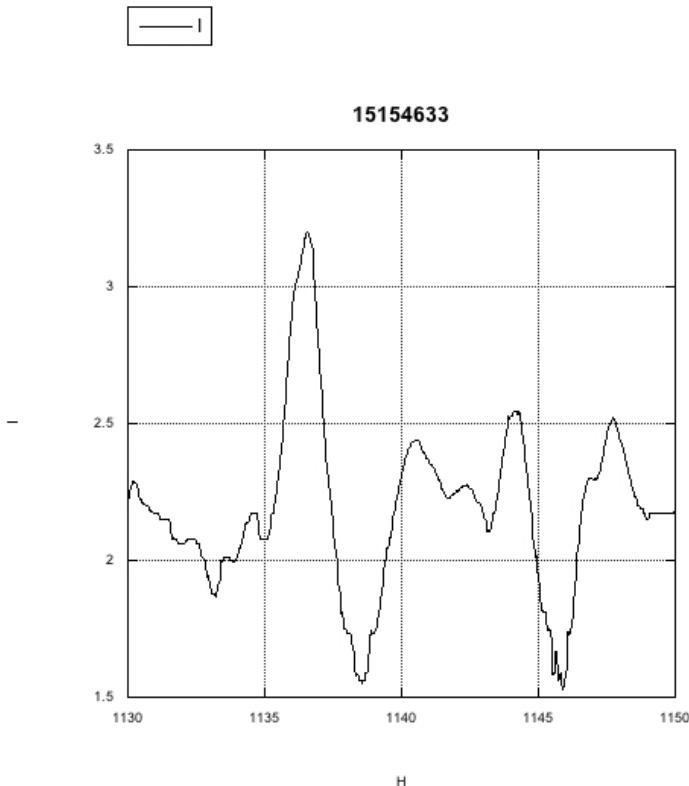
**Figure 32** A 20 sec example of a wave trace from wire 0. The large wave with a steep peak coincides with the breaking wave identified in both video and stills camera images (Figure 24).

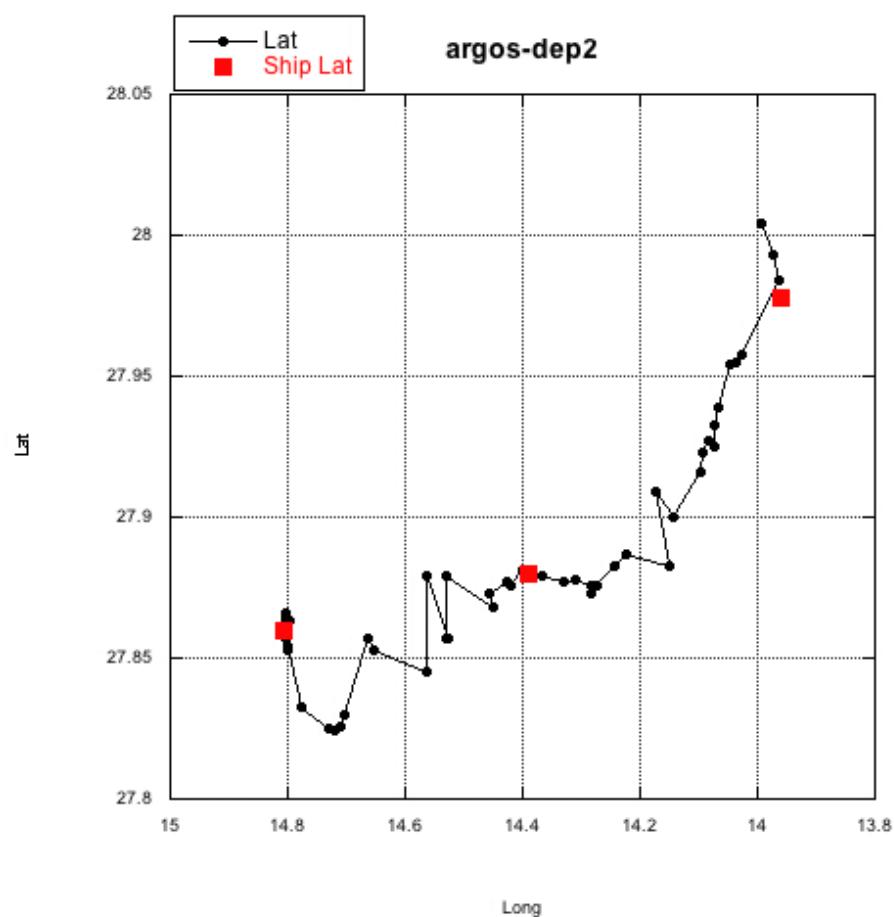
Figure 33 Track of Spar Buoy during deployment 2. Buoy Argos data (Black circles), Ship fixes (red squares).

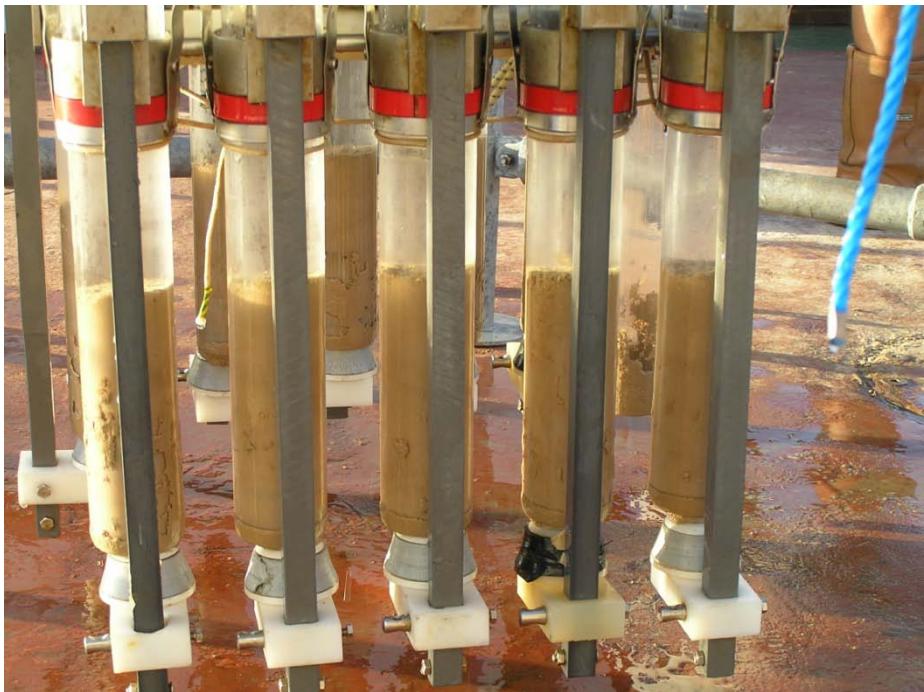
Figure 35 Image of multicore samples showing all tubes had penetrated and sealed successfully

Both deployments resulted in good samples which varied from 150mm to 210mm depth. The water sample trapped above the sediment was clear and showed little or no signs of disturbance. The external frame showed no signs of distortion or damage after deployment. The corer was washed in fresh water after the second deployment.

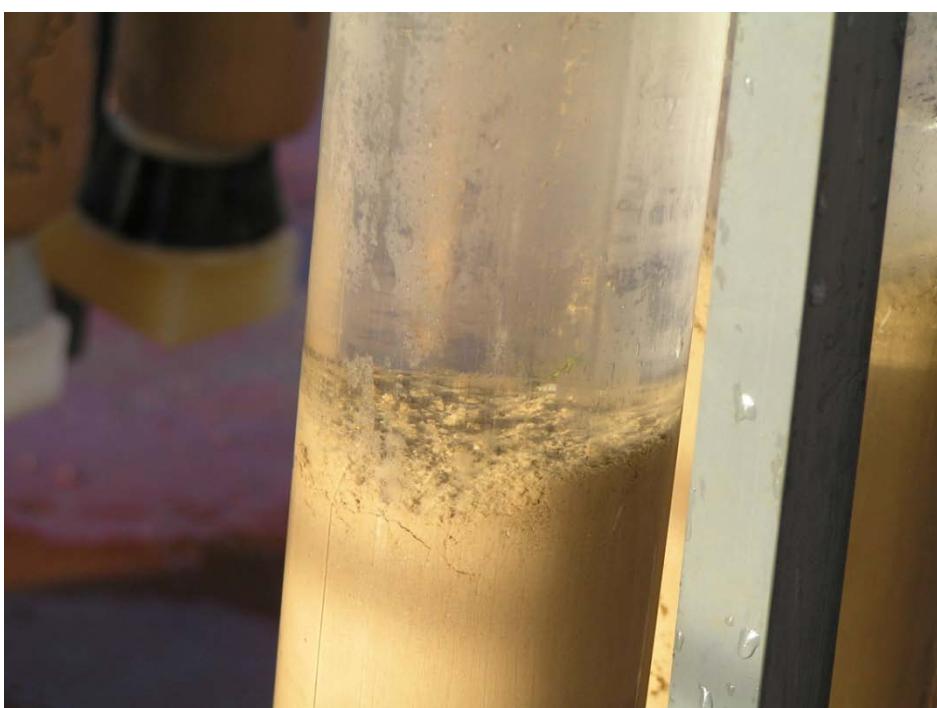
Figure 36 Detail of sediment water interface showing very little disturbance

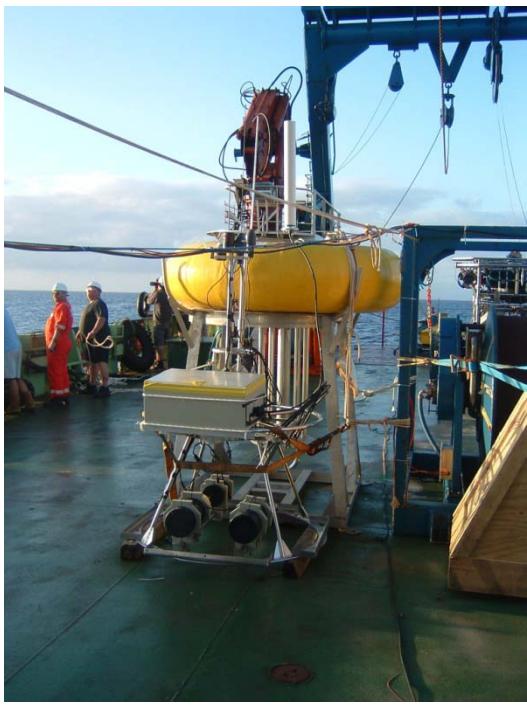
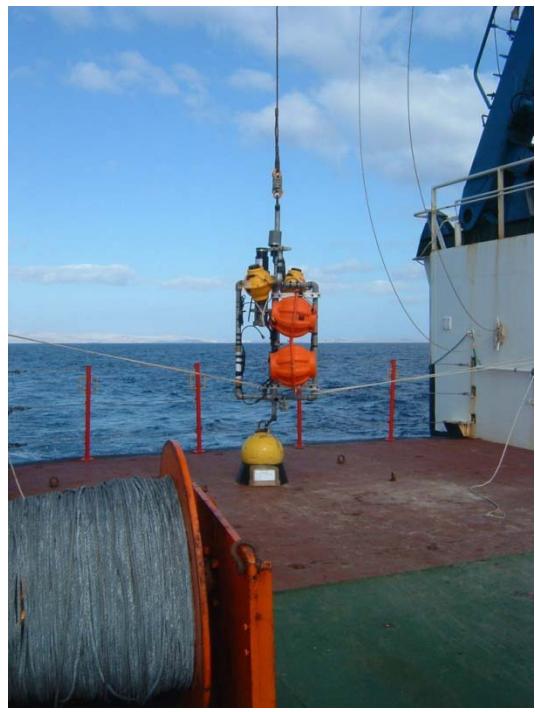
Figure 37 Wire test setup

a– Telemetry tower on the after deck with antennas, battery packs and satellite modems attached

b – Wire test frame before deployment with LinkQuest and Benthos acoustics attached and a Seabird MicroCAT

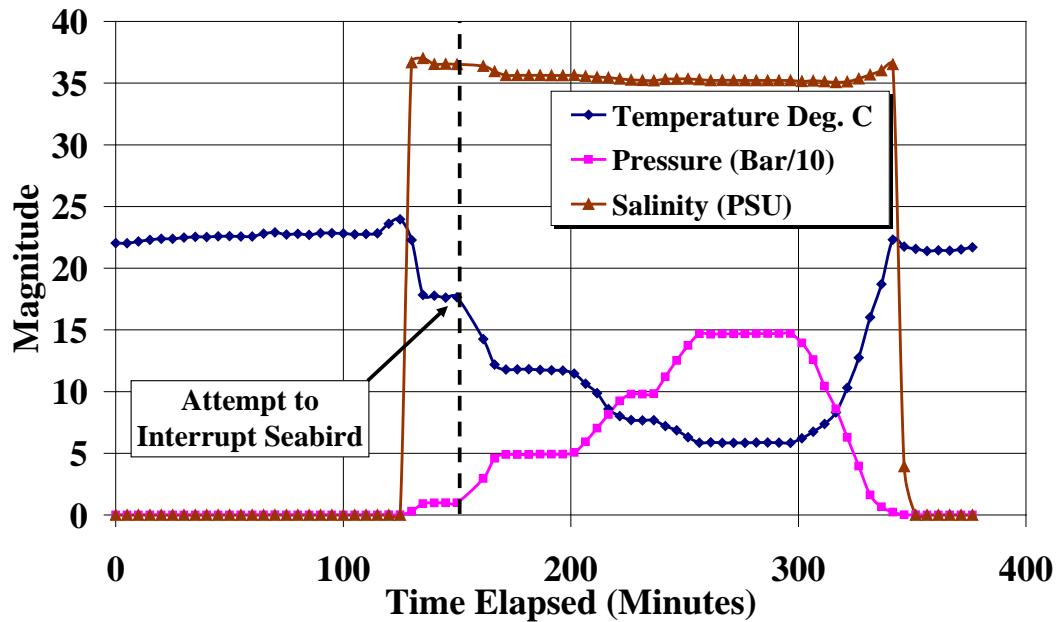
Figure 38 Recorded MicroCAT data

The test began at 10:45GMT and finished at 14:00GMT. At noon a request to change the MicroCAT sample rate from 5 minutes to 15 minutes was issued. Although the Orbcomm modem received this command and processed it, the acoustic link proved to be problematic, preventing the MicroCAT sample rate from being changed. Corrupted data were regularly being transferred from the bottom modem to the surface modem, which prevented the bi-directional data transfer from operating correctly. A plot of the recorded MicroCAT data is shown in Figure 28. During the trial only one attempt was made to interrupt the MicroCAT logging. Problems associated with the acoustic link and the subsequent corruption of the data resulted in the attempts to re-configure the MicroCAT sample rate failing.

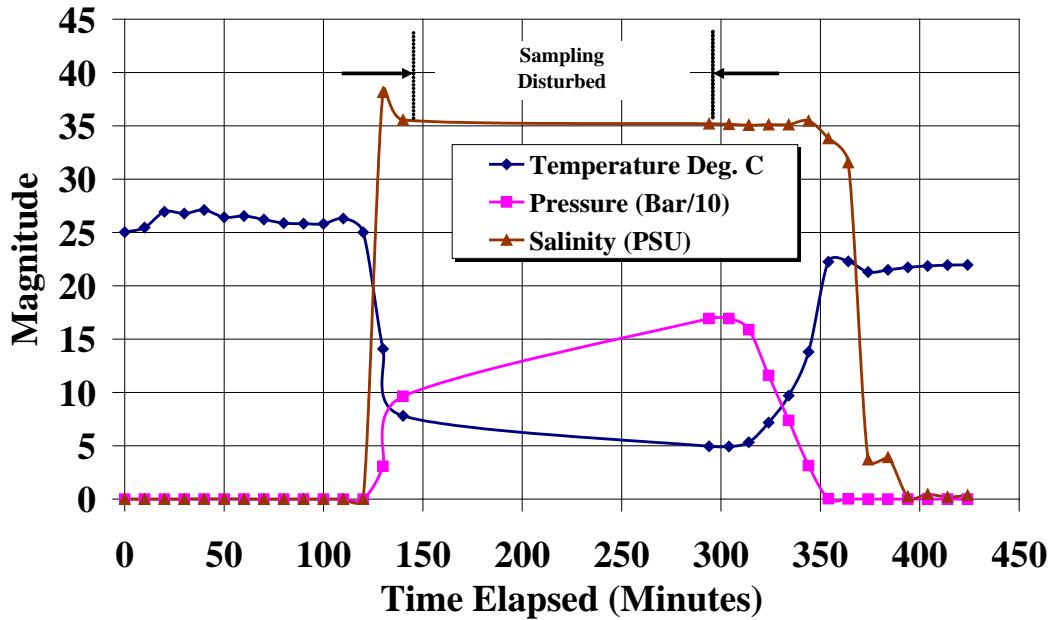
**Figure 40 Recorded MicroCAT data for full deployment 1**

Drift of the buoy meant that there was a 2 hour window to conduct the test due to the LinkQuest deep water acoustic modems having a beam angle of  $70^\circ$ , which corresponds to a surface range of approximately  $\pm 1\text{km}$  from the deployment site. During the test an e-mail command was sent from POL and although the acoustic data link was problematic an attempt was made to disturb the MicroCAT on the sea bed, as shown in the plot of the recorded data in Figure 30. It is evident is that the surface buoy has attempted to communicate with mini-MYRTLE via the acoustic link and the MicroCAT sampling has been disturbed.

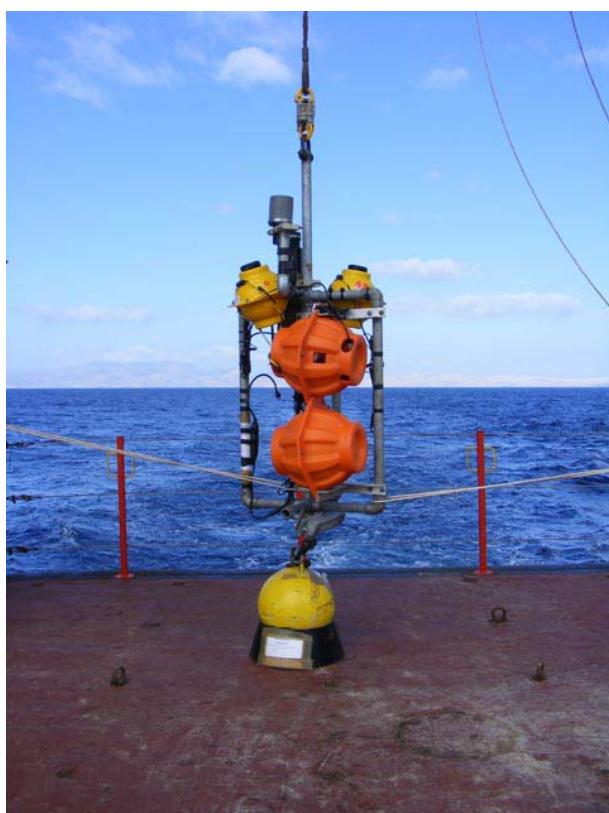
A wire testing assembly was constructed from scaffold pieces, and the equipment to be tested was bolted, clamped or taped to the frame.

Figure 42 Acoustic release and benthos smart modem wire test assembly

The wire test assembly was lowered to a depth of 500m on 15/10/08 and then stopped. A range of tests were conducted with the Benthos XT6001 acoustic releases and also the Benthos Smart Modem. Once these tests were completed, the frame was lowered to 1000m and then stopped. The tests were repeated and then the frame lowered to 1500m. At this depth the tests were repeated again and an additional test of firing the burn wire releases was performed. All acoustic systems were responding well and giving clear indications of acting upon the commands transmitted. Once the tests were completed, the frame was brought back to the surface and when examined, the releases had successfully operated the burn wires.

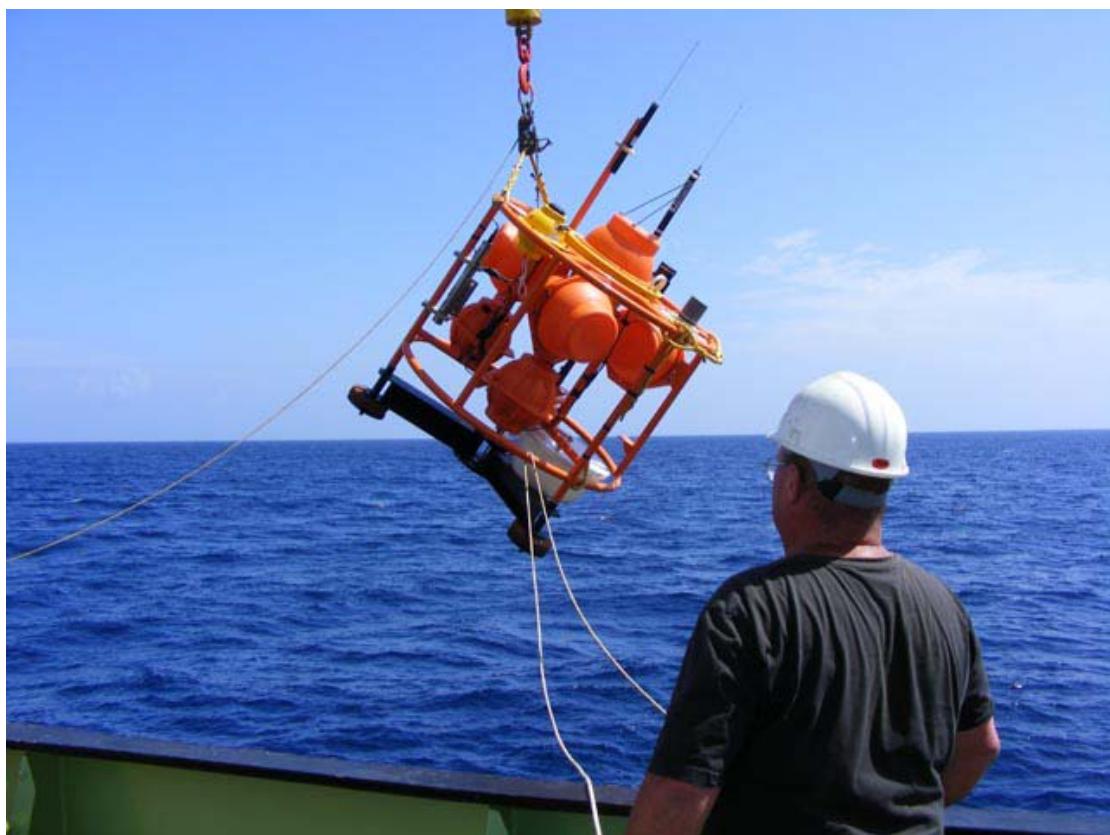
**Figure 43 Benthic Lander (Mini-MYRTLE) deployment 1**

The mini-MYRTLE X frame was deployed at 27° 59.927' N, 14° 02.095' W on 17/10/08 and tracked acoustically to the seabed. A range of acoustic tests were done and all performed normally.

The POL telemetry buoy was then deployed and tracked as it passed over the lander site. When it was about 1 mile past the lander position and getting further away, it was retrieved and then the frame was recovered. The acoustic conditions were good and release code D was sent to the 11.5 kHz release. The lander has two acoustic releases fitted to it as redundancy, in case a failure occurs in one of them. The release command was not transmitted to the 10.5 kHz release. It took about 45 minutes for the frame to reach the surface after releasing.

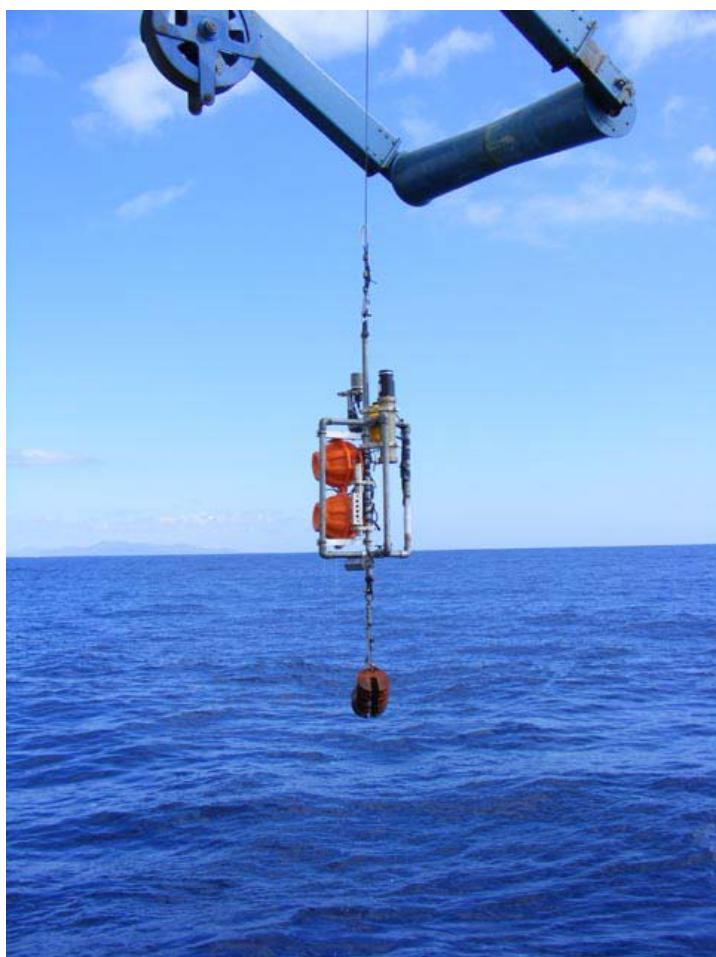
Figure 45 Acoustic release and benthos smart modem wire test assembly test 2 on CTD gantry

Acoustic conditions were dreadful. It was very difficult to even obtain range readings. The release command was transmitted to the Benthos XT6001, but on recovery it hadn't activated.

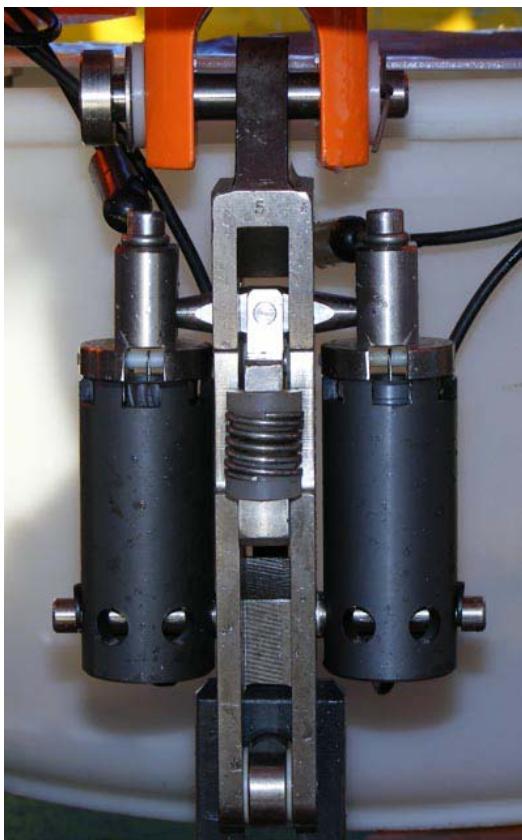
On examining the release system on the frame, it was found that none of the burn wires had operated.

**Figure 46 Detail of acoustic release that failed to release the lander at depth. The photograph was taken very shortly after retrieval and indicates that mechanical failure was not the cause.**

As soon as one of the burn wire modules was removed, the release gate operated, dropping the plastic end of the retaining bar. This confirmed that it wasn't mechanical failure of the release gate.

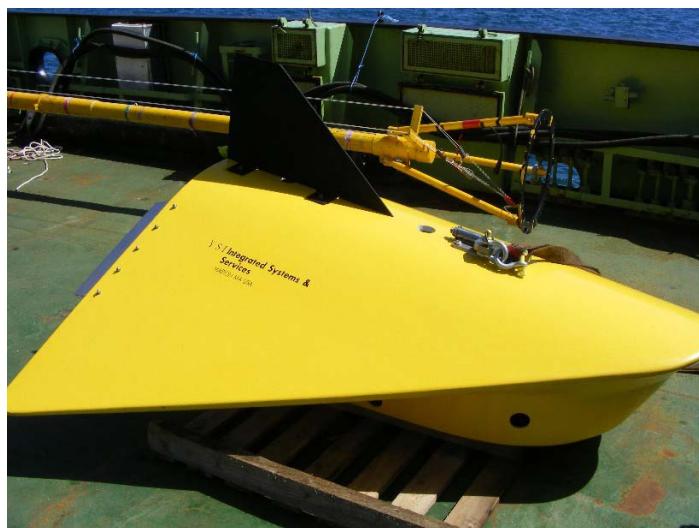
Figure 47 YSI V-Fin Model 671

The V-Fin is a towed instrument platform manufactured by YSI. It is a “depressor” designed to produce a downward force while being towed in order to keep it as low as possible in the water. Its depth is controlled by a combination of towing wire length and speed. POL recently purchased a model 671 V-Fin for use in near-surface waters to measure fast sampled currents probably in association with POL’s recently developed towed thermistor-fluorometer chain.
