# D333: Multidisciplinary Equipment TRIals Cruise (METriC)

*14-23 October 2008, Canary Islands*

*Cruise report*

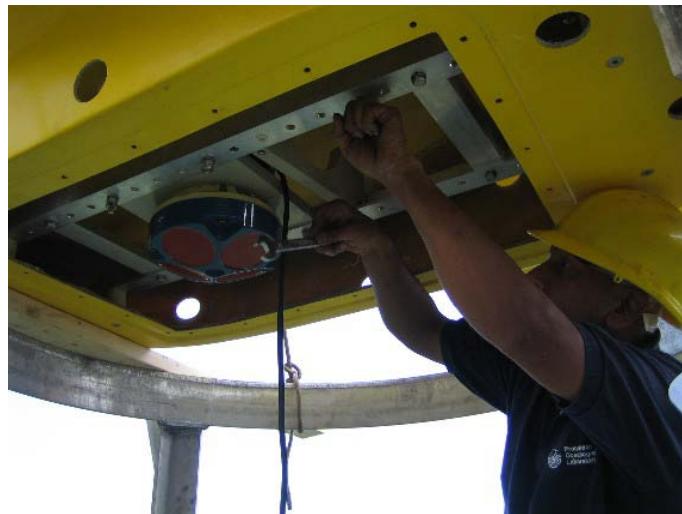
Figure 48 Downward facing RDI ADCP on YSI V-Fin

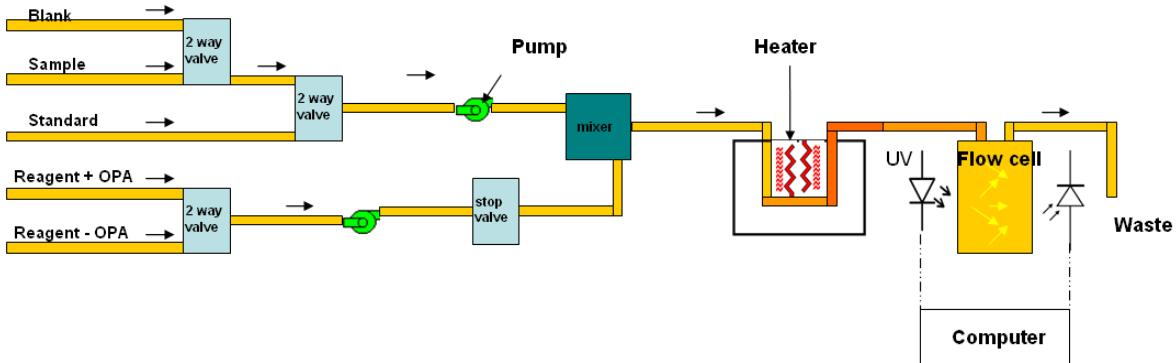
**Figure 50 Schematic of the Ammonium Sensor System Components**

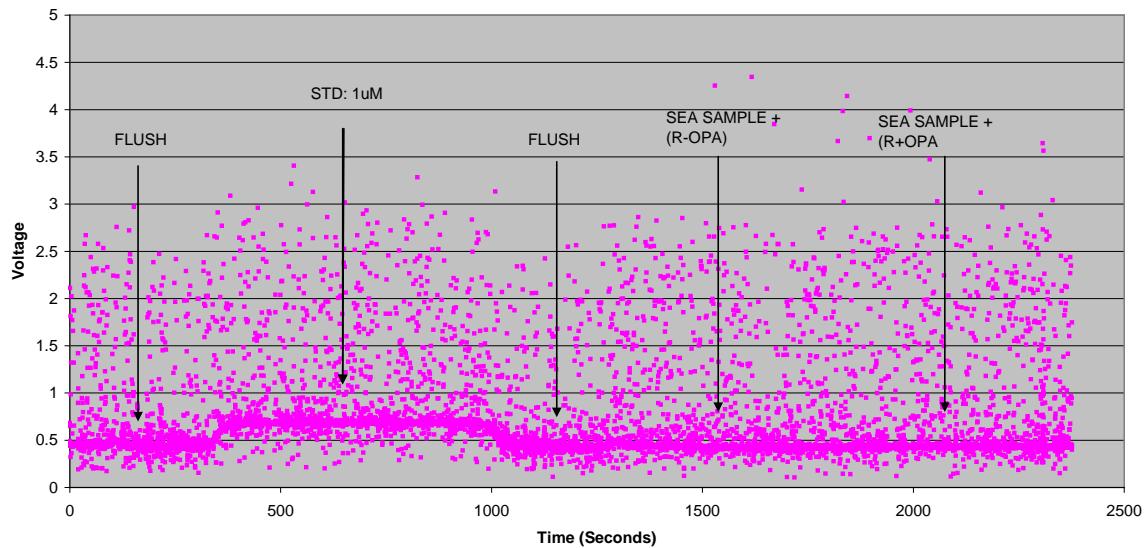
Figure 51 Resolving 50nM of NH<sub>4</sub><sup>+</sup> using a photodiode

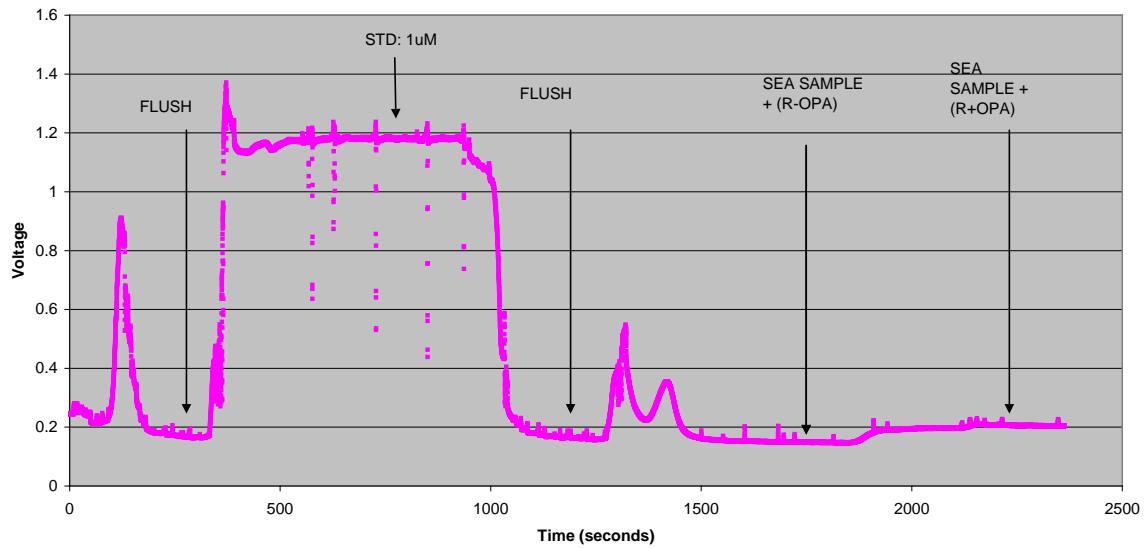
Figure 52 Resolving a 50nM of NH<sub>4</sub><sup>+</sup> using a PMT

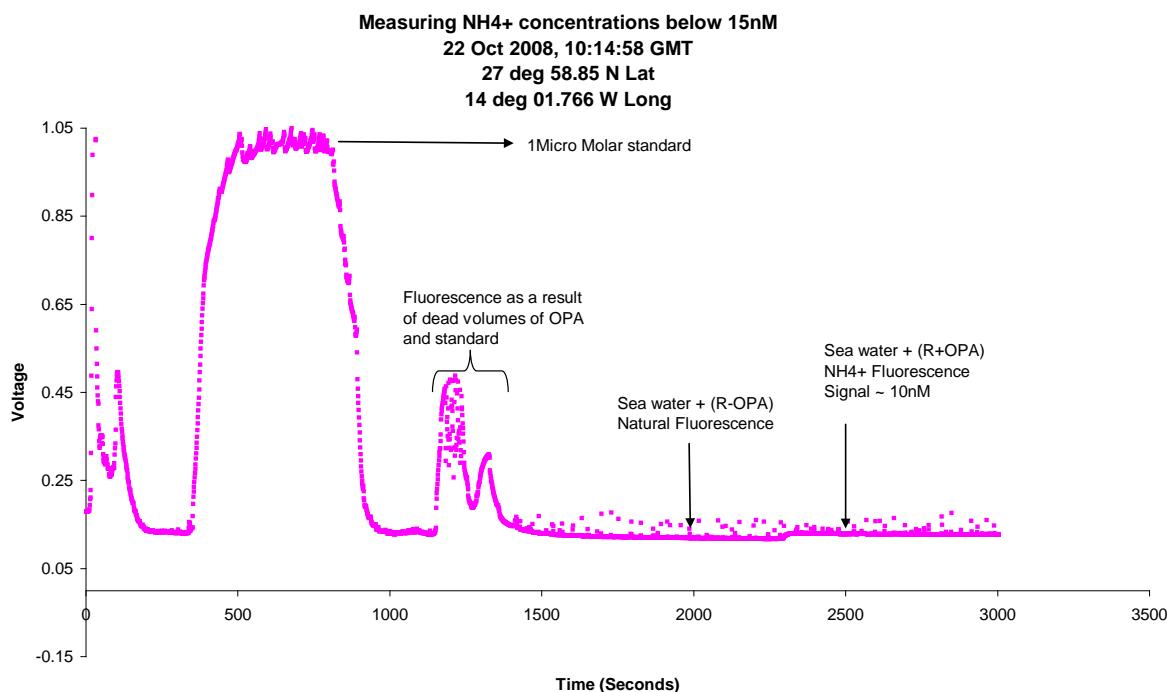
Figure 53 Measuring 10nM NH<sub>4</sub><sup>+</sup>

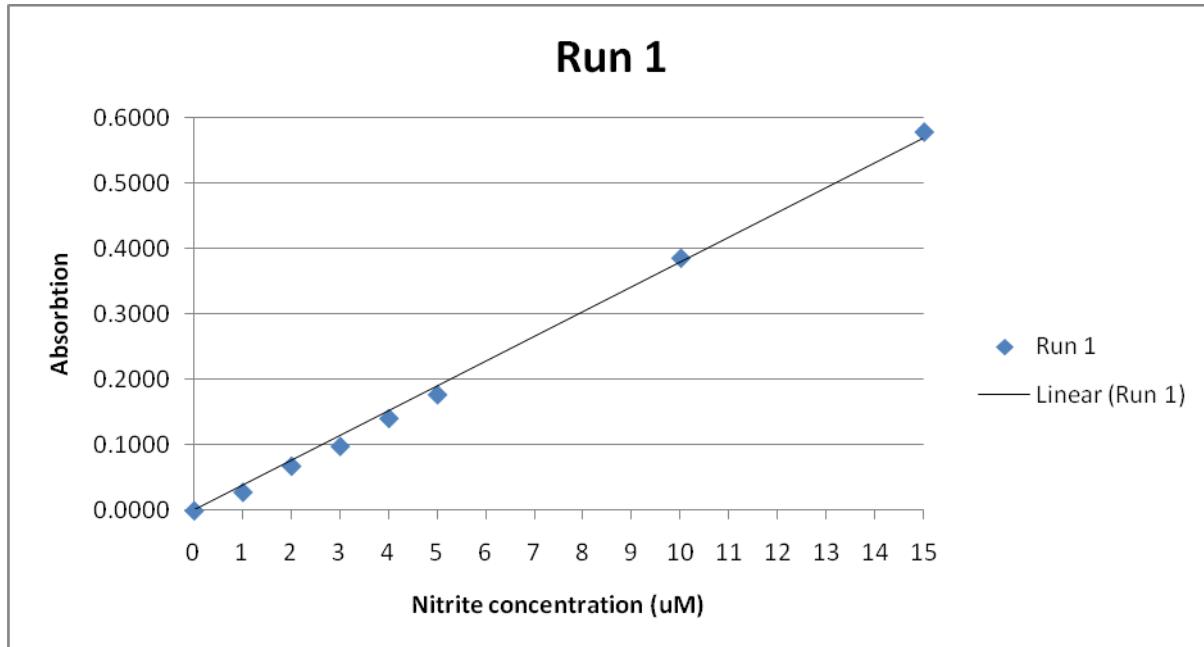
Figure 54 Example calibration data for Lab on a chip nitrite analyser

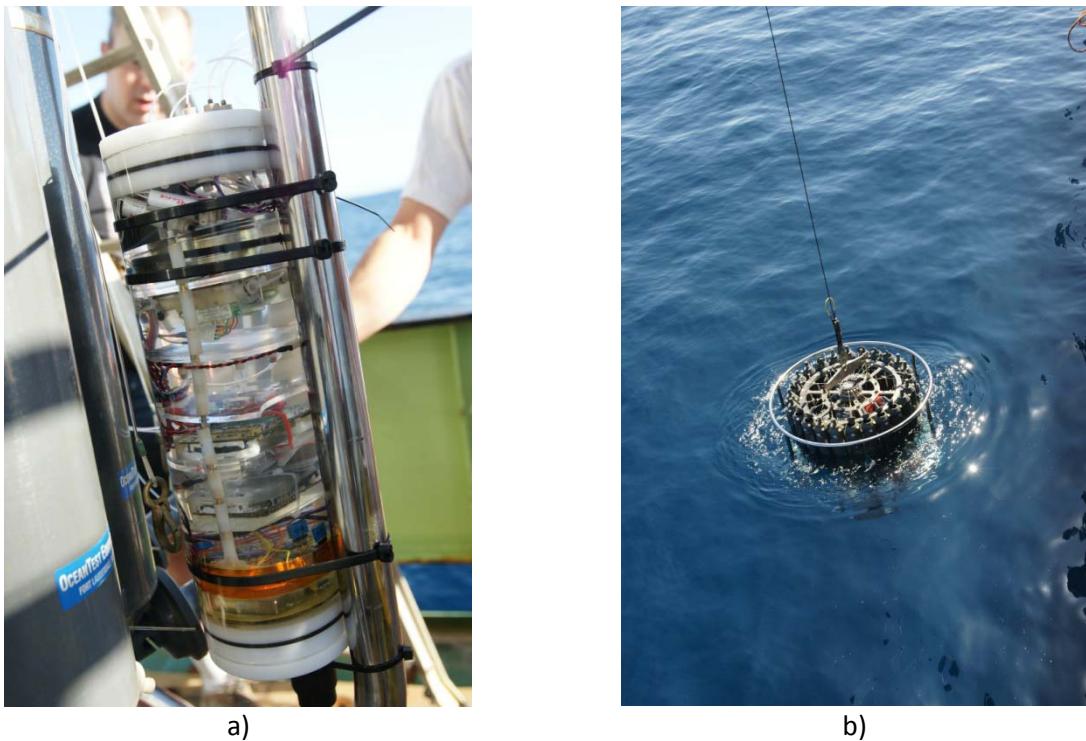
Figure 55 Lab on a chip chemical analyser a) as installed on CTD frame b) entering the water

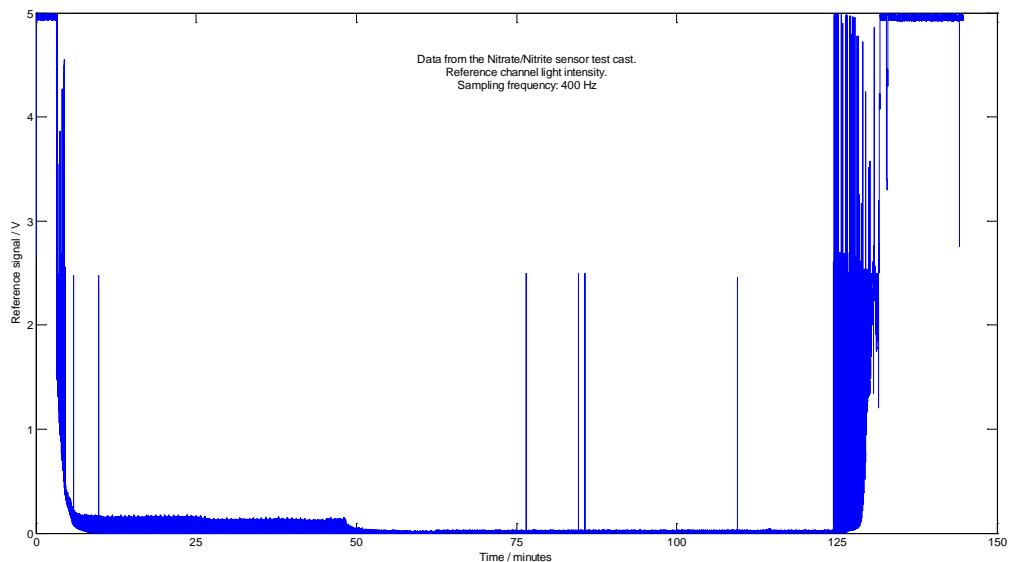
**Figure 57 Double beam spectrophotometer reference channel station 16475#H**

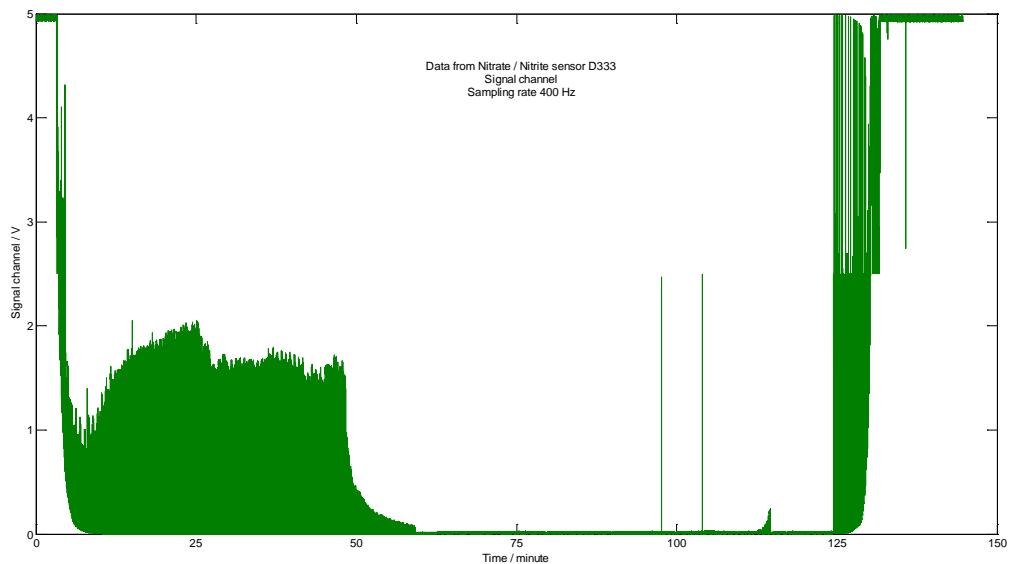
**Figure 58 Double beam spectrophotometer signal channel station 16475#H**

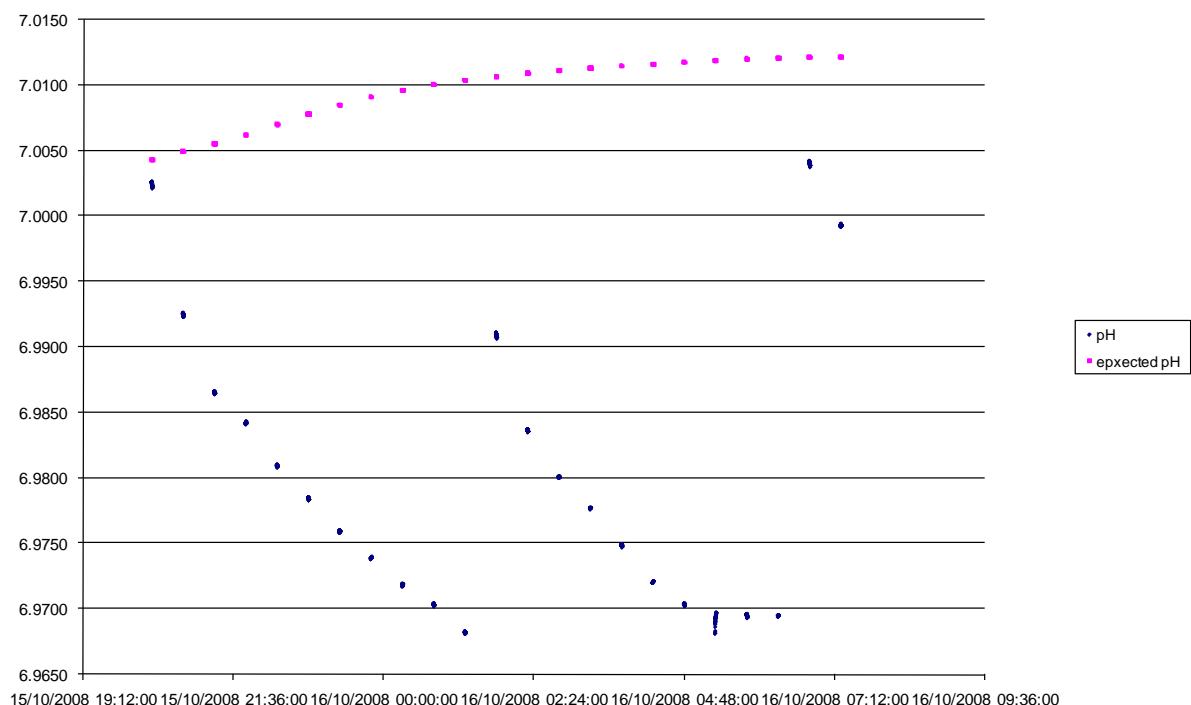
Figure 59 pH data from the long term stability test using the in line pH module. Blue are the actual data, pink are the expected pH values from the buffer vs T curve. Data collected over night using the timed data collection function: 100 points at 10 Hz every 30

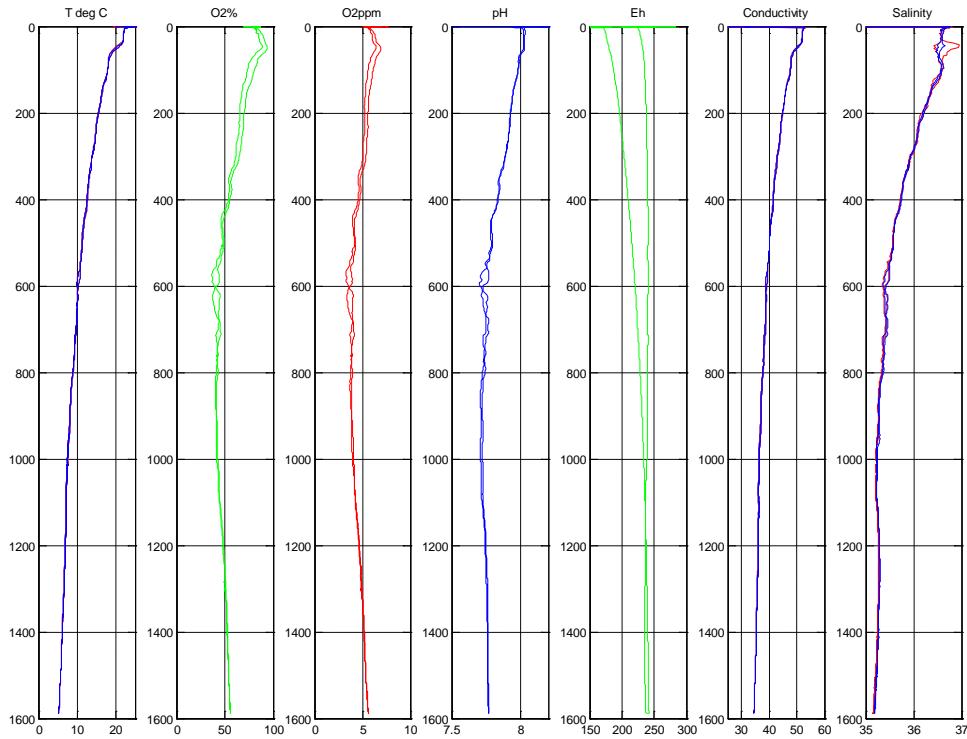
**Figure 60 Example of the data obtained during a CTD cast. All the variables are plotted against pressure in dbar.**

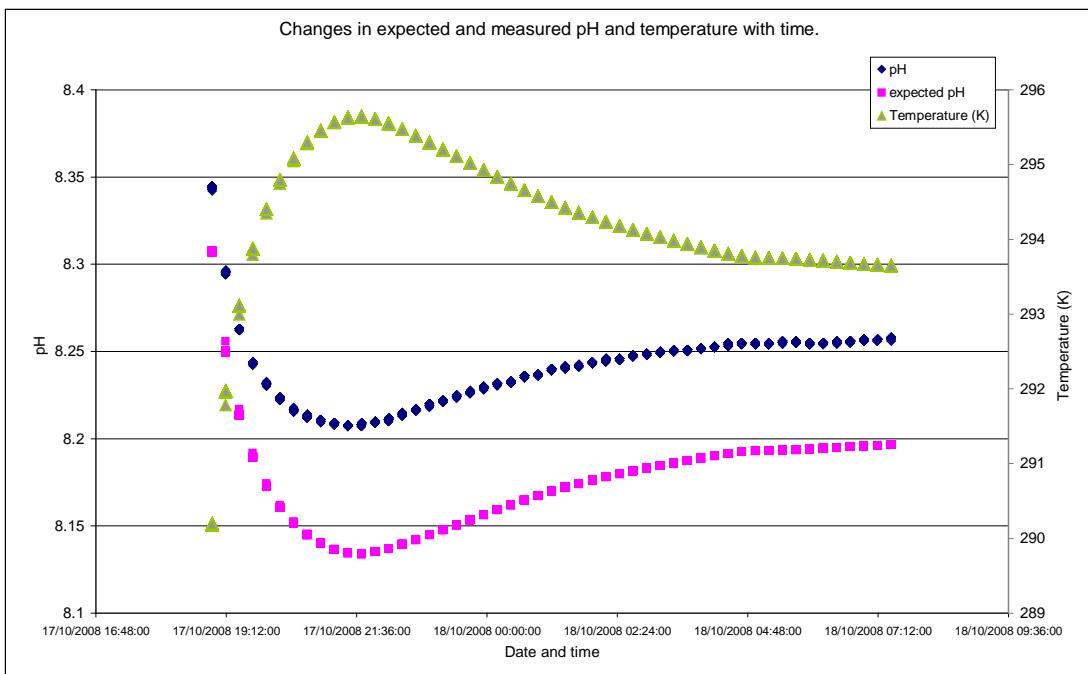
**Figure 61 pH measured, pH expected and temperature vs. time**

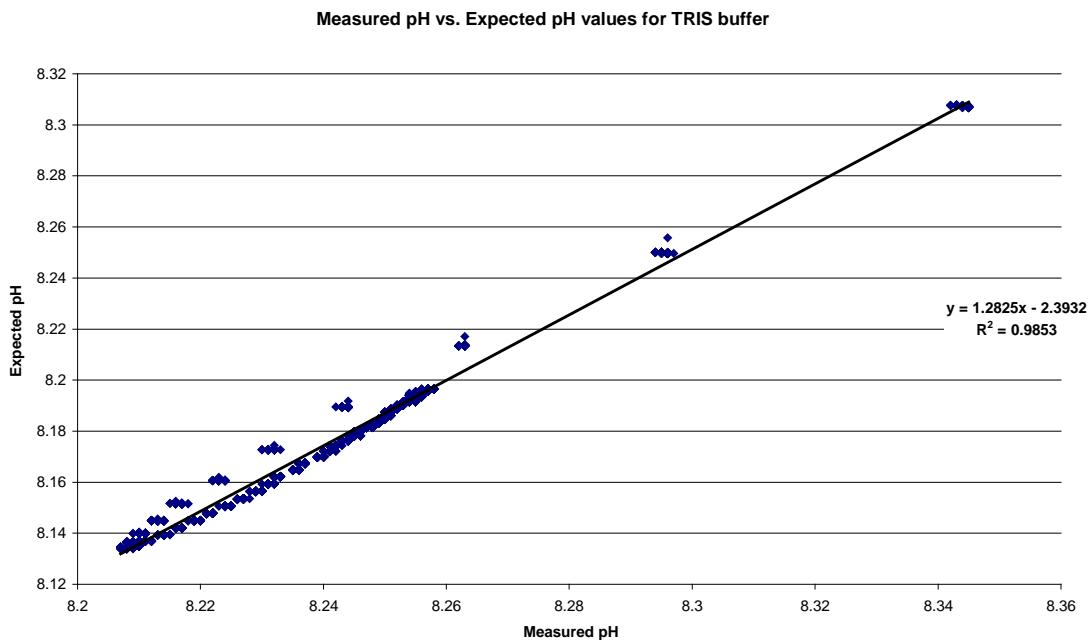
**Figure 62 measured pH vs. expected pH**

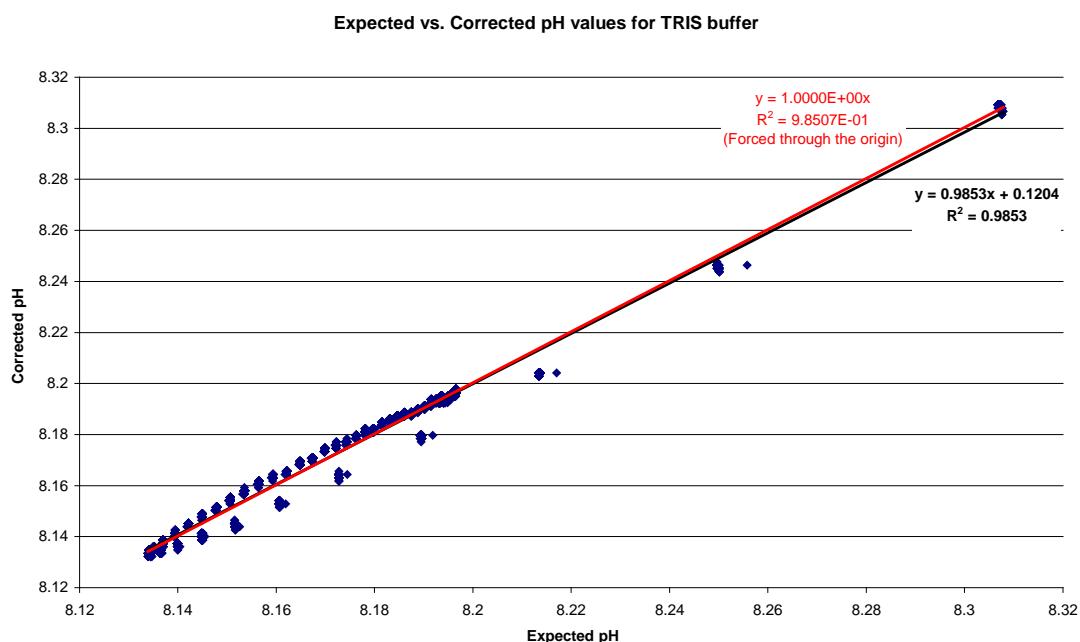
Figure 63 corrected pH data vs. expected pH data.

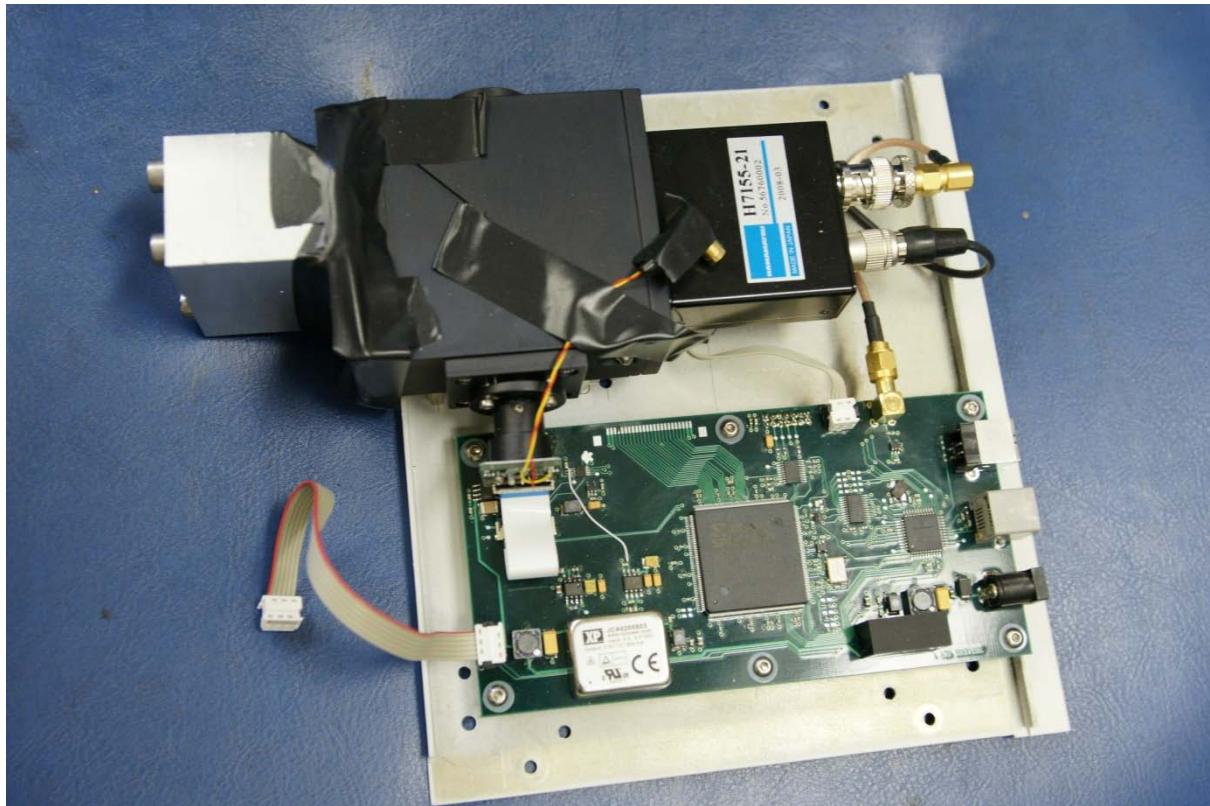
Figure 64 Fluorescence based pH sensor.

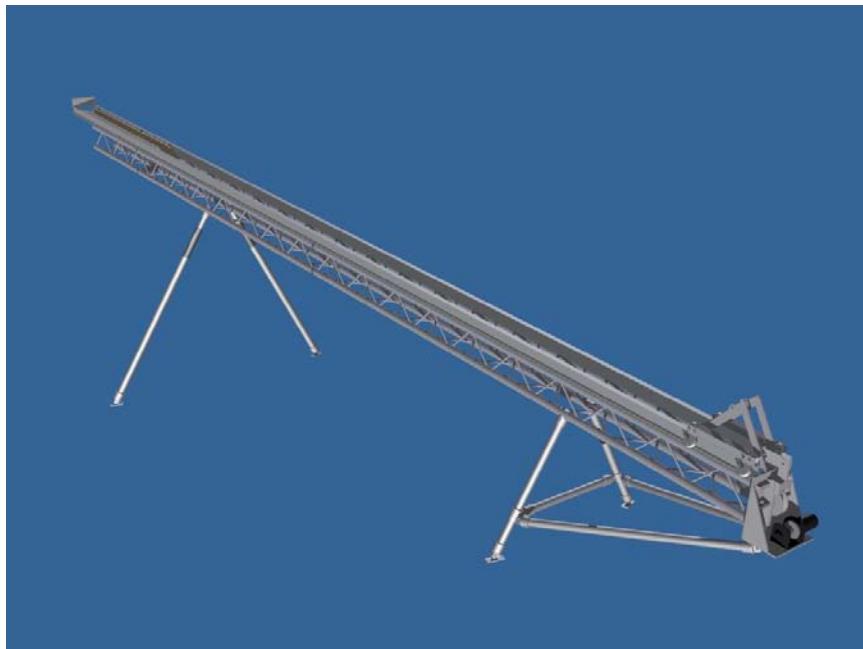
Figure 66 - UAV launcher design

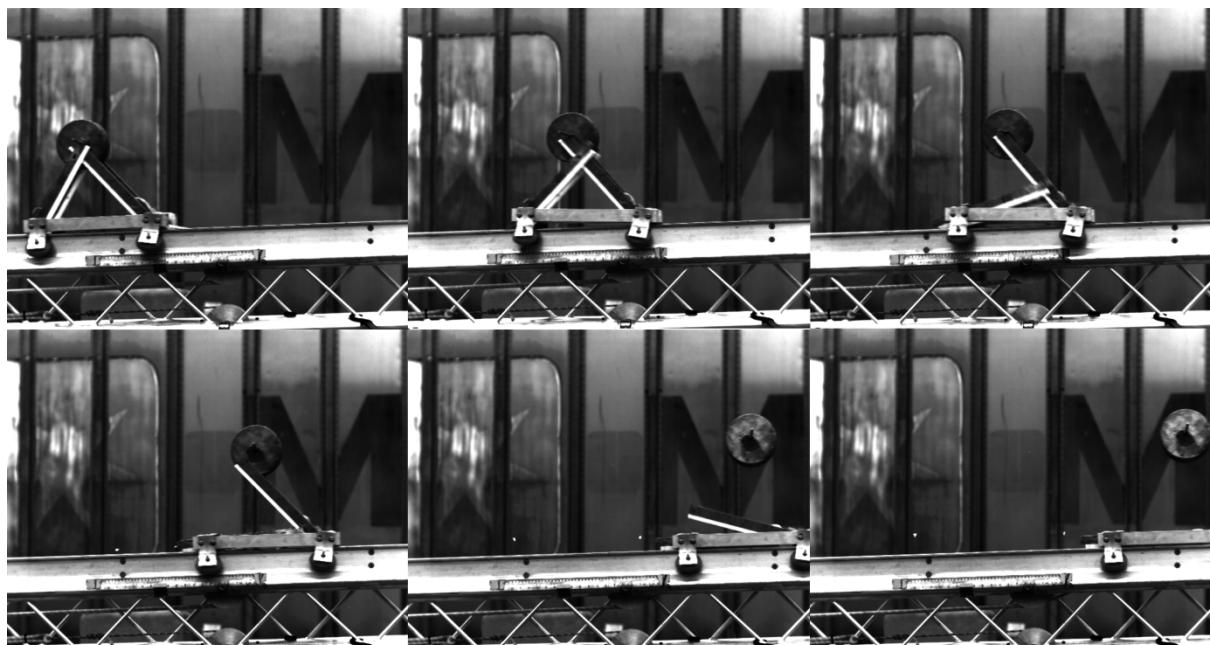
Figure 67 - UAV release mechanism in action

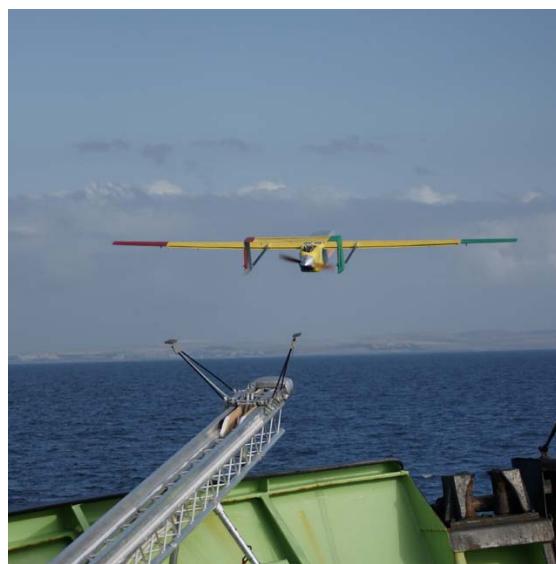
Figure 68 - Launch of the UAV

The test flight took place at 9:00 GMT on Friday the 17th of October. The ship was on a heading of 12 degrees into a light breeze of around 10 knots. The UAV launched smoothly (Figure 53) and flew directly away from the ship before turning to perform laps along the port side around 200 metres off. Telemetry was streamed to the ground control system and images tagged with position and other information were recorded. The flight lasted for 7 minutes when during a slow speed flight test the engine was stalled. The pilot performed a controlled descent into the water although due to the lack of propulsion the vehicle landed more heavily than anticipated and the wing tips were broken. The vehicle floated high in the water and was recovered easily using the ship's rigid inflatable boat.

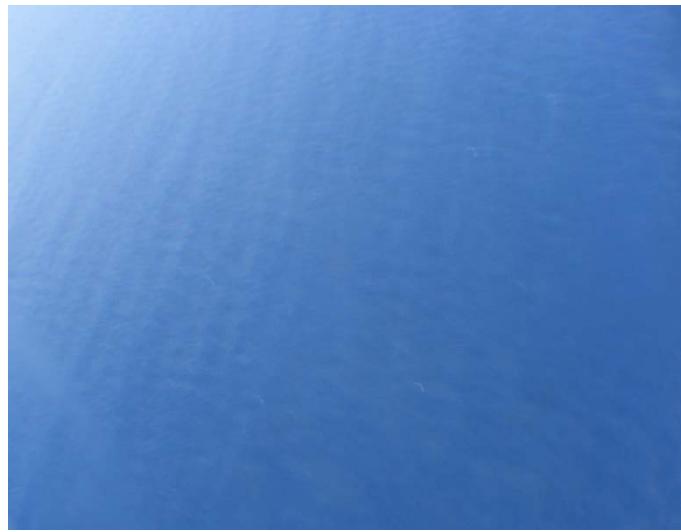
Figure 69 - Image captured by the UAV during flight

Figure 54 shows an image captured by the UAV during the flight, this is accompanied by telemetry data detailing the position and orientation that the image was taken from. It is proposed that this data could be used to measure sea state in the local area of the ship as well as detecting plankton blooms using multi-spectral imaging. This data could be stored or partially processed onboard the vehicle and transmitted in real time to the ship.

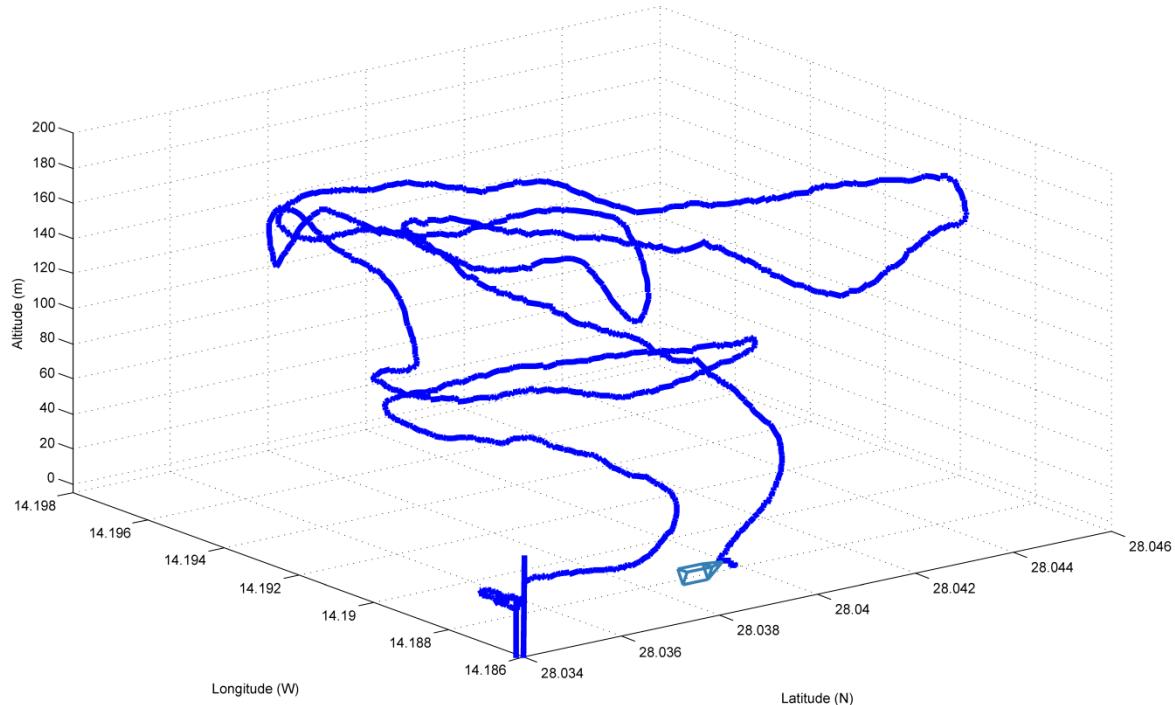
Figure 70 - Flight path of the UAV
