RRS *James Cook* Cruise JC80

The East Scotia Ridge and the Kemp Seamount Calderas

Cruise 4 of the NERC Consortium Grant 'Chemosynthetically-driven ecosystems in the Southern ocean: Ecology and Biogeography' (ChEsSo)

2nd December to 30 December 2012

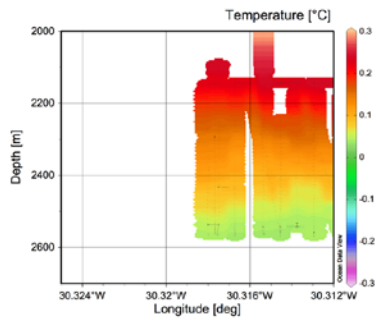
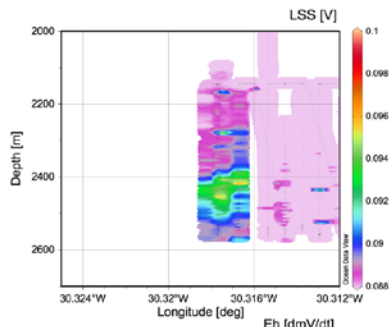
Figure 4. CTD Tow-Yo data shown for anomalies in light scattering (LSS) and reductive potential (Eh). The diffusive area of venting discovered is indicated. We do not think that this was the source of the strong Eh/LSS plume (also indicated).

trough plume
from high-
temperature source

Since we were unable to head south due to ice cover over E9 and the Kemp caldera we had more time at E2. Between ROV dives we were able to explore areas identified in 2009 as having high LSS signals. The difference between that survey and the one we could do now is that we have an Eh sensor from Ko-ichi Nakamura of AIST, Japan. The detection of LSS and Eh anomalies together indicates a relatively young plume as Eh dissipates rapidly in seawater as it is thought to be a mainly result of dissolved hydrogen sulphide which is high in vent fluids but is rapidly diluted and/or oxidised in seawater. CTD 26-43 and 46-63, were a series of Tow Yo surveys over the northern part of E2. We did not get any closer to identifying where the source of these strong Eh and LSS signals in the water column. A summary of this data can be seen in Figure 4.

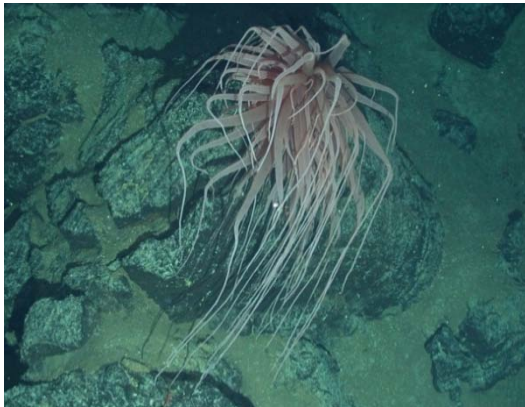
Figure 6: Long-armed red big anemone

Of particular interest is the collection of three specimens of a long-armed red big anemone (Figure 6) that is a different species of probably a new order of hexacorals according to taxonomist Estefania Rodriguez.

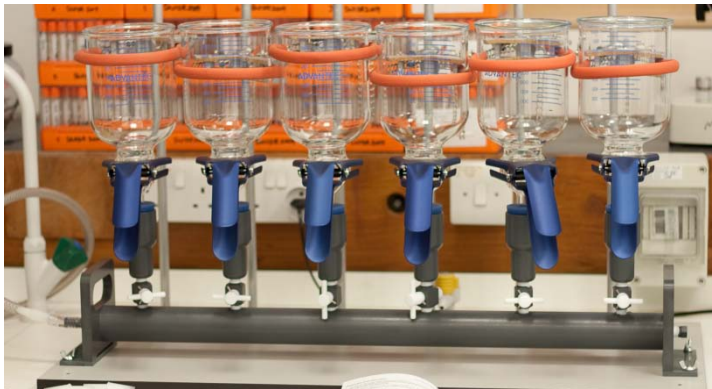
Figure 1 Water filtration system used on the JC80 cruise. One manifold with six glass containers with filters to sample the microorganisms in seawater was used. The glass containers were held in place with rubber bands (orange) and clamps (blue).

Before collecting water the filtering system was rinsed (thoroughly rinsed with Milli Q water and subsequently washed with the sampling water) and new filters were placed into a suitable container. A pre- filter (47mm diameter, 3 μ m pore size) was used with a subsequent filter of 0.2 μ m pore size. The 0.2 μ m filter was placed on the iron “filter” first and then the 3.0 μ m filter. Care was taken not to touch the filters with fingers and sterile gloves were worn at all times during filtering.

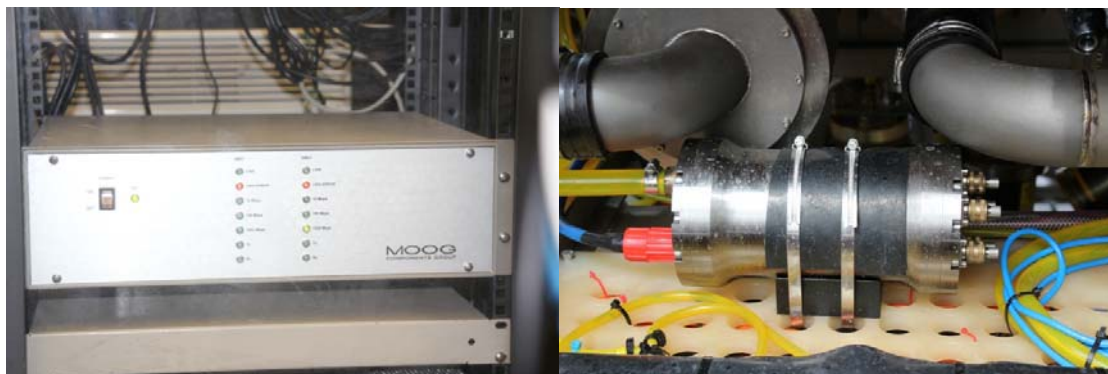
*Topside Rack mounted CWDM unit
Isis ROV*

The solution comprised a topside rack mount unit housing components, virtually identical to the subsea stack, with rear panel fibre ST connector breakouts and front panel indicator LED's.

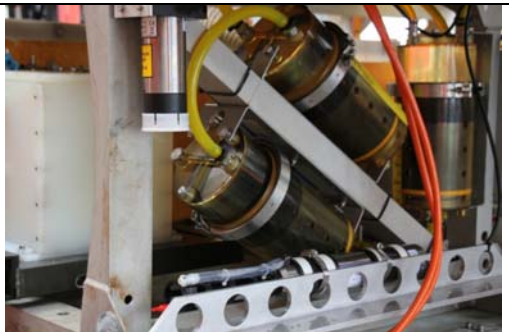
MCIL-4-F Connector

This new Seabird Fastcat CTD unit was installed for this cruise, mounted at the aft port side base of the vehicle tool-sled. A 12V power supply pre-installed in the low-power tube and cable glanded into the low-power junction box with RS232 communications.

1 0V	
2 RS232 Rx	
3 RS232 Tx	
4 Vin	
	Top left - Turbidity Sensor Bottom centre - CTD

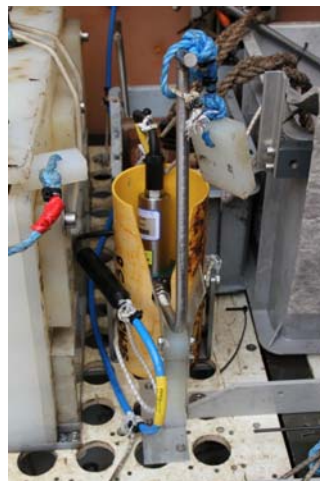
Thermometer with T- handle mounted on tool-drawer

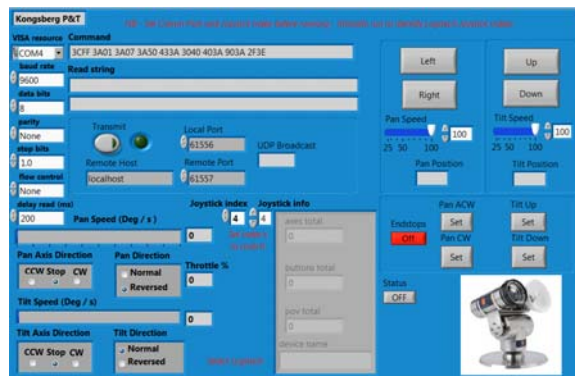
Kongsberg P&T GUI

Prior to the cruise software for the new Kongsberg pilot pan & tilt was developed for operation with proportional control firmware. Operation in parallel with the ROS science pan & tilt and operation from pilot joystick and ancillary joysticks required further development during mobilization. This performed well throughout.

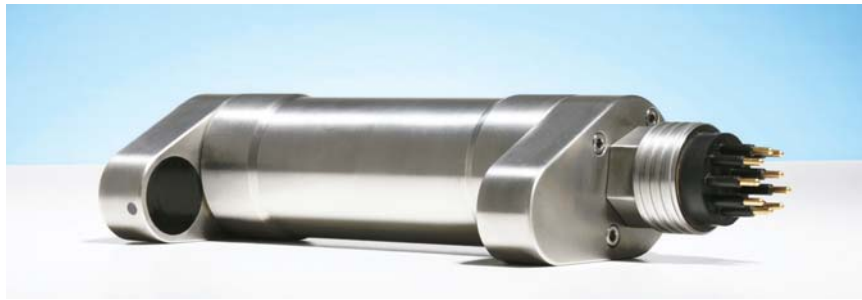
MCIL9F pins	LPIL-7-MP pins
1 Comms-GND	2
2 RS232 Tx	5
3 RS232 Rx	6
4 RS422 TxP	
5 RS422 TxN	
6 RS422 RxP	
7 RS422 RxN	
8 0V	1
9 Vin	7

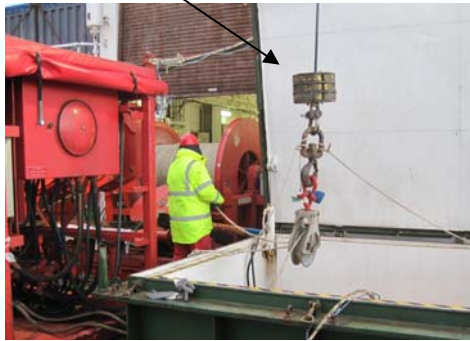
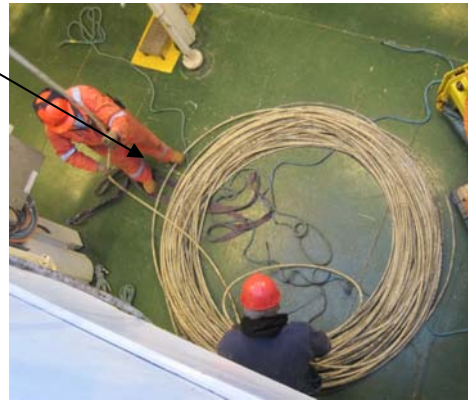
Outboard Stopper

Spooling into hold via hanging block

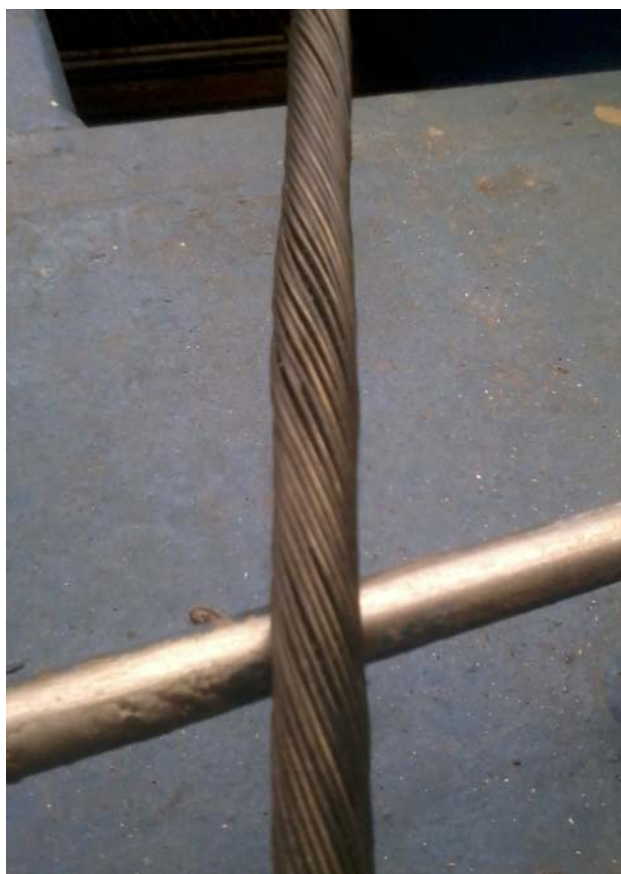
Wire 2 Operating Specifications

- New onboard 4/6/09
- Hours 1360
- Operating metres 597951
