Southern Ocean 6 Cruise Report

RRS *Discovery*, DY112

January 16-26, 2020

**Coastal and Global Scale Nodes
Ocean Observatories Initiative
Woods Hole Oceanographic Institution**

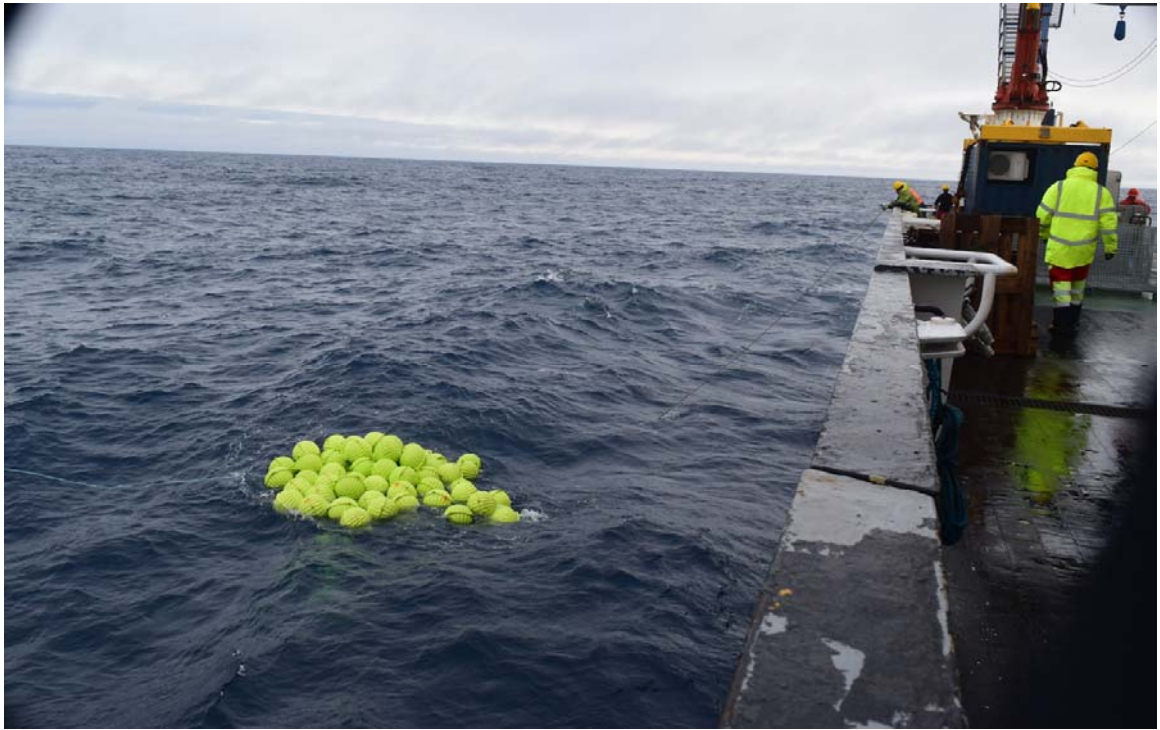
Figure 3-1 – Glass balls hooked with Colmega line leading away from the ship

The ship had to readjust its approach with the wind to keep the cluster on the starboard side with the Colmega line trailing away from the ship (Figure 3-1). The cluster eventually was hooked on the starboard side by a 5-ton Titanium pickup hook after the balls were held by grapnel to keep them close. The ship made forward headway letting the balls drift aft and away from the stern. The TSE winch hauled in, while adjusting the crane block height, until the cluster was on deck.

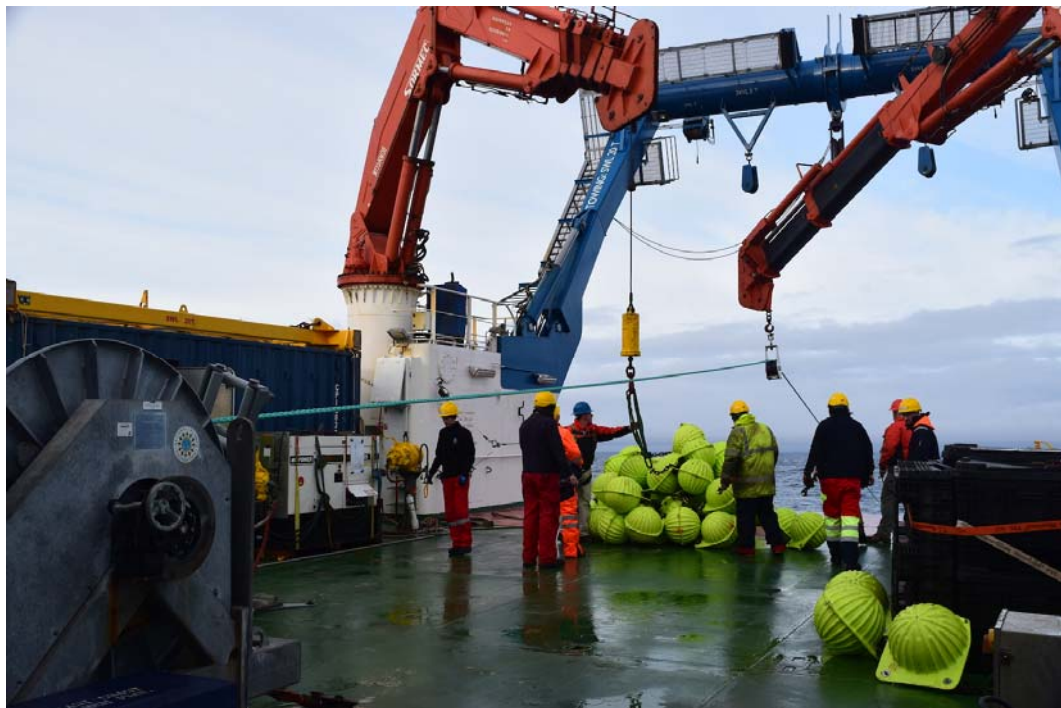
Figure 3-2 – Glass balls secured on deck and Colmega line being hauled in onto the TSE winch

The starboard crane moved the cluster of balls further forward until a Yale grip could be applied to the 1" Colmega that was leading off the ship's stern. The Samson stopper line was attached to the Yale grip, stopping off the mooring. Once tension was transferred from the winch leader to the stopper line, the Colmega line was cut and the balls moved further forward and out of the way of operations (Figure 3-2).

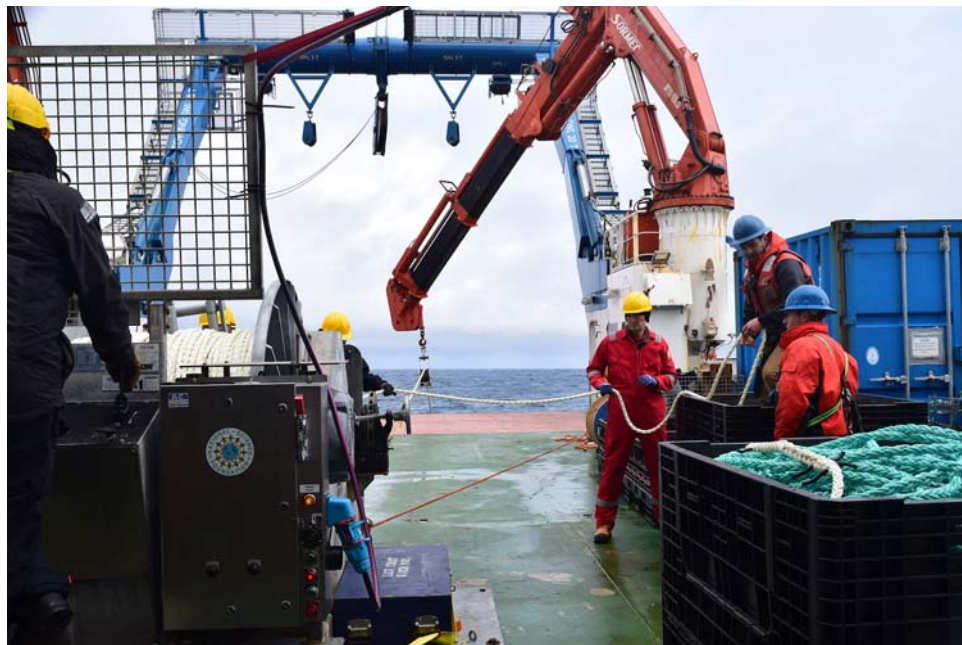
Figure 3-3 – Synthetics being off-spoiled from the TSE into Ropaks

Once the Colmega was fully removed from the winch, the Nylon was removed from the deck cleat and a bowline was tied to the bitter end through the winch leader thimble. Once attached and tension applied, the stopper line and Yale grip were removed from the Nylon. The winch paid in the Nylon until the drum was fully loaded. Citing the same procedure above, the Nylon was fully removed from the winch into Ropaks (Figure 3-3) and then the recovery continued.

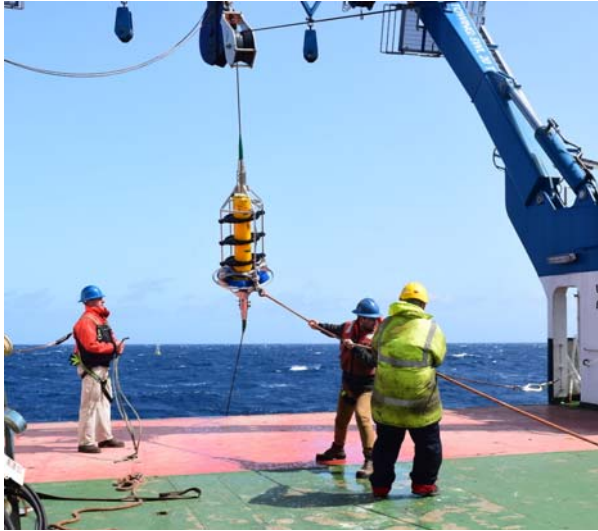
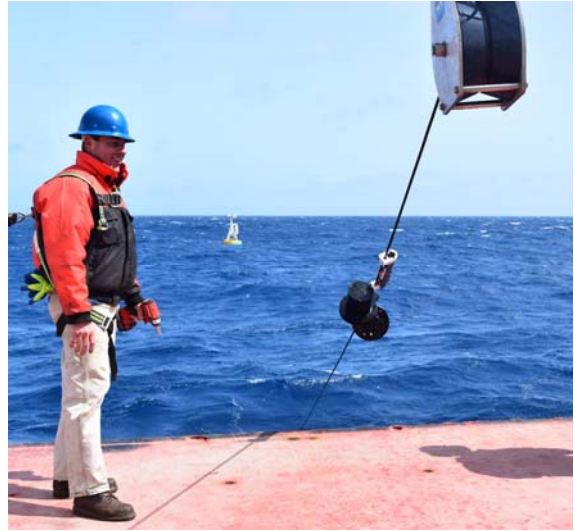
Figure 3-4 – Recovery of the ADCP (left) and instrumentation from the wire rope (right)

At the top of this shot, the Acoustic Doppler Current Profiler (ADCP) was recovered by continuing to haul in with the TSE as well as extending the height of the port quarter crane/block (Figure 3-4, left). Once the ADCP was on deck, a Yale grip was secured above the lower termination of the 485.5 m shot of 7/16” wire and secured with the deck stopper line. The ADCP was disconnected from both sides of the mooring wire rope. Once removed, a second Yale grip was added below the upper termination of the 1,000 m shot of 7/16” wire rope. The two Yale grips were secured with a 4’ sling and hardware.

The TSE then recovered approximately half of the 485.5 m shot of wire rope along with clamped instrumentation (Figure 3-4, right). Once the wire became relatively slack, a line was secured to the wire aft of the hanging Gifford block to control any recoil once the wire rope was cut with the hydraulic cutters. The wire rope section leading to the buoy was cut at the 180 m depth mark, thus releasing the surface buoy and allowing the remaining section of mooring riser free, setting up for a buoy-last recovery. Due to the top-heaviness of the buoy, having a portion of the mooring riser hanging below the buoy is suggested to keep it upright and stable.

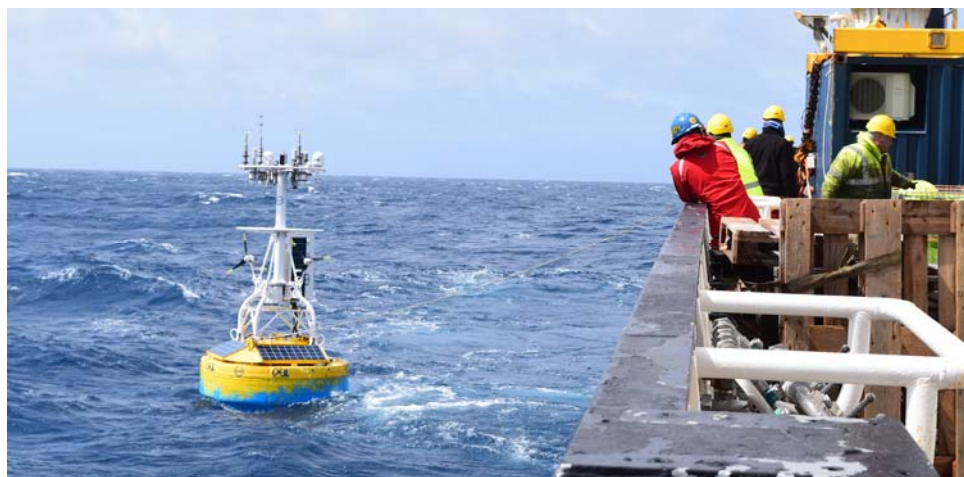
Figure 3-5 – The hooked surface buoy moving around the starboard quarter

The deck was prepared for the buoy recovery. The TSE winch leader was reeved through the 2.5-ton block secured to the port quarter crane and brought around to the starboard bulwark then shackled to a long 5-ton recovery hook pennant (Note: a specialized pennant length of approximately 12 meters was made and used for the buoy recovery to make it easier to connect to the ship's core wire at the transom). The ship repositioned allowing the buoy to come along the starboard side. When the buoy was hooked, the ship moved slow ahead allowing the buoy to come astern (Figure 3-5). When the buoy was center line, the TSE winch hauled in bringing the buoy closer to the ship's stern. Once the end of the 5-ton pennant was on deck it was disconnected then shackled into the ship's core (trawl) wire which was reeved through the A-frame center line block.

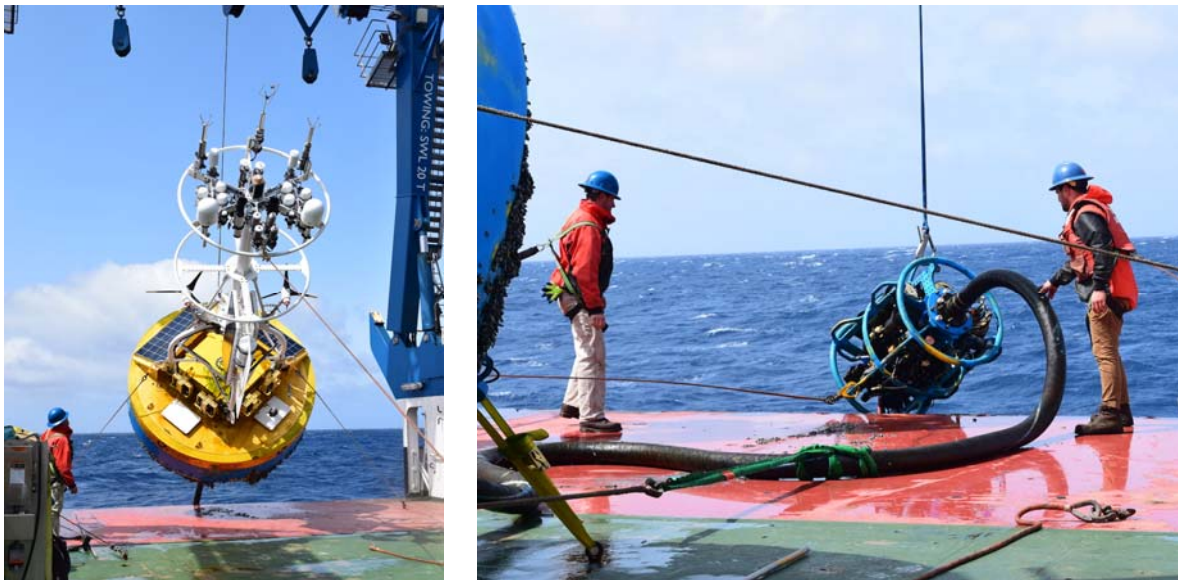
Figure 3-6 – Recovery of the GS01SUMO-00004 surface buoy and NSIF

When the buoy was lifted out of the water it turned, allowing the masthead to face forward; two tugger leaders were attached to the port and starboard buoy tag line bales with a third tugger secured to the masthead, preventing the buoy from swinging further. The A-frame was brought in bringing the buoy on board (Figure 3-6, left) and yellow aircraft straps were used to secure it on deck. Once secured, a 6-foot sling was choked around a cleaned section of the EM chain and secured to the TSE winch leader. As the TSE hauled in, the EM chain was brought forward, adjacent to the buoy foam until the NSIF broke the water's surface. Using the starboard crane winch and 5-ton recovery pennant, the NSIF was brought on deck (Figure 3-6, right). Using the deck mounted port tugger winch, the NSIF was brought as far forward as possible to allow enough room to secure a Yale grip to the remaining 7/16" wire rope still in the water. A deck stopper was secured to the Yale grip and the wire rope was cut, thus freeing the NSIF. The TSE winch leader was secured to the Yale grip and the stopper removed. The remaining wire rope and inductive instrumentation were recovered (many of the instruments from the upper 485 m wire rope shot were damaged or missing – see Section 3.1.3 for details). The recovery was completed at 19:05 UTC (16:05 local) 20 January 2020.

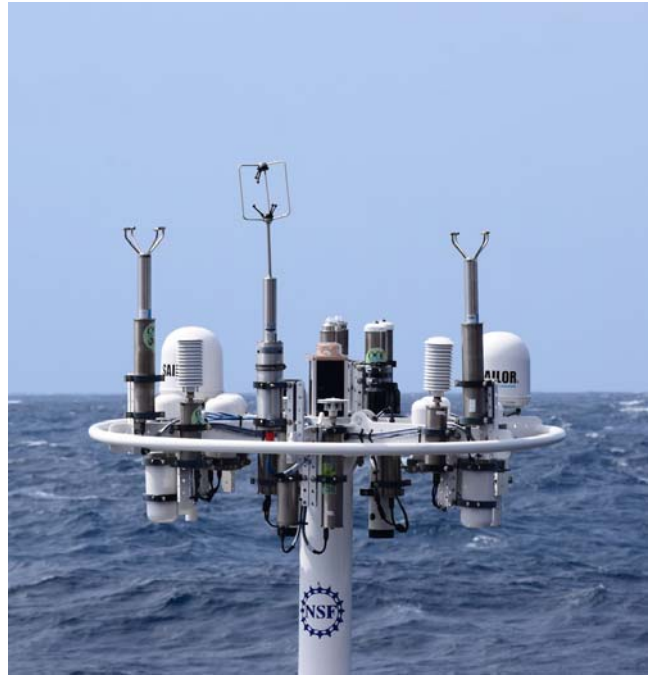
Figure 3-7 – GS01SUMO-00004 Buoy and Halo

The GS01SUMO-00004 mooring was in fairly good shape when it was recovered. The buoy was intact with all instrumentation and telemetry components in place on the halo, and all solar panels and wind turbines intact (Figure 3-7). Both wind turbines were spinning – the port-side WT1 spinning faster than the failed starboard-side WT2. The FDCHP instrument was bent slightly and one of the top sensor tines was missing (Figure 3-7, right). This instrument was not damaged on deployment, but did fail one day after the mooring was deployed.

There was little bio-fouling on the buoy deck and sides of the foam, and some of bottom paint was rubbed off. The bottom of the buoy had a number of goose-neck barnacles attached. All of the subsurface buoy instruments were in place but covered with gooseneck barnacles. The FLORT instrument on the bottom of the buoy failed during deployment. On recovery it was found to have a corroded bulkhead with one pin missing. The METBK-CT 2 sensor had slight corrosion on the bulkhead. Data continued throughout the entire deployment but brief periods of garbage data were observed periodically.

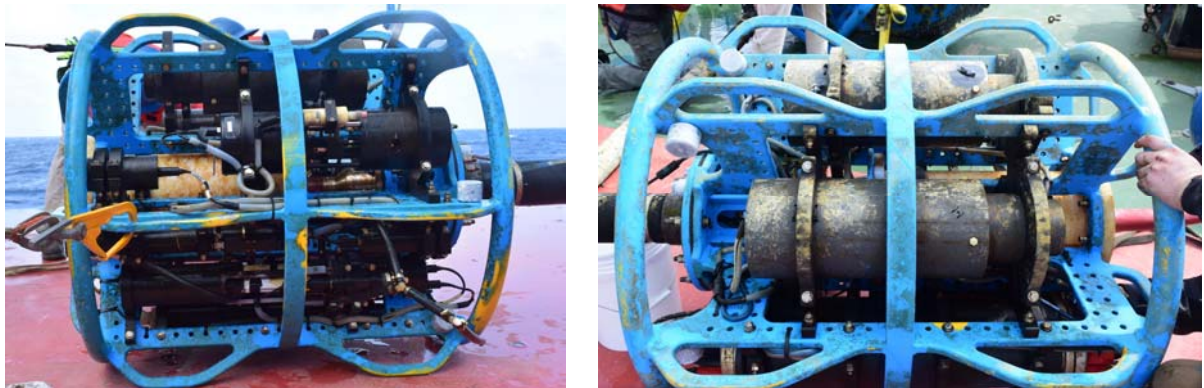
Figure 3-9 – GS01SUMO-00004 NSIF – OOI core instruments (left), CUSTARD sensors (right)

The NSIF was in good condition with little bio-fouling – just a thin slime coating (Figure 3-9). The OPTAA plumbing was securely connected to the exhaust ports, but had had come lose from the pump; the intake plumbing remained intact and secure. The PCO2W copper screen was gone – presumably dissolved away as small bits remained at the tie-wraps used to secure it in place. Bio-fouling components such as the NUTNR brush, SPKIR copper shutter, FLORT copper face and wiper, and DOSTA UV-light all appeared to be have remained functional throughout the deployment. Internal data logged on the PCO2W was found to have stopped 15 March 2019. Battery levels on recovery were low, but sufficiently high to be able to establish communication and download data.

The CUSTARD instruments mounted in the NSIF appeared in good condition (Figure 3-9, right). They were removed from the NISF and cleaned, and data was downloaded from throughout the entire deployment.

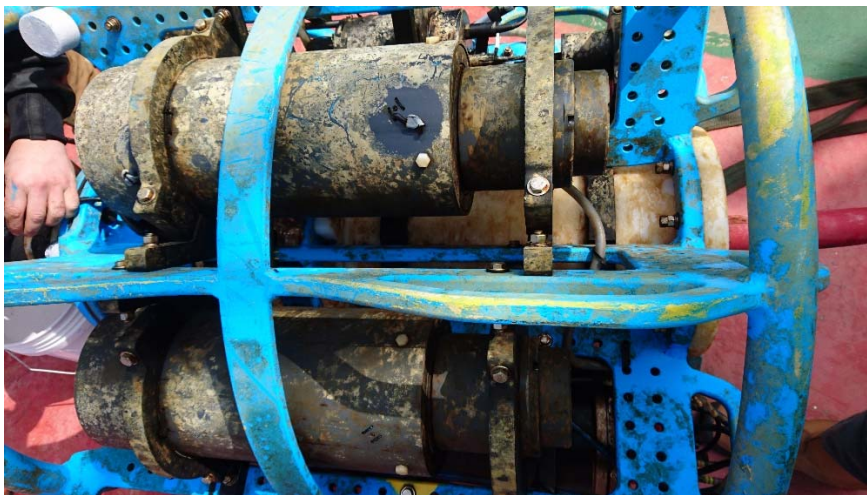
Figure 1 Lab-on-a-chip sensors within the NSIF on recovery of the buoy.

Following recovery of the buoy, the two NOC Lab-on-a-chip sensors were detached from the NSIF frame that hung 12m below the buoy. Biofouling was apparently light given the 14 months they had been in the water. They were cleaned with fresh water and left to dry for 36 hours. After this the casing was removed. Remaining reagents and waste products were decanted into a carboy. Standards and blanks were split, with one set being run on board and the other stored (nitrate in -20C freezer and silicate in chill room). The analysed set demonstrated that the standards remained very stable throughout giving values apparently identical to the original concentration. The inside was carefully cleaned and then left to dry for another 24 hours. Following this the data cable was attached and data were downloaded. Raw files were numbered sequentially, starting in December 2018 and finishing on the date before the buoy's recovery, suggesting that all files were recovered, though as there are over 400 for each sensor they weren't opened individually to check. The data will be analysed back in NOC.
