RRS *Discovery* Cruise 116

Time-series studies at the Porcupine Abyssal Plain
Sustained Observatory

Cruise report number 73

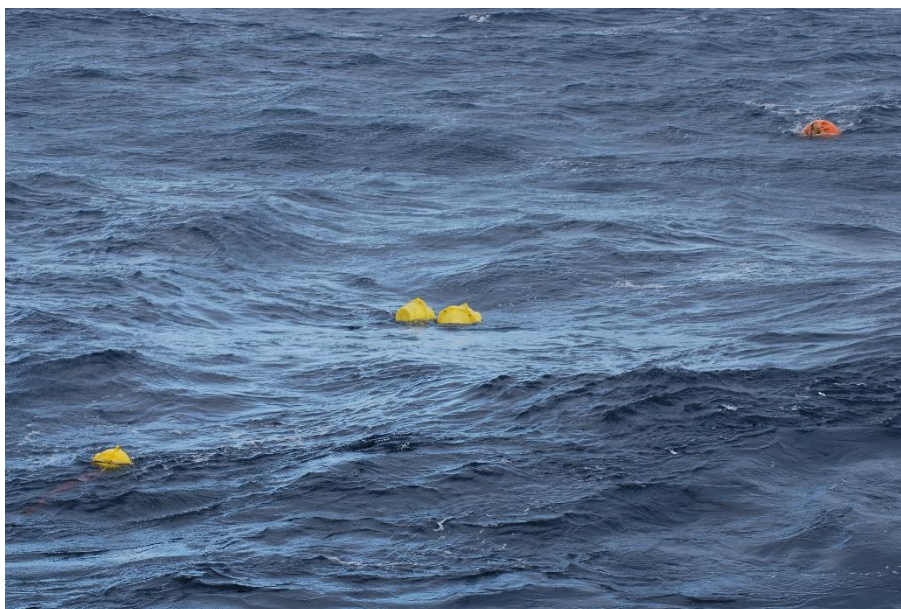
Glass spheres from Whittard Canyon mooring on the surface

At this point only the three glass spheres and the top ADCP 75kHz floatation sphere were visible from the deck. The top glass spheres were brought on board and disconnected with the use of a chain stopper fitted in the red zone. The outboard line was then reconnected to the winch and the line hauled in to bring the first ADCP sphere out of the water.

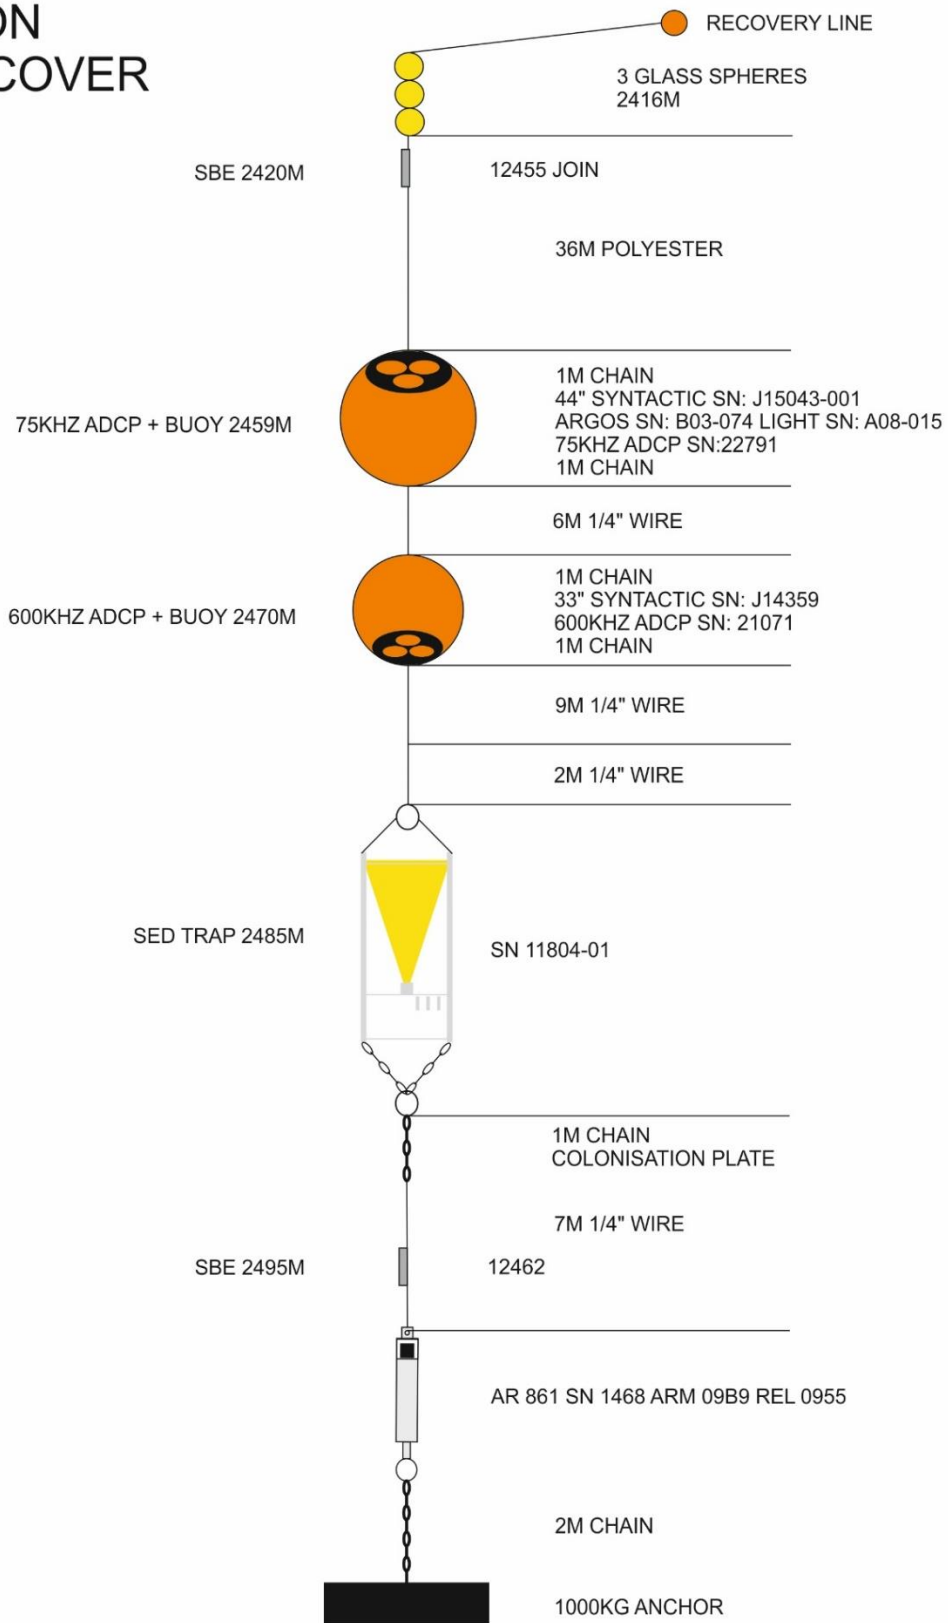
WHITTARD CANYON TO RECOVER 2020

WATER DEPTH
2500M

The polyester rope had stainless steel thimbles instead of galvanised. This is an error by the supplier, but needs to be picked up during pre-cruise prep. The ½” shackles were nut and split pin instead of euro-shackle, which is the preferred style for all moorings.

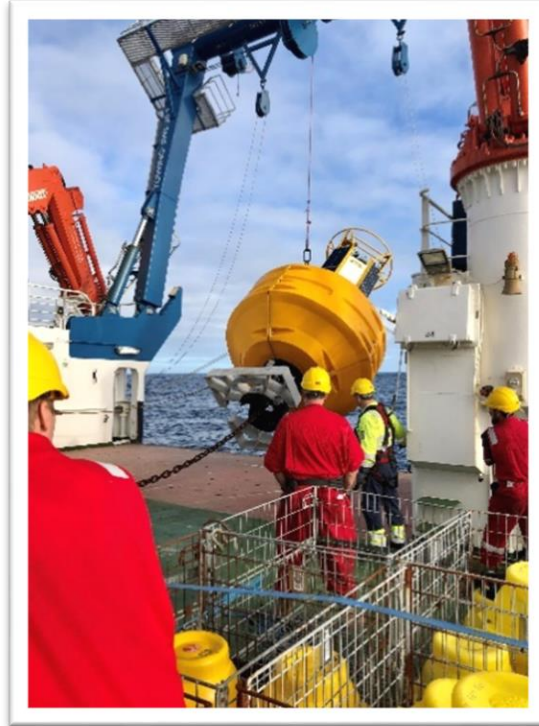
First deployment of the new Met Office Mobilis buoy

The buoy had been connected to the main warp through the centre sheave on the gantry and held on the large Seacatch. The Port crane was disconnected and stowed. At this stage the keel chain was leading from the keel straight up the deck through the scroll with a couple of turns on the PAP winch. The wire barrier on the red zone was then removed for deployment. The Buoy was lifted on the main warp and steadied into the sea with the two ropes. Once in the water and buoyant, the ship started ½ knot ahead and the winch payed out. The process continued until the line was broken to add the mid-water float and the last shackles were welded in position. The float and the rest of the line was then payed out until we were ready to release the anchor, which was done shortly after 6pm. Triangulation was attempted, but no useful acoustic responses could be detected.

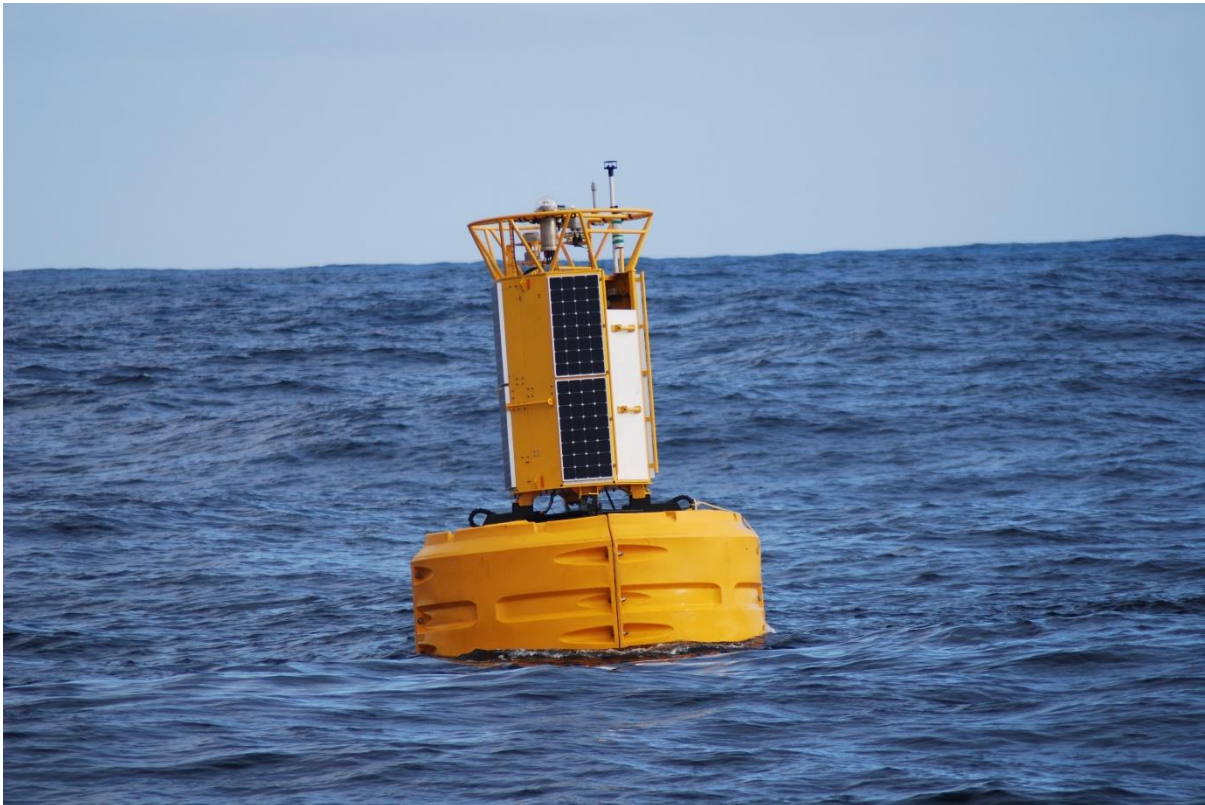
The new Mobilis PAP-1 buoy shortly after deployment (DY116-008)

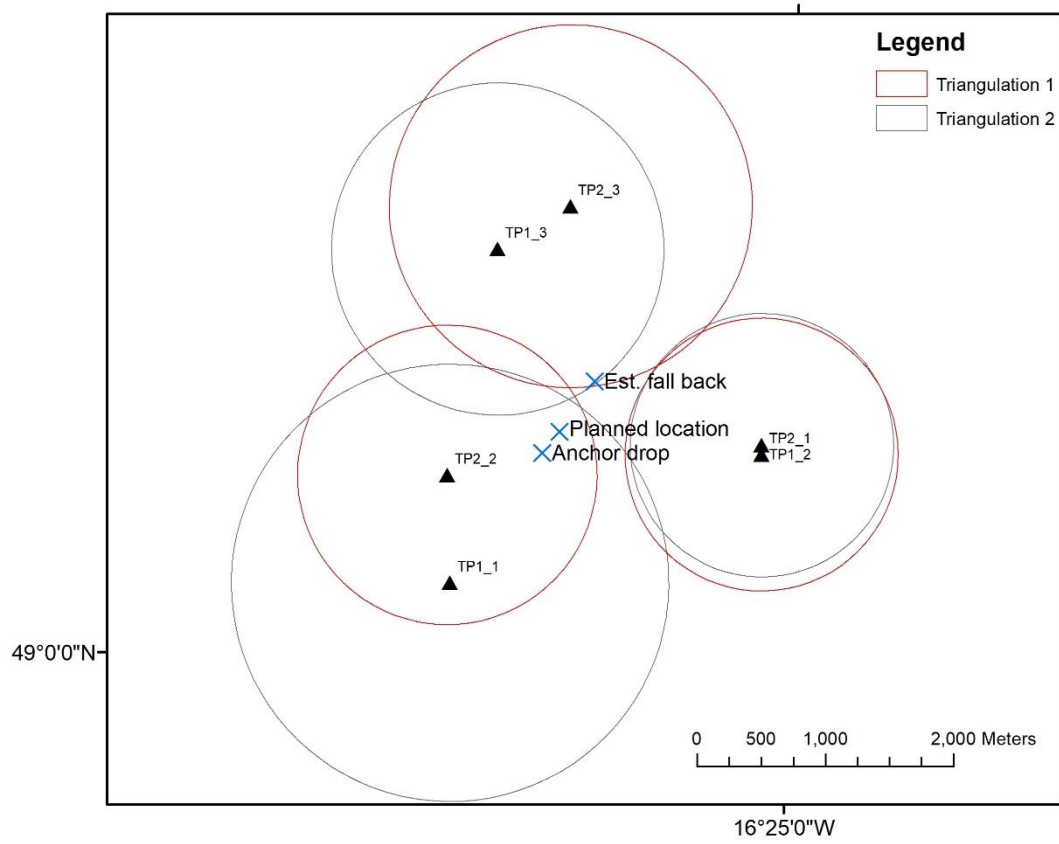
PAP 3 Triangulation Attempts

Chart showing attempted triangulation of PAP-3 mooring (TP = triangulation point)

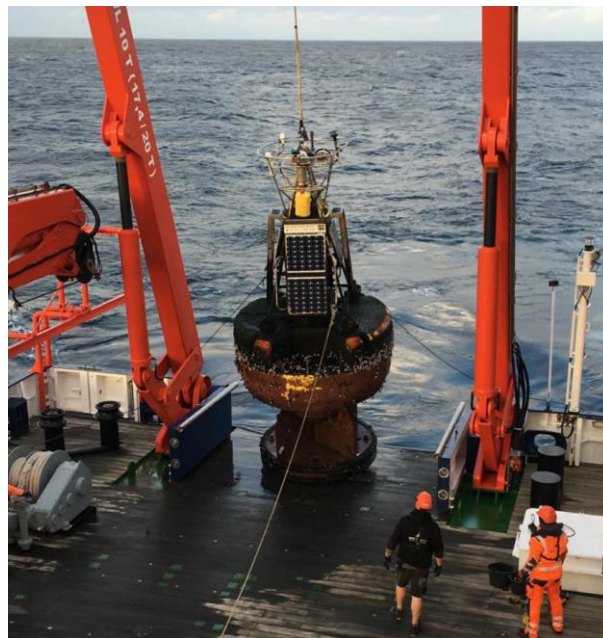
DY103 PAP1 buoy onboard FS Maria S Merian, showing the extent of biofouling

Met Office Odas buoy with NOC sensors deployed on DY103. PAP1 ODAS buoy was adrift from ~23rd October 2020, after over 15 months deployment. It headed east towards the Channel and was tracked using the external GPS Tracker (4 hourly alerts). The priority was to retrieve the buoy and get the data back as there was no near real time data transmission. Maps were plotted daily (with thanks to Jon and Brian, see start of this cruise report) so that the buoy could be collected by German colleagues working in the area. Dan Comben liaised with the ship and the buoy was retrieved on the FS *Maria S Merian* (5th Nov 2020). We are very grateful to them for the recovery, cleaning, dismantling and for shipping the buoy back to us.

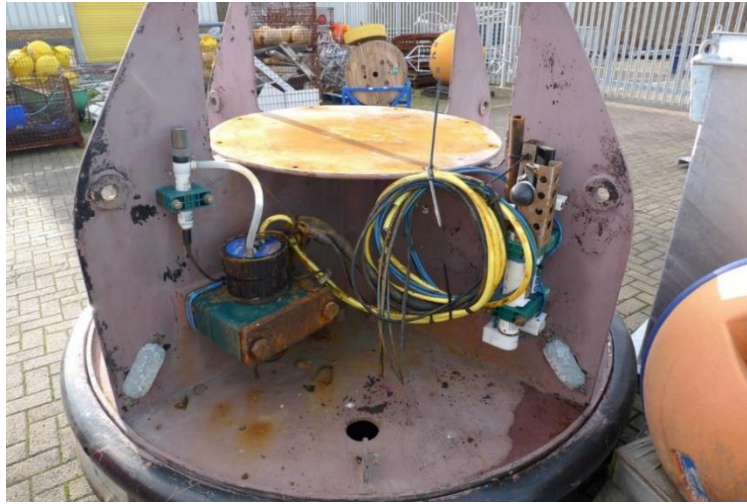
DY103 buoy CO₂ (SN 34-201-45) and microcat ODO (SN 16503) back at NOC

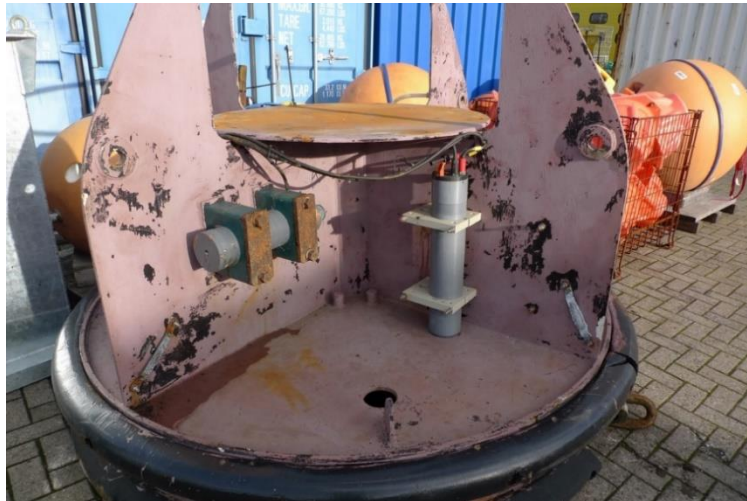
DY103 SeaFET pH sensor and battery pack (SN63) at NOC

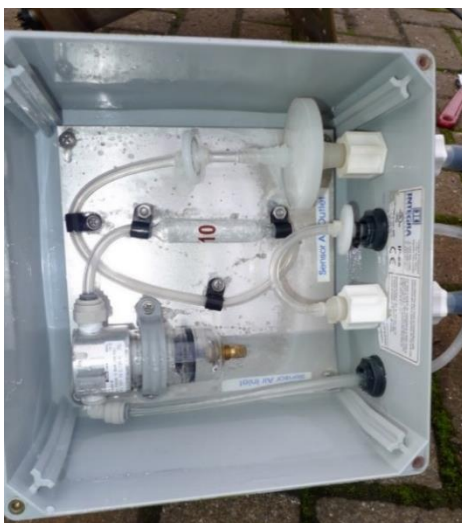
The Pro-Oceanus CO2-Pro- atmospheric sn 34-201-45 had flooded and very little data were retrievable (~1 month) suggesting that the flooding happened early in the deployment.

'Dry box' section of Pro-CO2 atmos sampler

At the time of writing the air-side box may be salvageable and has been returned to Pro-Oceanus. If water was able to get past the water trap and hydrophobic filters in it, there are two additional hydrophobic filters inside the submersible sensor portion of the sensor to prevent water ingress this way. The damaged bulkhead looks more problematic on the ATM sensor. Also, the ATM tubing had a connector part way up from the sensor. This was added on DY103 as the ATM was turned around at

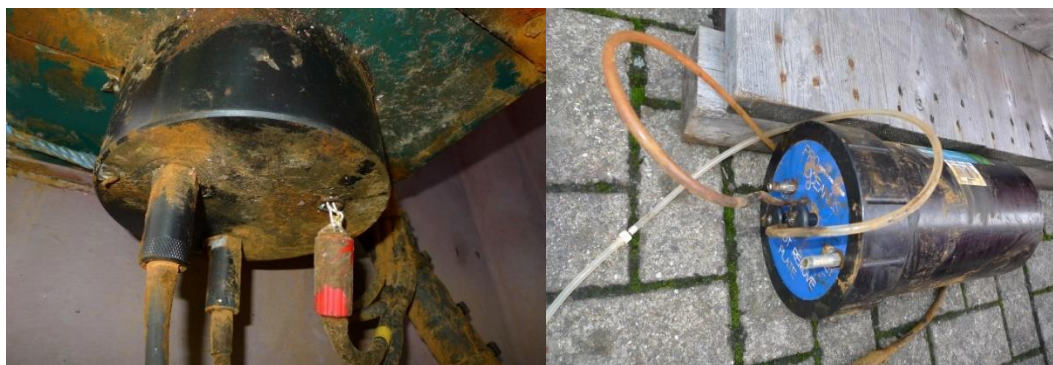
Photos of the Pro-CO2 atmos back at NOC (water side of the instrument)

sea from the previous deployment. It is best to avoid having these in the sensor as it adds an additional failure point. The next one should be prepared with an extra meter of tubing (especially now we are using the taller Mobilis buoy). Jon downloaded and cleaned the two PAP1 Buoy keel MicroCATS.

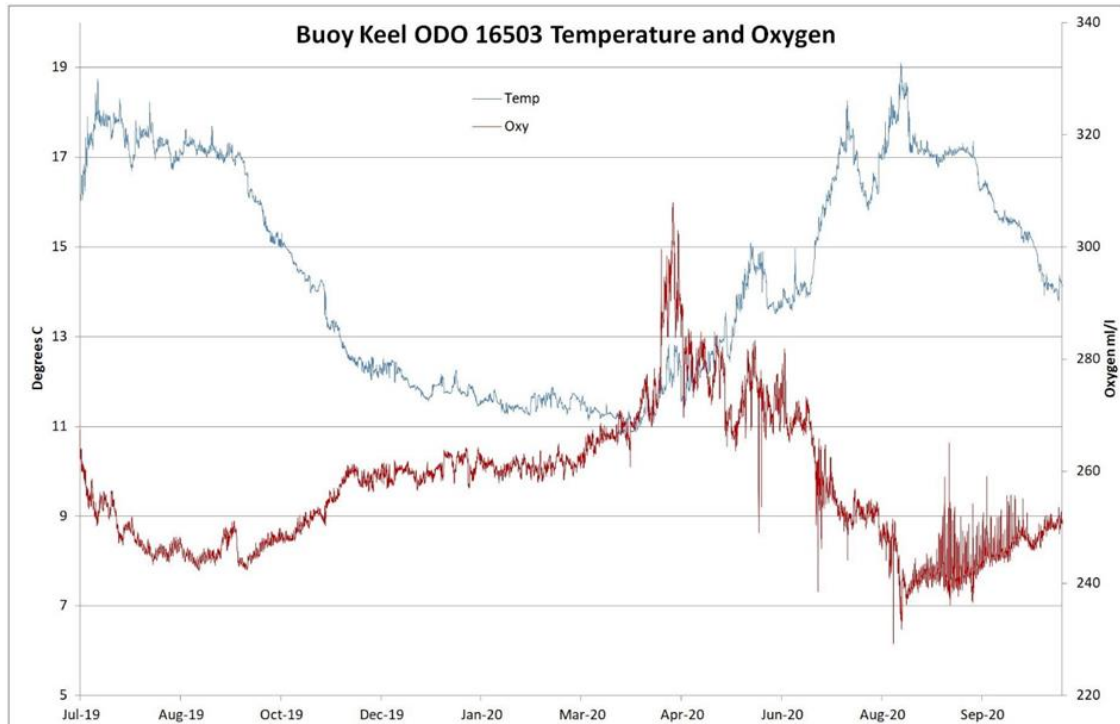
Microcat ODO SN16503 temperature and oxygen data from DY103 deployed buoy

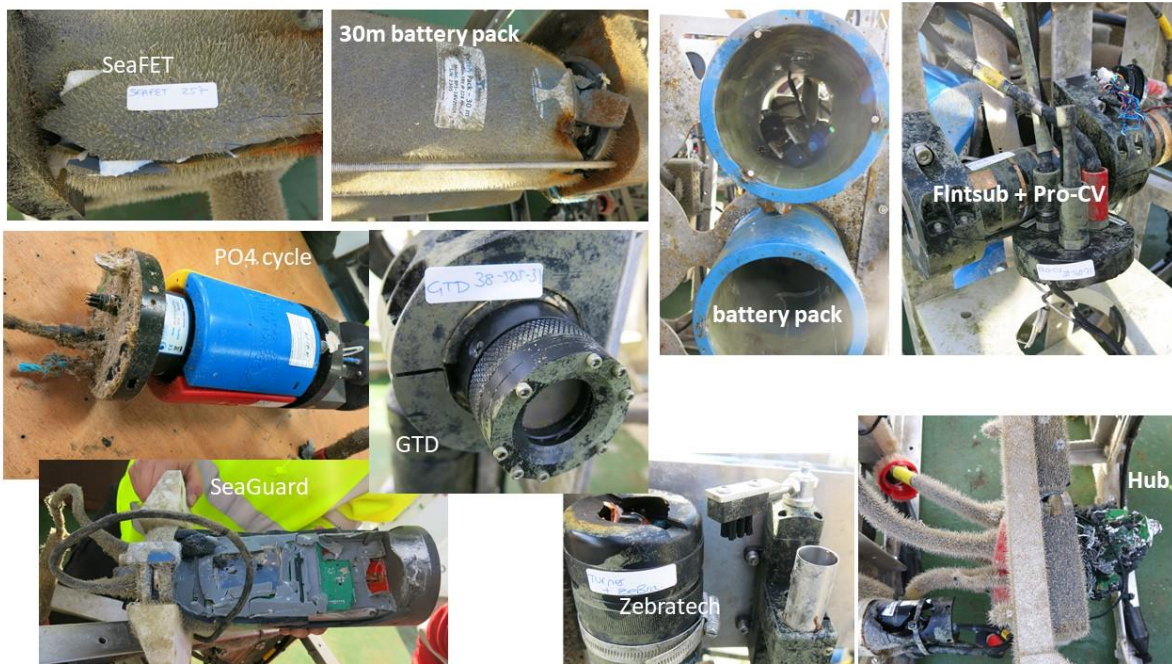
The mooring broke above the sensor frame (which then sank below the midwater buoy at 1000 m). The frame went deeper than most of the sensors are pressure rated to. The sensors (data and batteries) are mostly lost. These will all have to be reported as a write off on IMS.

Some of the PAP1 frame sensors at NOC. SBE SN 6907 was functional and possibly the PO₄ cycle.

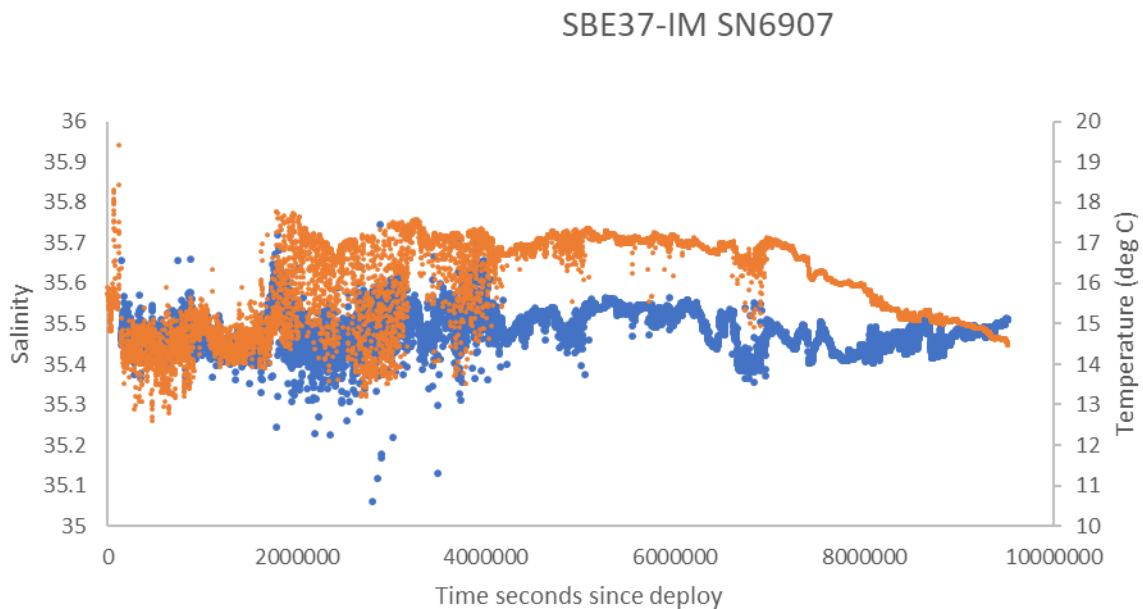
The **MicroCAT SN 6907** (temperature and salinity), was rated to 1000 m. Despite going below this depth it was possible to retrieve some data, though the battery was low. The instrument had been set up at 15-minute intervals from 02/07/2019 00:00:01 on DY103. However, it only ran for 4 months, until 20/10/2019 05:00.

Data retrieved from SBE37-IM SN 6907 microcat

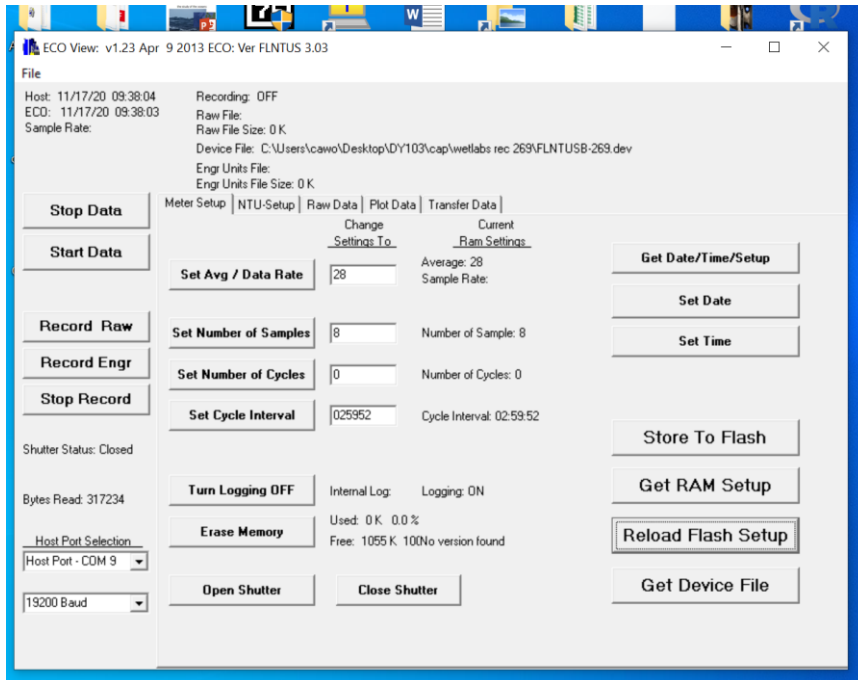
hourly deployment, setting as below. Note the settings are under the current RAM settings column, not the change settings to.

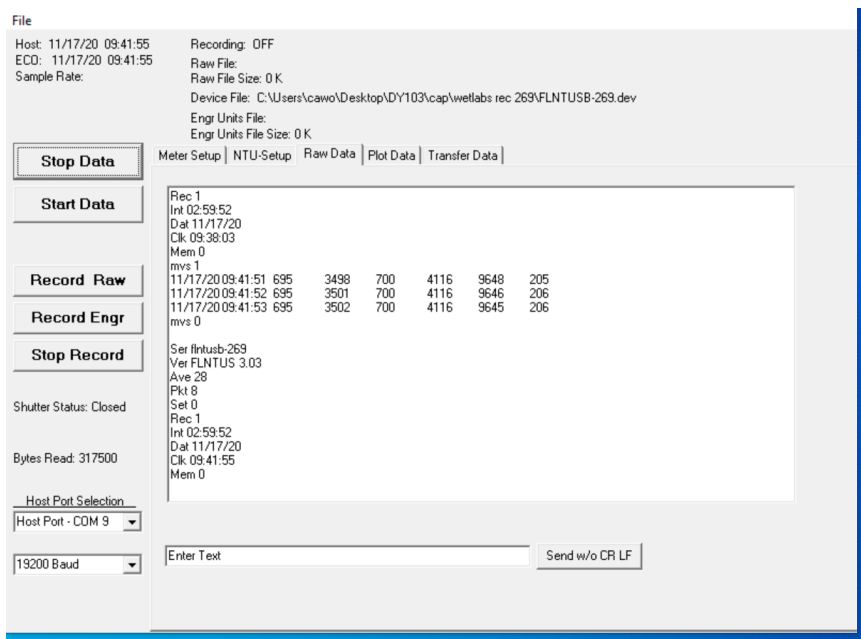
The flunusb was then disconnected and reconnected to display the settings as per below. Note it is the settings on the bottom two thirds of the display.

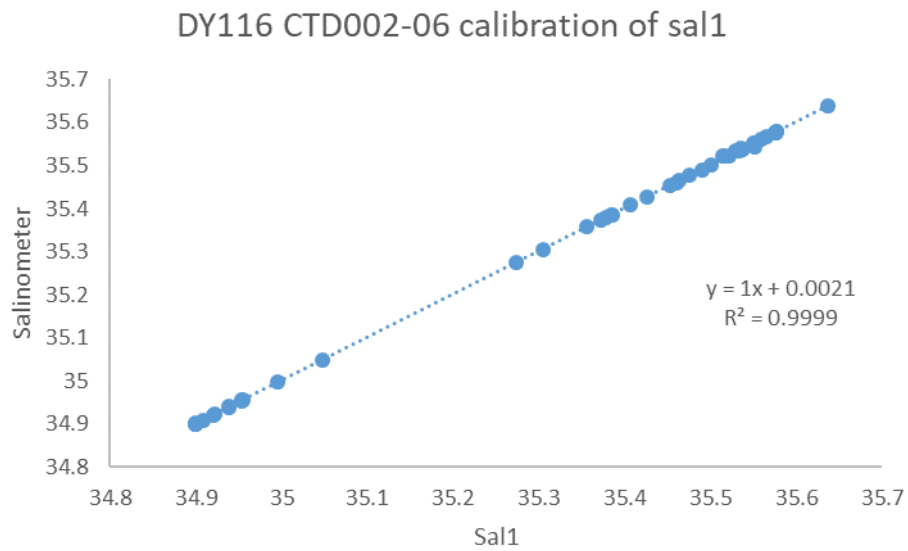
Generally, 3-12 salinity bottle samples were taken from each cast. Jeff Benson ran CTD002/CTD003 bottle salts on the Salinometer 21st November 2020 and CTD004-006 on 25th November. Calibration of Sal1 (to salinometer samples) based on 5 casts, see below.

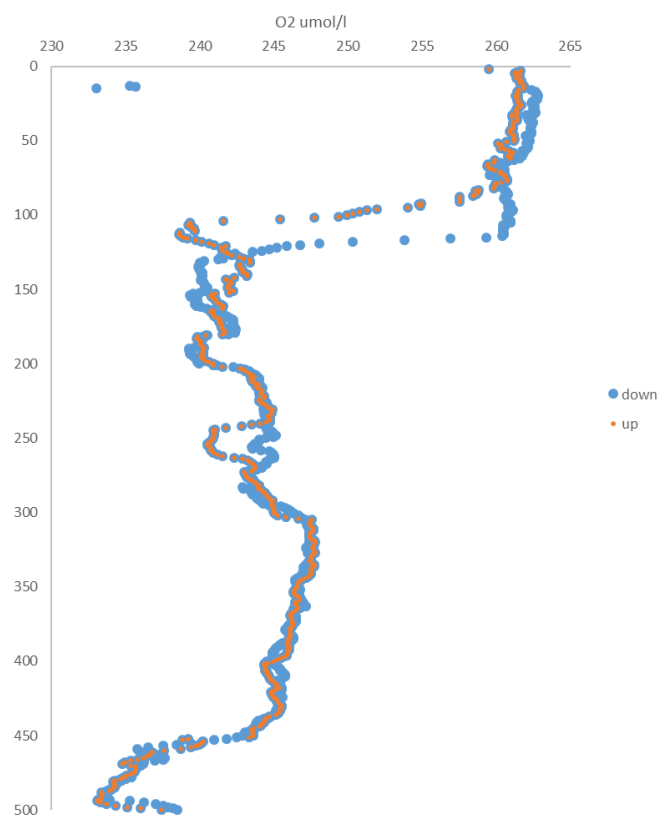
Example of shallow casts a) salinity and b) oxygen:

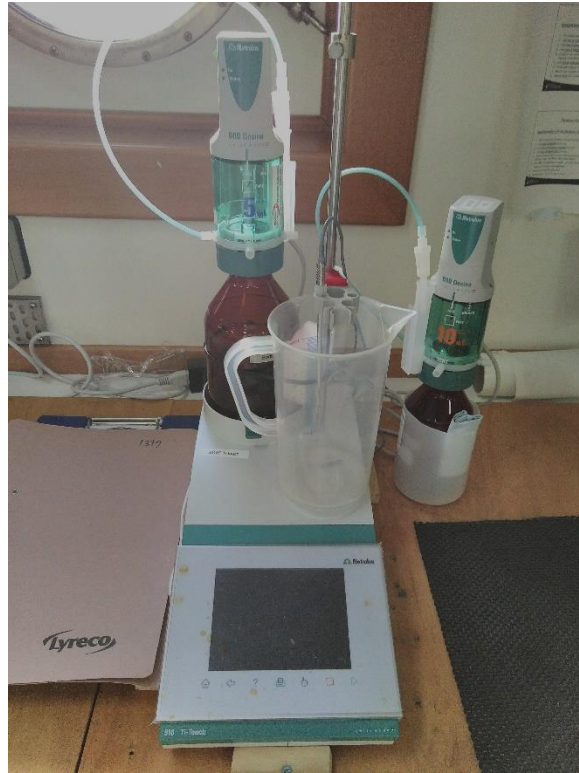
The Metrohm Ti-touch 916 setup used for oxygen analysis system on DY116.

At least 3 blank checks of the reagents and 4 standardisations of the sodium thiosulfate were measured using 5 mL additions of a 1.667 mol/l certified iodate standard (OSIL) for each set of analyses.

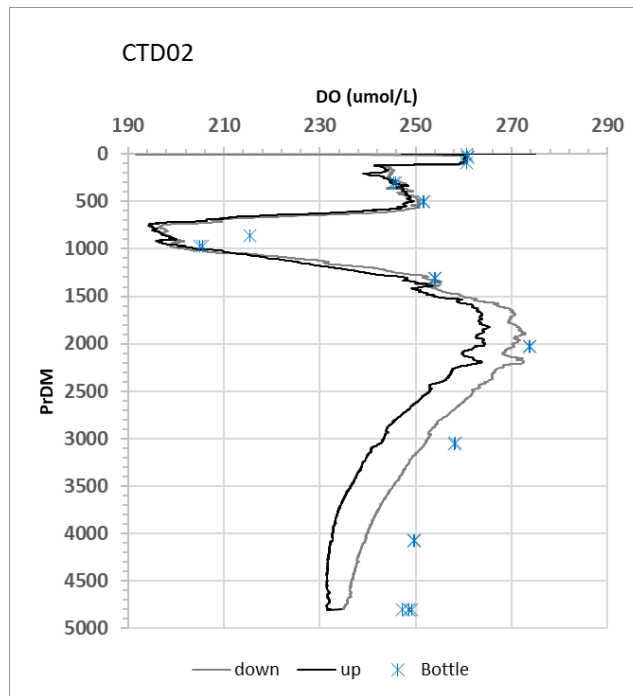
Example cast (CTD02) shows extent of hysteresis between up (black line) and down casts (grey line) for Sbeox O2 sensor (SN 0862). Bottle values are indicated (blue asterisks). No corrections applied yet.

The CTD SBE oxygen data (SN0862) was converted into $\mu\text{mol/l}$ for comparison with the bottle data. It should be noted that there was considerable hysteresis on the CTD oxygen sensor (above). The 10 minute mirocat calibration stops carried out may help to improve the CTD to bottle calibration fit.

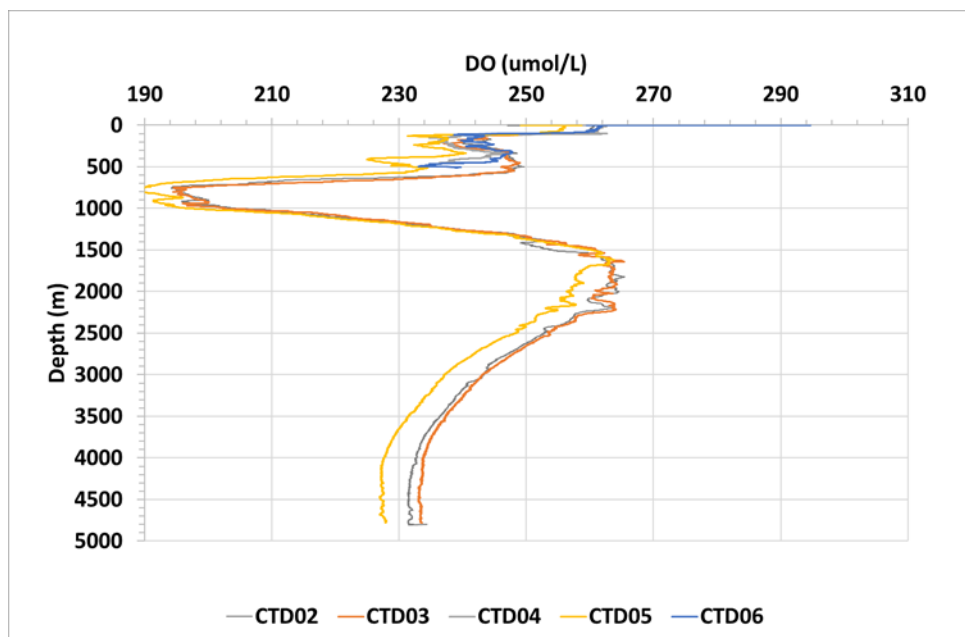
The full depth profiles show a clear oxygen minima around 850 m (Med water influence) and oxygen increases again around 2000 m before decreasing in the Lower deep water (below).

Vertical DO profiles of upward CTD casts during DY116. Nor corrections applied.

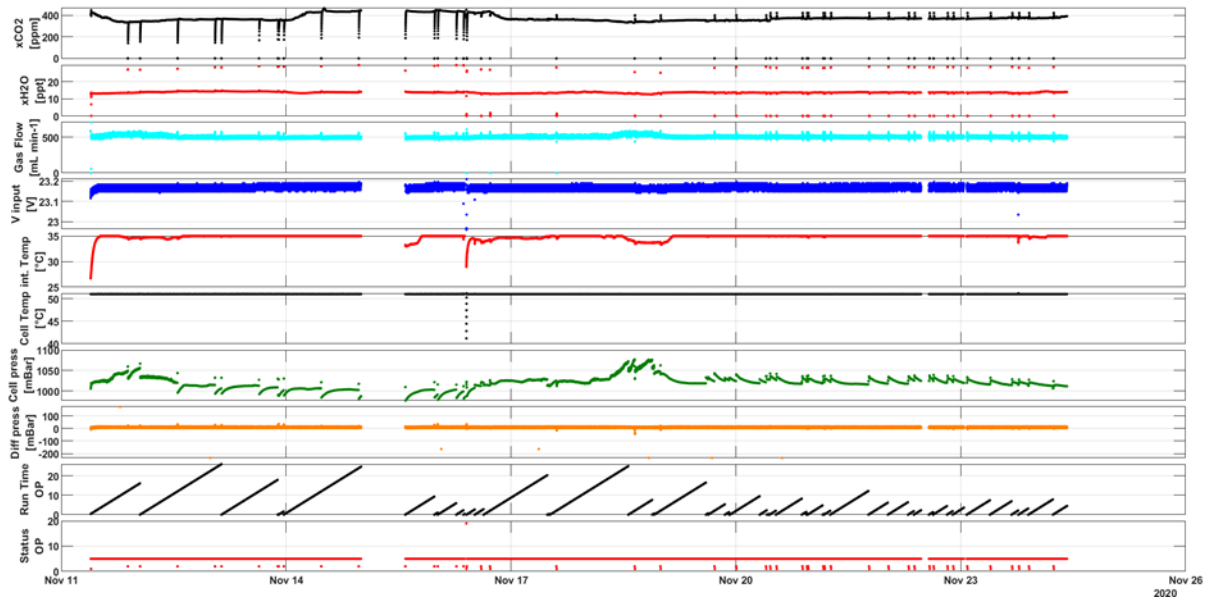
Raw data output of the SubCtech covering the entire duration of the cruise.

The data log interval was initially set to 20 sec. Changing the interval to 1 min averages does not work at the moment, thought to be caused by a software bug (personal communication with S. Raimund). On 16/11/2020 the data log was changed to 30 sec intervals.

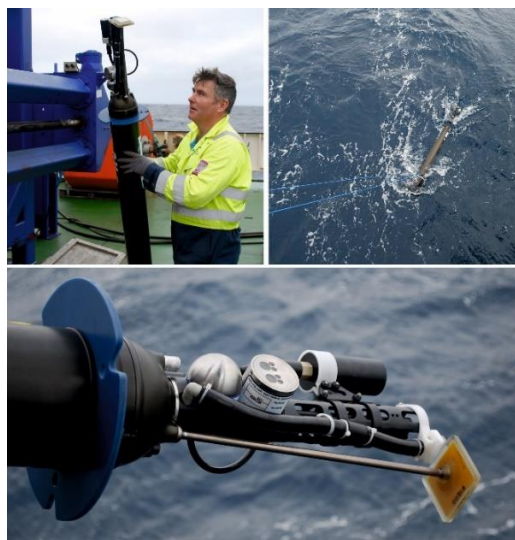
Deployment of the Met Office biogeochemistry Argo float at PAP-SO (DY116-006)

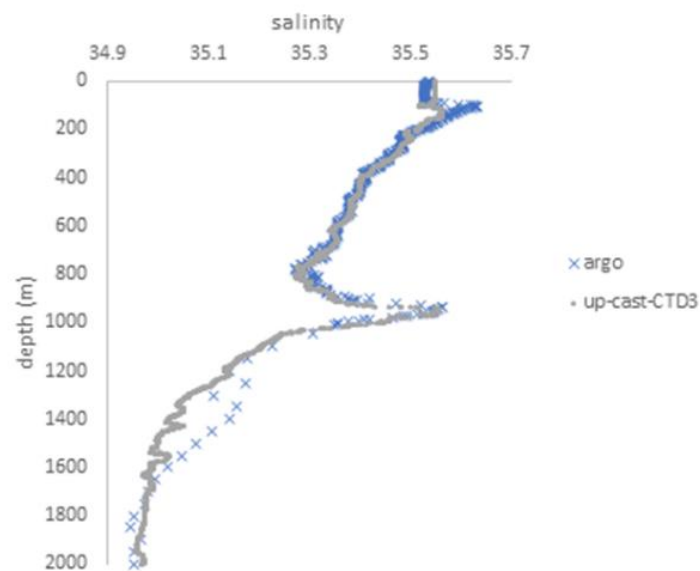
Plot showing salinity from the first BGC Argo dive and data from CTD cast just prior to deployment

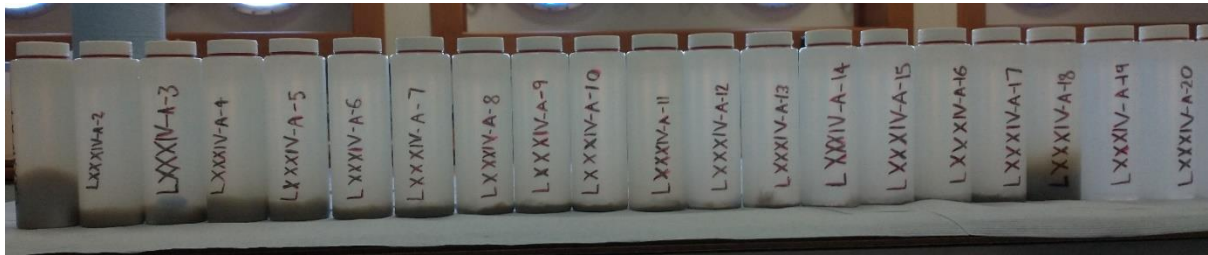
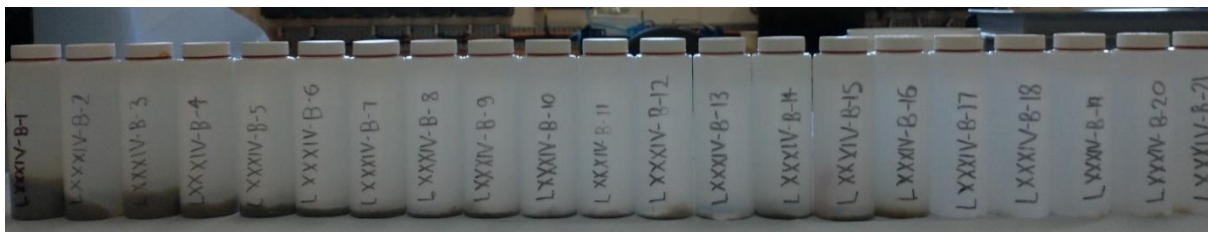
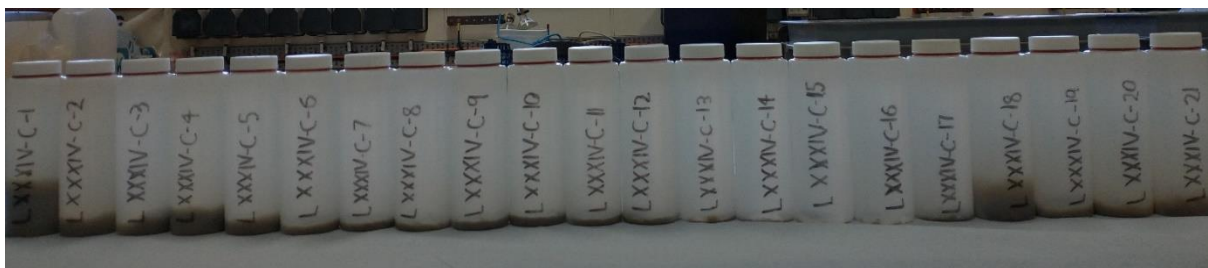
Images of bottles from the three sediment traps (upper = trap A at 3000 m, middle = trap B at 3050 m, Lower = trap C at 100 m above bottom)

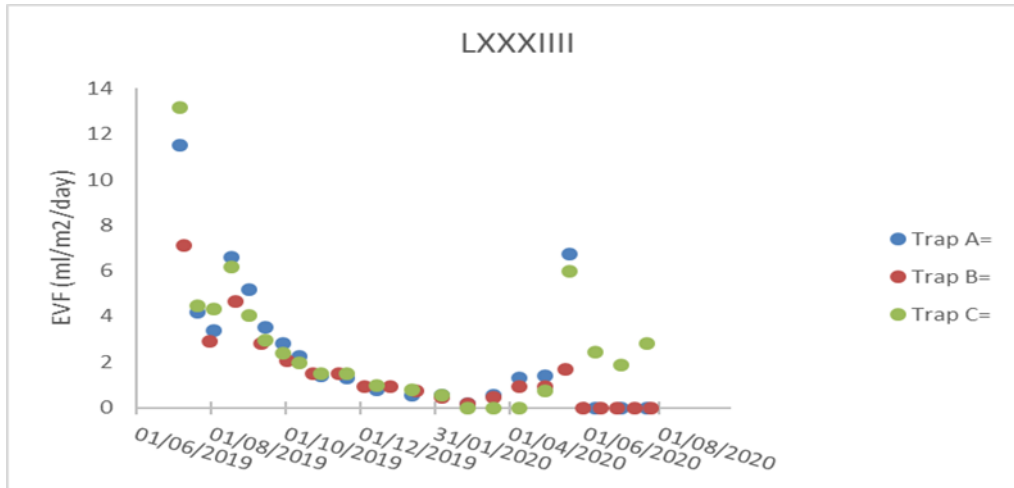
EVF from the three sediment traps during the deployment duration

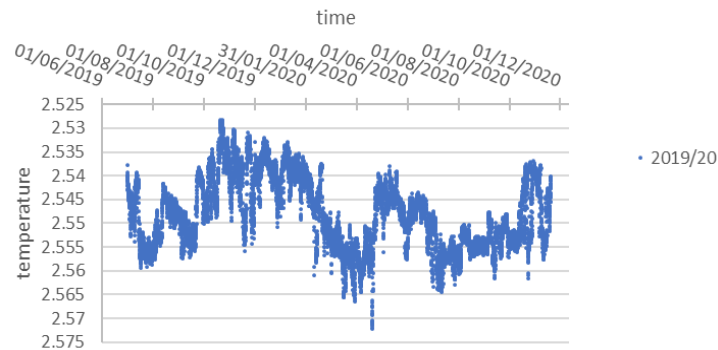
PAP 3 microcat recovered dy103-dy116

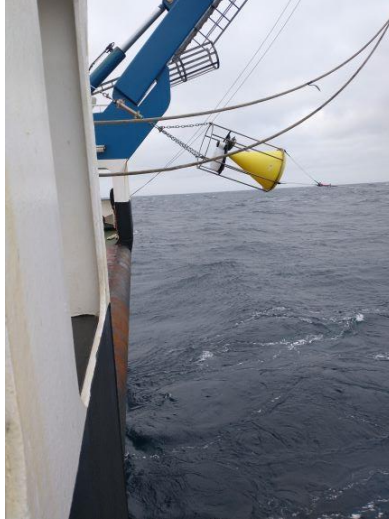
Deployment of PAP3

Mooring deployment was started at 15:15 and the anchor was in by 17:34. Trap A (s/n 12432_06), Trap B (s/n 12283-01), Trap C (12432-02). Microcat at 80mab (s/n 12462) nb this was recovered from Whittard canyon, calibrated and redeployed. Norteks were at 3100 m and 100 mab 6178 and 8351.

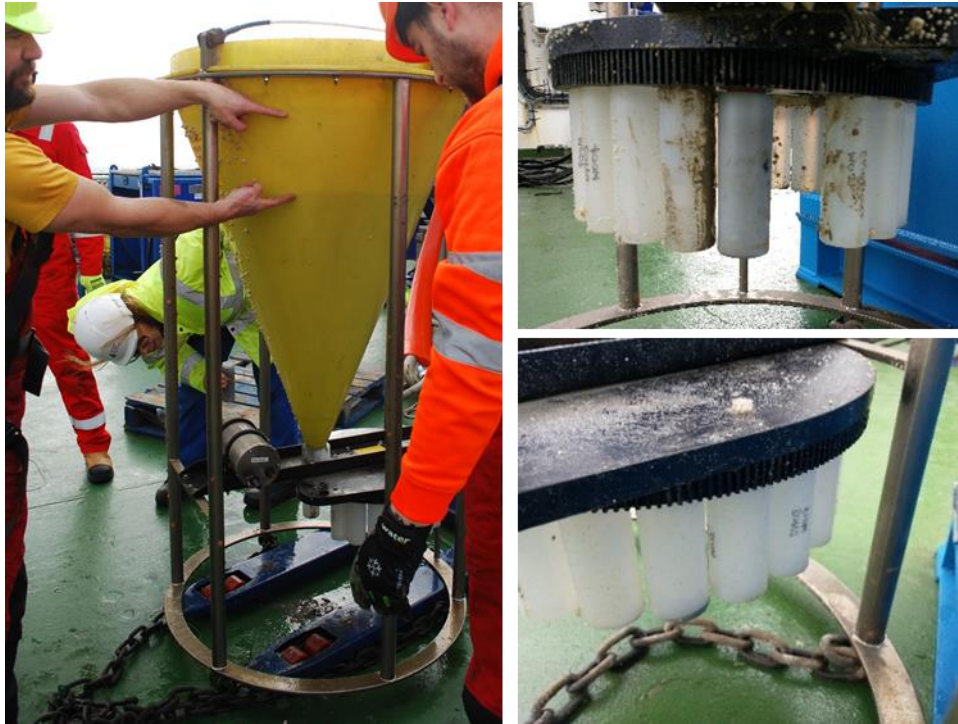
Inspection of the sediment trap from the WCM, filled with sediment on recovery to deck

The sediment trap funnel was two thirds full with an unknown deposit on retrieval adding to its weight and negative buoyancy of the end of the mooring, this being the reason the 600 kHz buoy did not quite reach the surface.

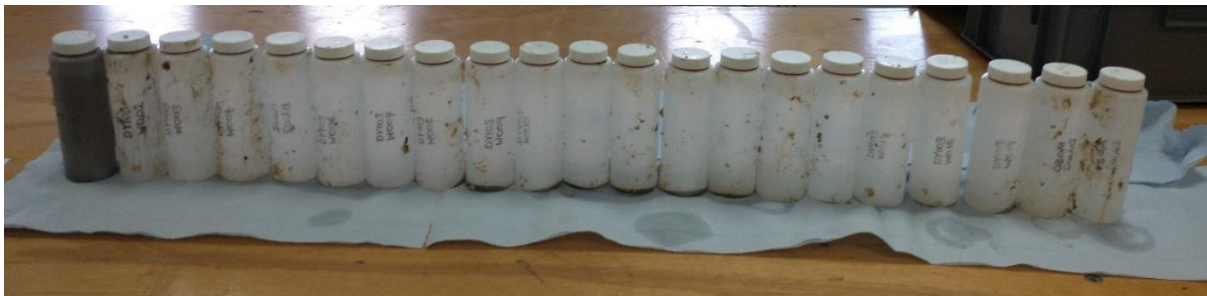
Sediment trap bottles removed from WCM and shown in sequence in the laboratory
