JB02:

RRS John Biscoe South Georgia and South Orkneys Marine Biology (OBP2) February 1980 - April 1980

February - April 1980

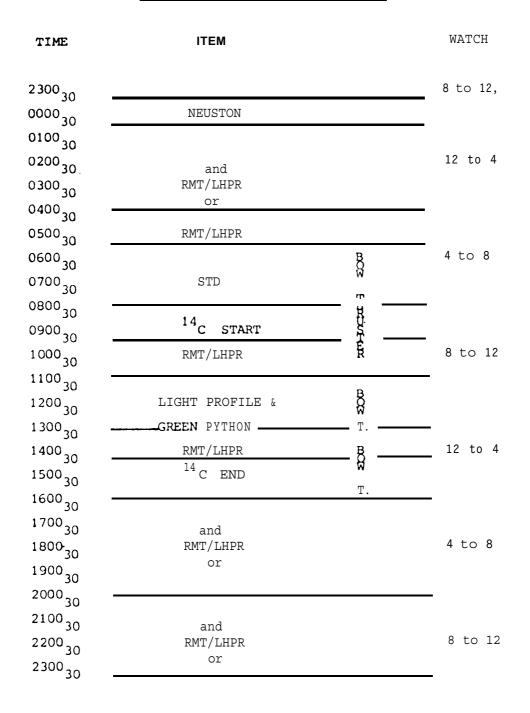
Appendix 1

REGULAR DRIFT STATION PROGRAMME

SLACK TIME TO BE USED FOR ACOUSTIC KRILL SURVEYS ON GIVEN COURSES AT 5 KNOTS. WATCH FOREMAN TO INFORM BRIDGE ASAP.

It gradually became apparent that the chances of a krill patch developing in the vicinity of the ship were slight. Consequently the decision was taken to extend the current drift survey by 6 days and to substitute a krill patch search and investigation leg **for** the second drift survey. The Drift Survey was otherwise extremely successful. **A** total of 174 stations were worked in a total drift time of 17 days, in which 100.4 **n** miles were 'covered (Fig. 1) at an average speed of 0.27 knots. Fifty three hours were lost through bad weather. The daily work schedule is given in Appendix I.

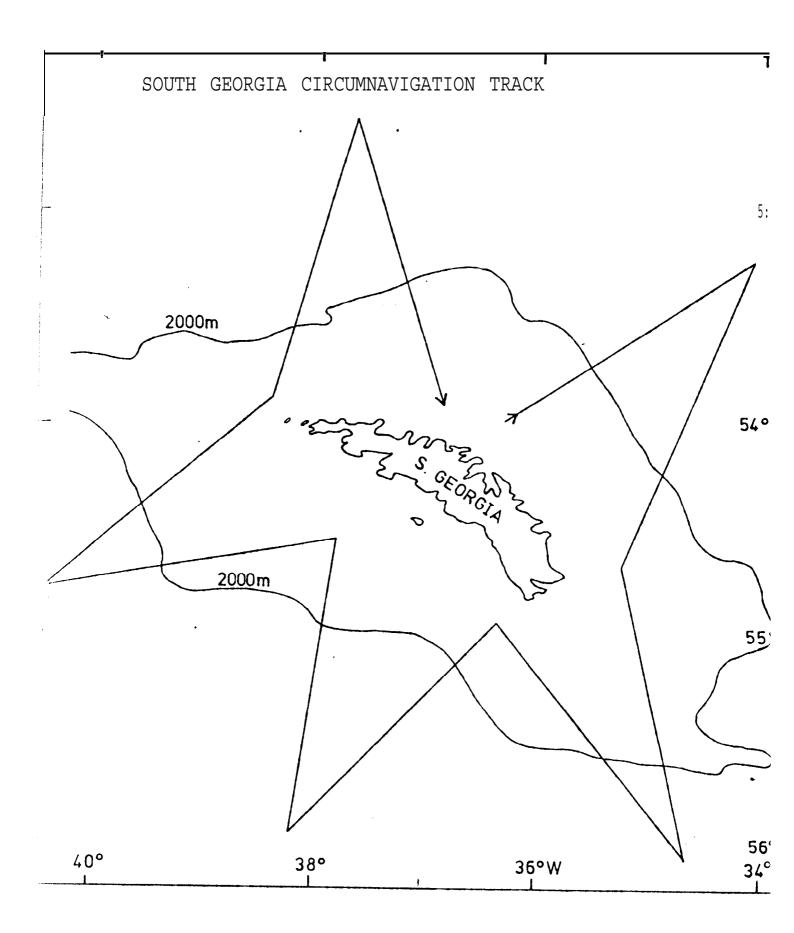
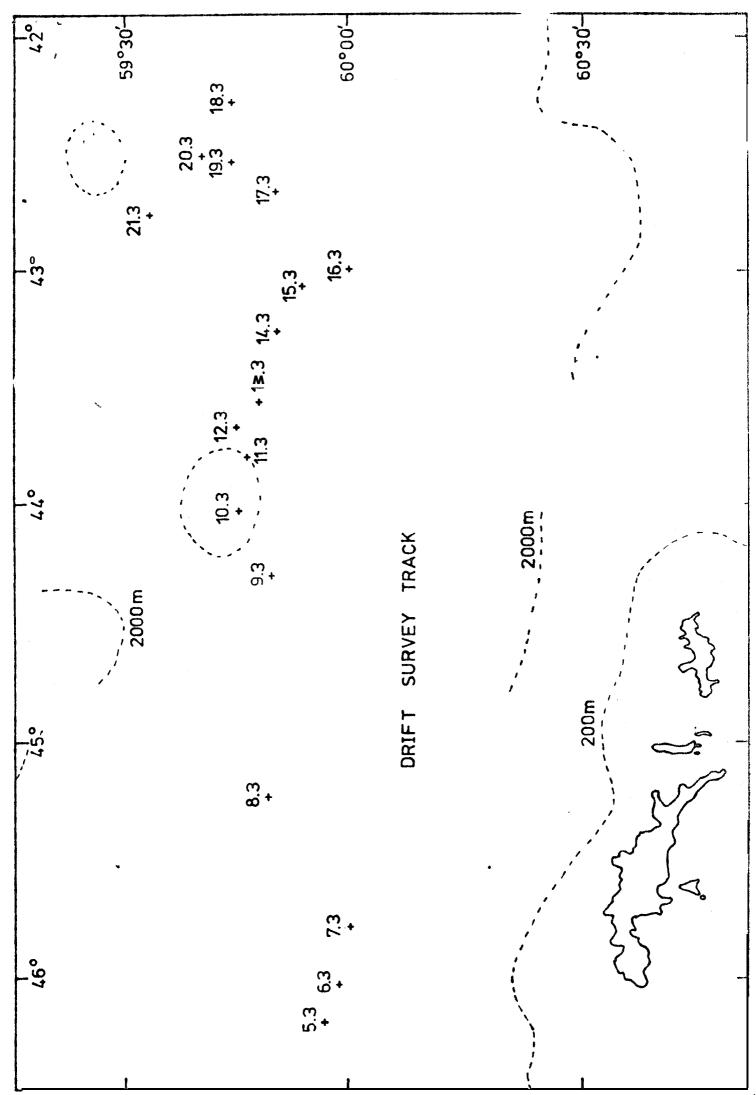
SOUTH GEORGIA CIRCUMNAVIGATION

Midnight Single oblique to 200 m **or** as RMT (NEUSTRON) topography permits HSTN, ACOUSTIC SURVEY, XPT's Service speed 7-8 kts STD's at 300 fm, 600 fm, 900 fm contours. Variable period because of poor depth echosounder Single oblique to 200 m or as topography permits RMT HSTN, ACOUSTIC SURVEY, XBT's Service speed 7-8 kts) STD's Variable time slot to allow for depth NEUSTON Midnight

South Georgia, Circumnavigation Survey began 0100 GMT. The daily March 27. work schedule is given in Appendix 2 and the Survey track in Fig. 2. The legs were approximately 100 n miles long but varied because the programme waz built around a series of midnight stations alternating over shelf and The survey was successful and 163 stations were worked in 11 deep water. Thirty four hours were lost through bad weather. The ship echosounder days. waz very unreliable even in shallow water and considerable time was spent finding the 300 fm, 600 fm and 900 fm contours, The expandable bathythermograph proved disappointing with a 'success rate of less than 1 in 5 (at the time the probes were thought to be affected by the cold but information recently received from Institute fur Seefischerei, Hamburg suggests that the probes were old and had deteriorated during storage).. Fortunately there. was
