RRS James Clark Ross

Cruise JR106

Autosub under Arctic Sea Ice

Cruise Report

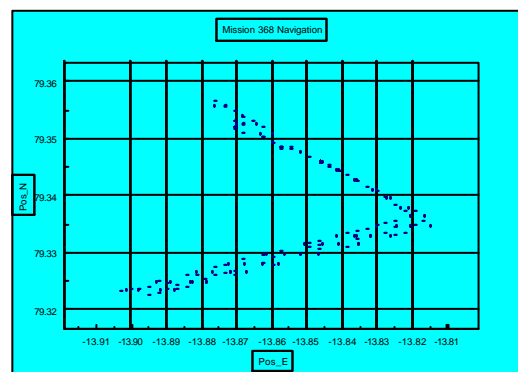
Figure 2: Navigation for Mission 368. Post processing assumes a constant velocity error between GPS fixes. This causes some distortion to the apparent track.

Another possible cause is GPS outages. On Mission 368, a jump of 80 m in GPS position at the start of the mission is indicates that there may be a problem with GPS jumps.

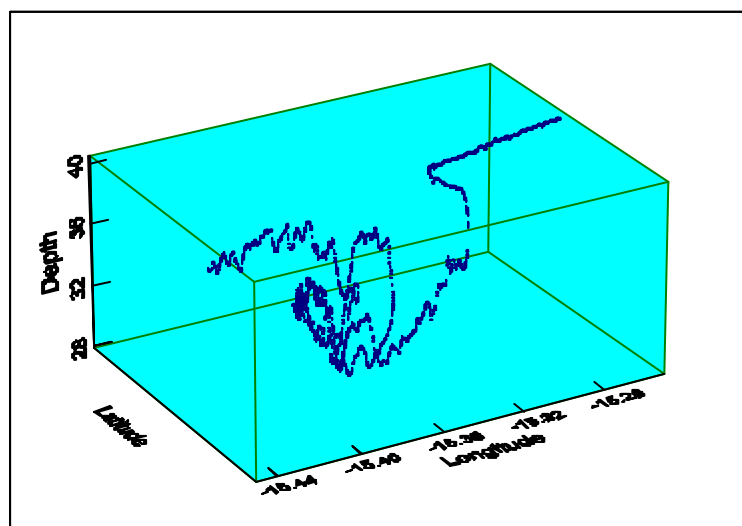
Figure 1. Track and depth of Autosub as it manoeuvred around an obstacle detected by the forward looking sonar, during the return leg of mission 365. The Autosub track is from left to right (heading Eastwards). It turns around twice and retreats, finally succeeding in avoiding the hazard on the third attempt.

The behaviour of the vehicle following triggering of the collision avoidance state, is configurable. In most cases, when an obstacle is encountered when the Autosub is heading out, we configured it to abandon the mission and head back towards the recovery waypoint. This occurred on missions 363 (due to limited headroom), and for mission 364 (due to collision imminent sensed by the forward echo sounder). Following this we reduced the minimum altitude to 25 m and set the Autosub off on a long 24 hour under ice (mission 365). On this occasion the Autosub was able to get to the destination waypoint, but detected an imminent collision on the way back. In this situation, Autosub attempts to find a way around the hazard, by first retreating along its path (known to be safe), and then attempts to round the hazard by trying a different track. If it encounters the obstacle again, it repeats this behaviour but with a randomly chosen new track. Figure 1 shows that it took three attempts for Autosub to find its way around the obstacle.

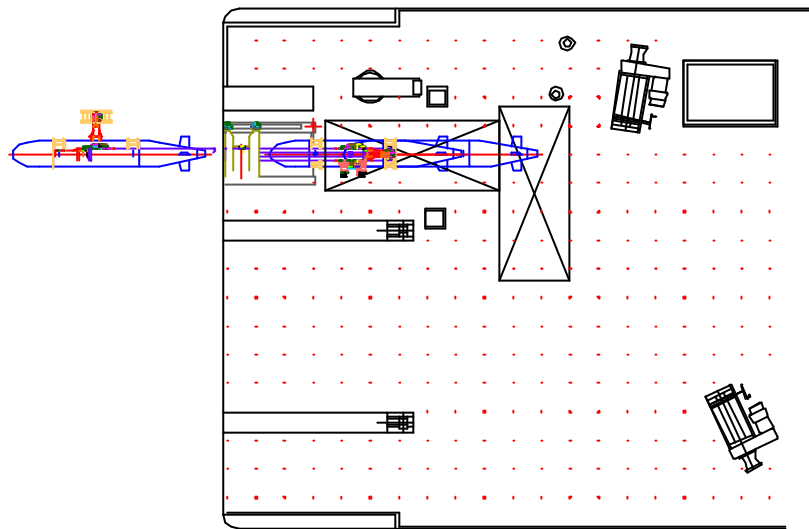
Figure 1 Plan layout of the containers on the aft deck

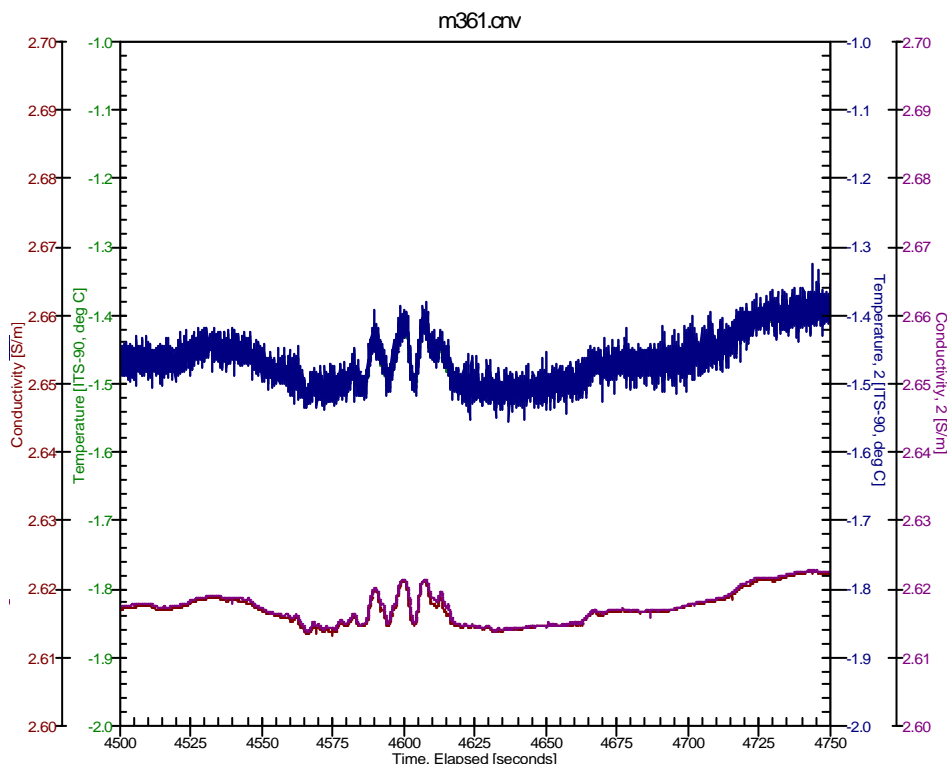
Figure 1. Primary and Secondary Conductivity and Temperature Data for a Section of Mission 361

Data from the system is continuously logged whenever Autosub is switched on but, in order to prevent excessive wear on the pump, water is only pumped through the C/T sensors once a predetermined pressure threshold has been exceeded. The data is stored on the Autosub logger in a proprietary format but is normally translated into a Seabird format data file (.dat) at the end of each mission. This data file, together with the necessary configuration file was then passed to the scientific party for further processing. Sensor calibration data is stored in a separate file with the .con extension. For the JR106 cruise the data was initially processed using the 0696Plym04bPre.con file which contained the most recent calibration data prior to the start of the cruise. An unprocessed section of the data from mission 361 is shown below. This appears to show a good correlation between the primary and secondary sensors although the secondary temperature sensor (the blue line) appears more noisy. This data would normally be further processed to compensate for the time delay between T and C sensors in order to remove any false salinity spikes.

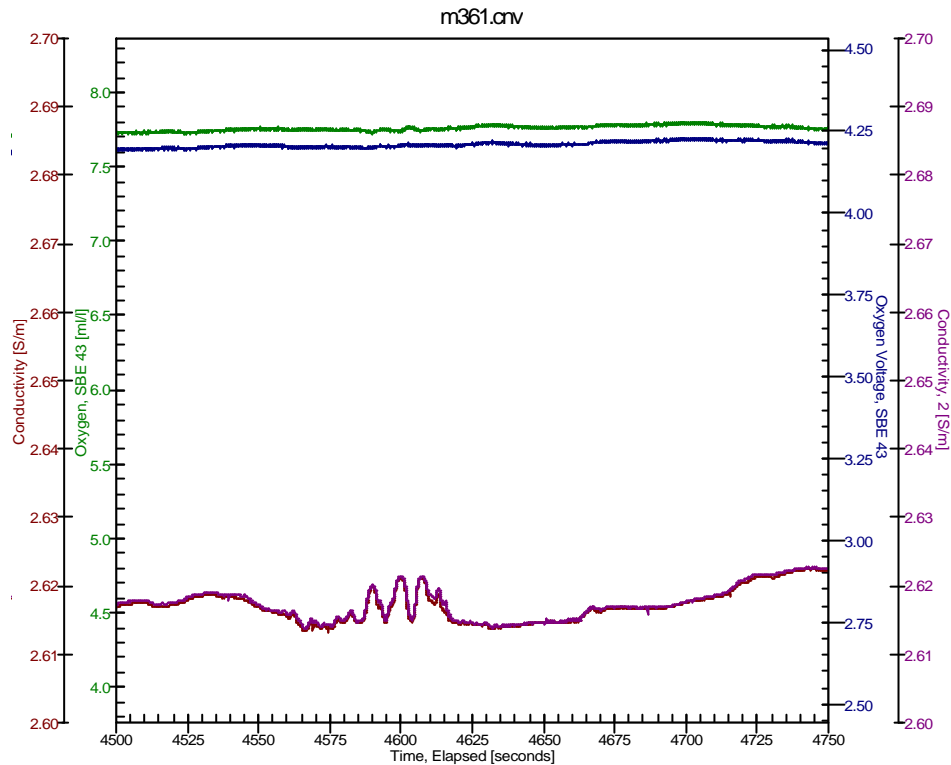
Figure 2. Oxygen and Conductivity Data for a Section of Mission 361

However, towards the end of the cruise it was noticed that the data from the SBE 43 Oxygen sensor was not giving sensible results. On further investigation it appears that the sensor had been connected to analogue input 4 rather than input 0. A new configuration file, 0696JR106Start.con, was produced which will accept oxygen data on analogue channel 4. The oxygen sensor data for the same period as figure 1 is shown below in figure 2.

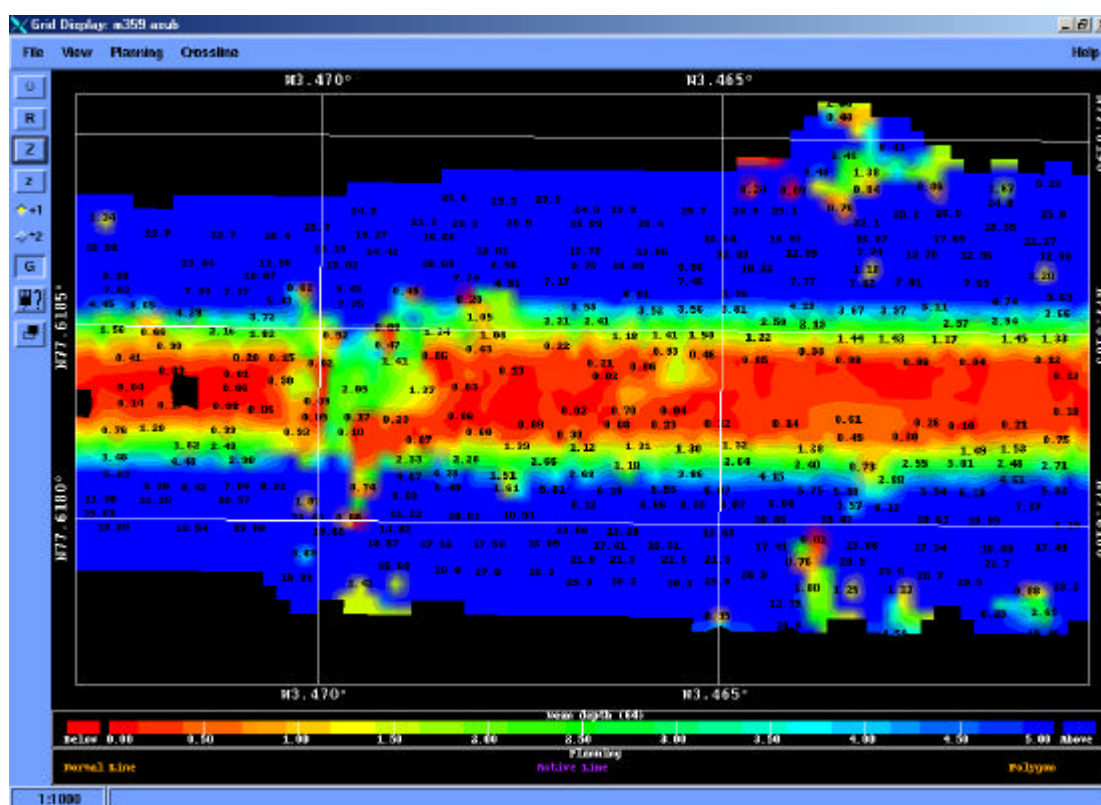
Figure 1. Section of Gridded EM2000 data from Autosub Mission 359

The first mission to give data from the EM2000 was mission 359 which was run in reasonably open water with a few well spaced ice floes. A short section is shown below in Figure 1. There appear to be returns from the ice but the sea surface does not appear to have been properly detected as the outer beams show increasing depths rather than a flat sea surface and, given the depth sensor offset, the sea surface should be at a greater depth than found in this data. Two factors were identified which could have caused this; a) the instrument sound speed was set to 1500ms^{-1} while the true sound speed was closer to 1450ms^{-1} and b) the depth sensor offset may have been too low. Both of these factors would cause the sea surface to appear to be above zero.

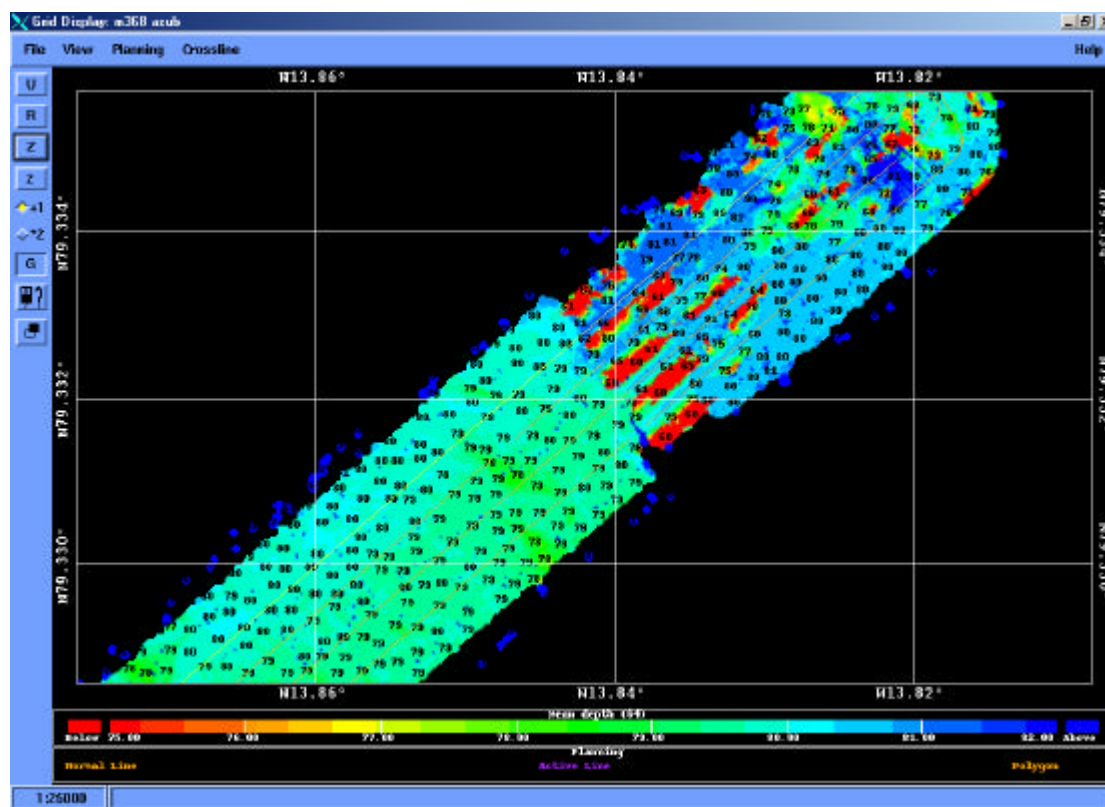
Figure 2. Section of Gridded EM2000 data from Autosub Mission 368 showing anomalies due to deliberate false roll setting.

The edge of the fast ice can be clearly seen but there are discontinuities between adjacent beams caused by the port/starboard reversal and the deeper depths shown by the red sections are caused by the vertical echo swamping the sea surface returns where no ice is present.

Mission 362 and all later missions were run in this configuration. While, from an engineering point of view, the system appeared to be collecting data, it will not be possible to look at the data in any real detail until suitable processing software has been written. The plot below highlights some of the problems that have still to be addressed by the additional processing software.

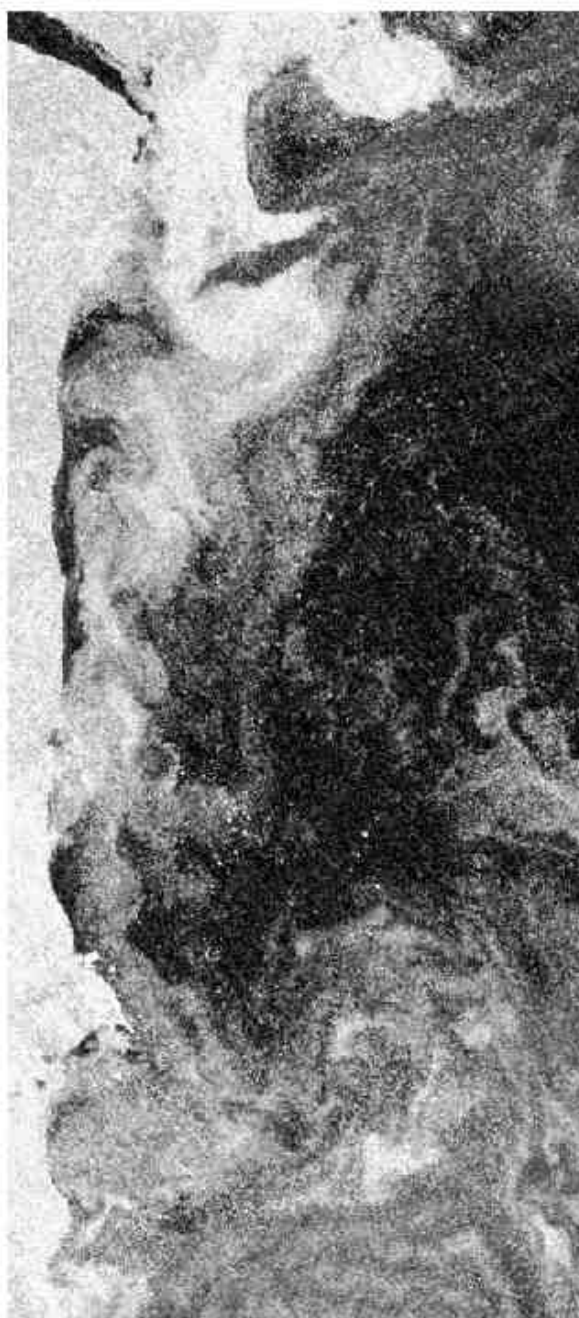
The final Envisat image, shown to the left, delivered for this portion of JR106 still shows the distinct fast ice edge between 79°N and 79°40'N still as it was at the beginning of the series of images. The fast ice floes broken off to the north were broken up and swept down to the south by a day of storm conditions in the Greenland Sea.

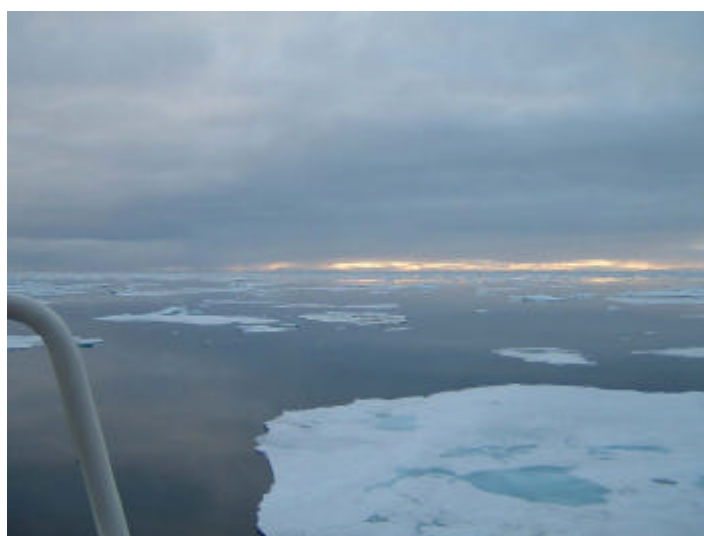
Figure 3. Sediment on surface of floe (dark area) in photo center also some lighter, smudgy areas of sediment on floe in the foreground, 19 August 0300.

Another indicator of the multiyear age is the observations of sediment on the surfaces of the older ice floes seen quite commonly in the outer reaches of the ice pack. Sediment in the ice originates from incorporation during first ice formation in turbulent conditions found primarily in shallow water on the Siberian Shelves such as in the Laptev and Kara Seas. The sediment accumulates progressively on the surface as ice melts during summer, so darker floes have drifted long enough to last through two summers' melt.

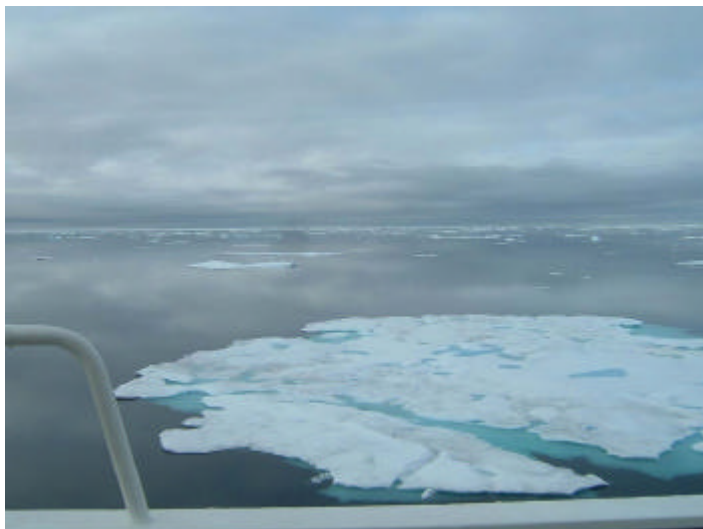
Figure 4: 18th August 1700 showing melt ponds and channels at full development of summer melt. Snow cover is still present but fully ‘ripened’ with large grains.

In the early part of the cruise, the full melting condition of the summer pack was in evidence. Estimates of melt pond coverage (tested at low salinity as essentially fresh water from snowmelt) were generally from 15 to 25% coverage of the ice surface. In almost all cases, however, there was approximately a 10 cm thick snow cover remaining throughout the region between the melt ponds (Figures 3 and 4). Some melt ponds were observed to completely perforate the floe to the ocean below. The snow cover was highly metamorphosed, with ~0.5 cm grains indicative of the grain growth that takes place when the snow is saturated with melt water. Channels into and between melt ponds also were evident showing the pathways of water flow from the higher topography of the floe to the low spots where the water pooled. (Figures 3 and 4).

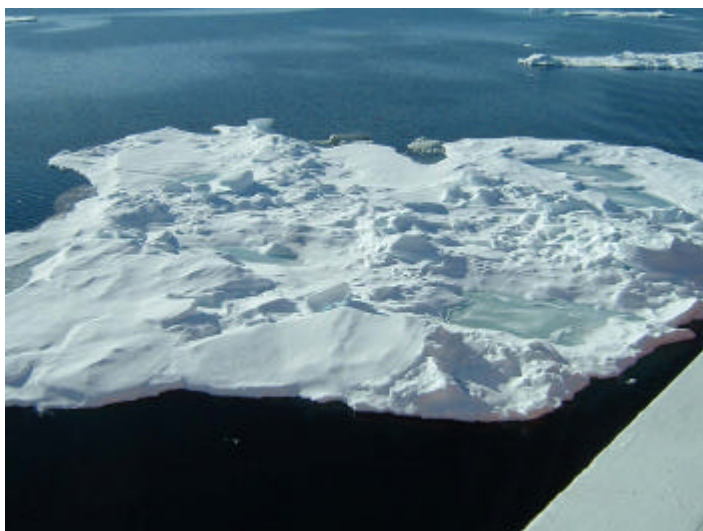
Figure 5: Photo from 26 August, 1500 showing frozen-over melt ponds and new snow cover at start of fall-winter transition in NE Greenland.

From the 22 August, new snow accumulated on the floes, measured at 5 to 10 cm from the surface measurements. Melt ponds were also frozen over with a thin layer of new ice starting from this time (Figure 5), another indicator of the transition to fall-winter conditions and the start of the ice growth season, as indicated by the new ice types observed as noted above.

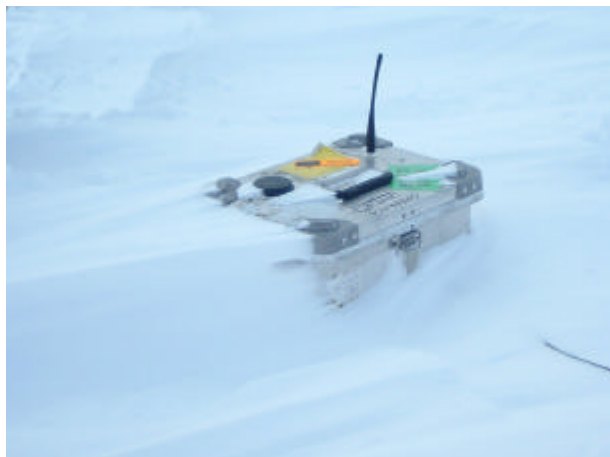
Green Ice “buoy” on a previous deployment.

As part of the international Greenland Arctic Shelf Ice Experiment (GreenIce) project, an ice thickness measuring “buoy” was deployed onto a area of thick ice near to the ship. The buoy’s position was chosen such that it was close to the centre of an area that had been surveyed previously, both by drilling and by an autosub swath mission. This location was chosen in order to allow cross comparison of various measurement methods. In addition to the measurements made by the JR106 team a series of E.M. measurements were made of the same area by the German teams from *Polarstern*.

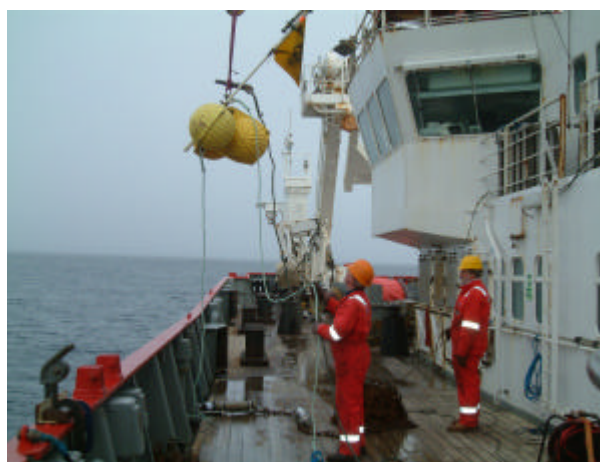
“Acoustic modem trial” mooring being deployed.

The short mooring string (around 7m long) consisting of modem, release, anchor and buoyancy was deployed into 2500m of water at a position 77°36.33'N, 004°06.69'W. After deploying the mooring the JCR was allowed to drift such that the range from the mooring site gradually increased. This drift allowed the testing of the acoustic link between surface and seabed at a number of different distances. At each of the ranges a number of different data streams were transmitted surface to seabed and then back again, allowing some of the performance characteristics to be established. Data packet sizes of up to 10Kbytes were transferred. Initial results suggest that the link performed extremely well when the surface, seabed offset was 1000m or less. At greater ranges the performance was not quite as good as anticipated, though some of the problems might be related to the high background noise levels associated with ships. These trials suggest that the modem system will be suitable for use in the DWOS project, they do however highlight the need for the careful design of the transfer protocols to enable the system to cope with the more extreme ranges. Further consideration of the test results should inform this design of transfer protocol.

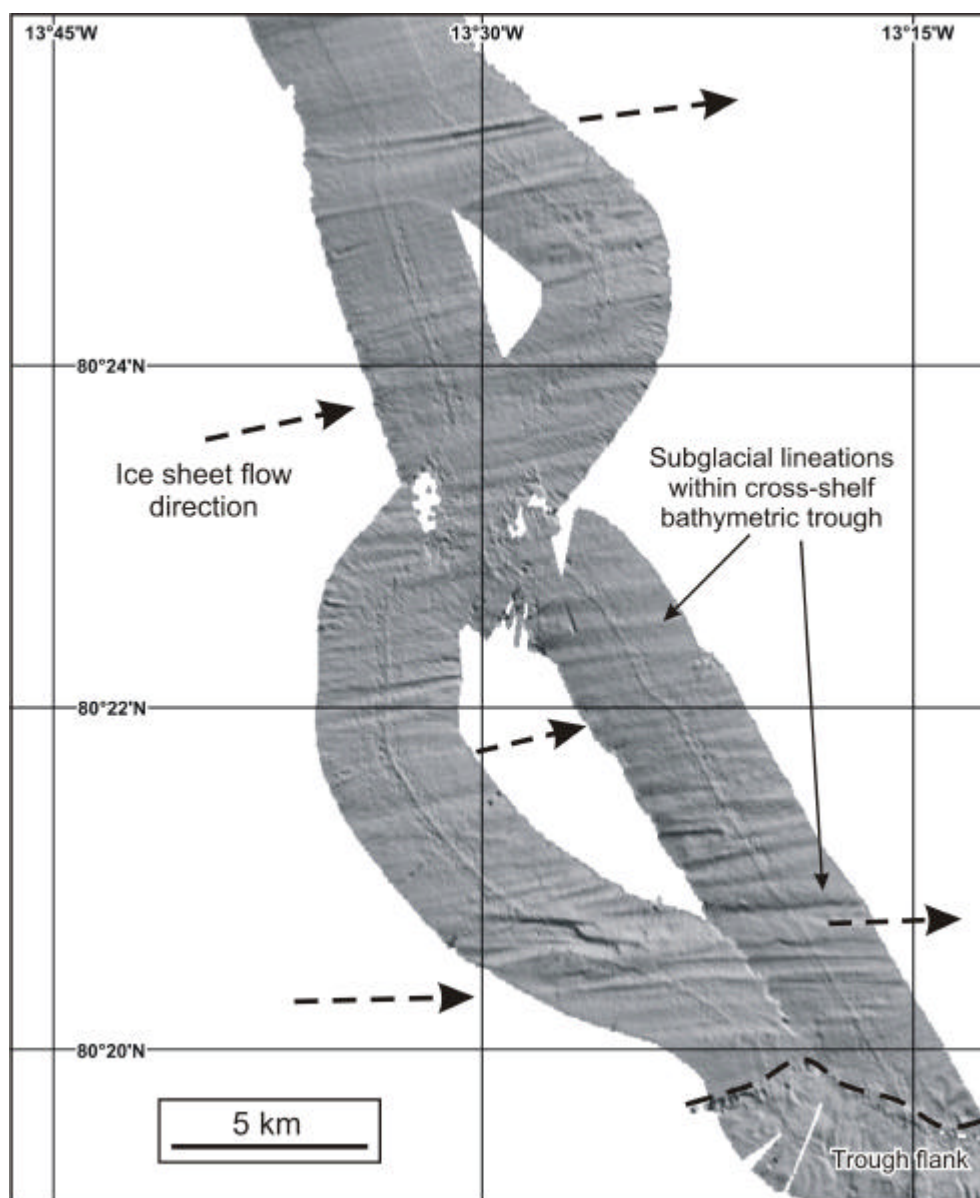
Figure 2. Unprocessed EM120 swath bathymetric shaded relief image of subglacial lineations in the cross-shelf bathymetric trough to the north of AWI Bank. The bedforms record former ice sheet flow to the east. Grid cell size = 30 m x 30 m.

TOPAS records indicate that the subglacial bedforms are formed in the surface of an acoustically transparent sediment layer that has a distinct continuous sub-sea floor basal reflector. This layer is interpreted as a till unit. TOPAS records from the trough east of Northwind Shoal *i.e.* east of $14^{\circ}30'W$, are dominated by a series of reflectors that dip towards the shelf edge. This unit is interpreted as a 'till delta' or grounding-zone wedge where subglacial sediment was advected to the ice-sheet margin. These sediments are overlain and truncated by the acoustically transparent sediment unit in which the streamlined subglacial bedforms occur. This implies that the ice advance, which formed the bedforms, occurred after the formation of the grounding-zone wedges and, therefore, that these ice-marginal features are probably a result of deposition during ice-sheet advance rather than retreat.

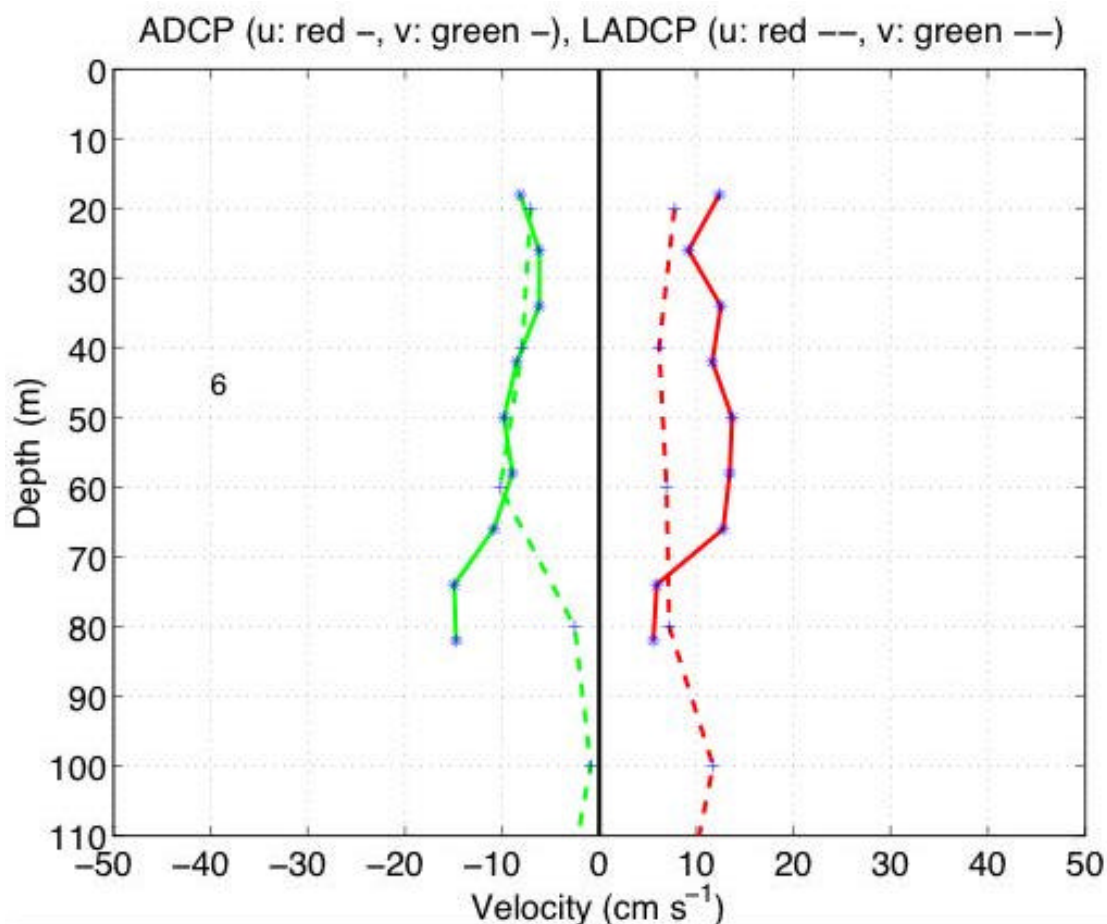
Figure 1. LADCP (dashed) and Ship ADCP (thick) velocities (u – red, v – green) for Stn 6. The Ship ADCP data are the time average velocities over the duration of the LADCP/CTD cast.

Initial comparisons with the time-averaged Ship ADCP data for each cast were found to be promising (see below).
