FRV *Clupea*

Cruise 1300C

## REPORT

11-20 September 2000

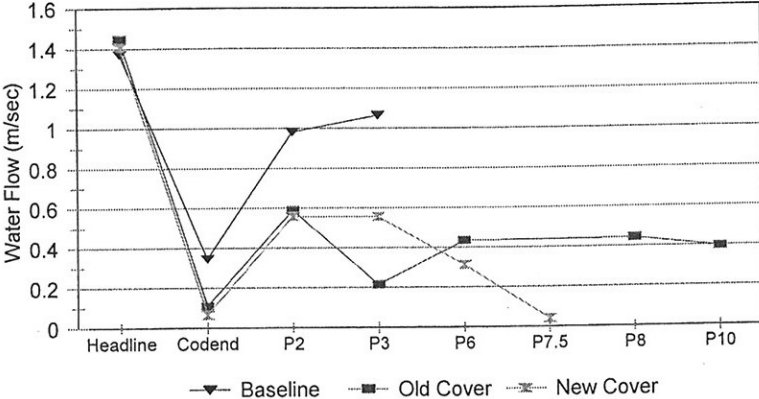
Water Flow, at 1.4 m/s towing speed,  
in and around Codend, New & Old Covers

Complete descriptions of the flow in around the cod-end and the original cod-end cover were obtained over a range of towing speeds (2.0-3.5 kts). Only a partial description of the water flow in the new cover design was achieved, however, because of equipment failures. Figure 1 summaries these results at a typical operational towing speed (1.4 m/sec), where: P2 is at the head of the cover; P3 above the cod-end; P6, P7.5 and P8 are ~5.5 m, ~8.5 m, and ~9.5 m behind the cod-end respectively; and P10 is 0.5 m ahead of the end of the cover.

It is clear that attaching a cover to the cod-end of a trawl significantly influences the flow in and around that cod-end. Moreover, in the original cover design there is still a substantial flow in the rear of the cover which is potentially injurious to any fish captive within the cover. Both these observations have important implications on the interpretation of escape mortality data obtained using this original cover design.
