**CRUISE REPORT No. 16**

**RV Ronald H. Brown Cruise RB0602  
and RRS Discovery Cruise D304**

RAPID mooring cruise report March and May 2006

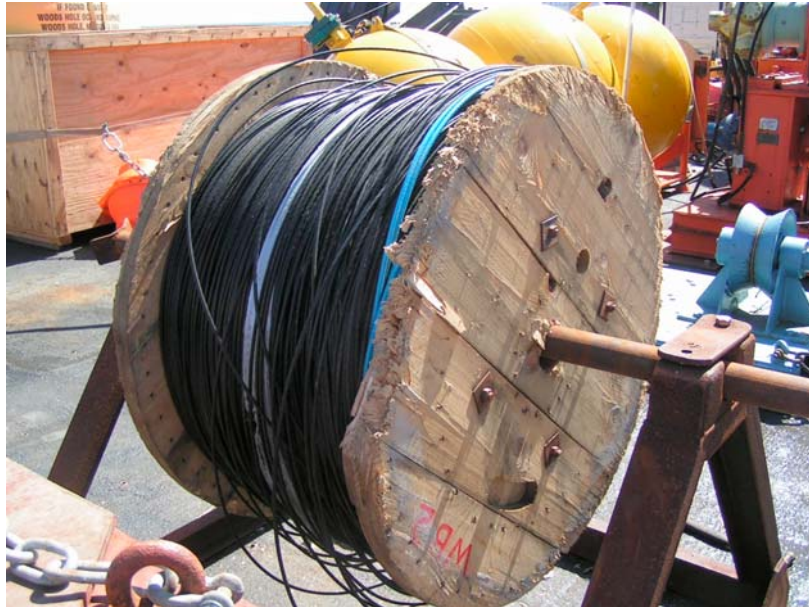
**Photograph C.1: Damaged drum containing pre-wound wire for WB2**

All the wire section of the moorings WB1, WB2 and WB4 had been pre-wound to wooden drums at NOC ready for deployment. However the wind was so loose that complete re-winding and tensioning was necessary. This involved winding off from the wooden drums onto a steel reeler drum and then through a snatch block hanging on the crane back onto the wooden drum mounted on the second reeler. During the rewinding it was found that the drive shaft on the reeler was bending due to the load of the heavy wire on the wooden drums and the drum was fouling a previously cut off framing on the reeler. This stub was cut off using the moorings angle grinder to allow enough clearance for the drum to turn.

WB2 had to be redesigned to somehow compensate for the damaged wire. By moving the remaining useable wires up in the mooring to replace the damaged wire, a section of Parafil could be used to infill for the missing wire. There was no spare wire supplied to the ship, only Parafil. The redesign has substantially heavier wire supported by the 50 inch subsurface buoy and when run on the mooring design program it was seen to sag and create a catenary if glass buoyancy was placed at 1800 metres. Thus buoyancy was moved up in the mooring to 1000 metres. Below the heavy wire section stiffness was no problem as the Parafil inserted has very low water weight. Also the opportunity was taken to create a two-stage mooring by moving the two-stage from WB4 to WB2 and manufacturing replacement buoys onboard for WB4.

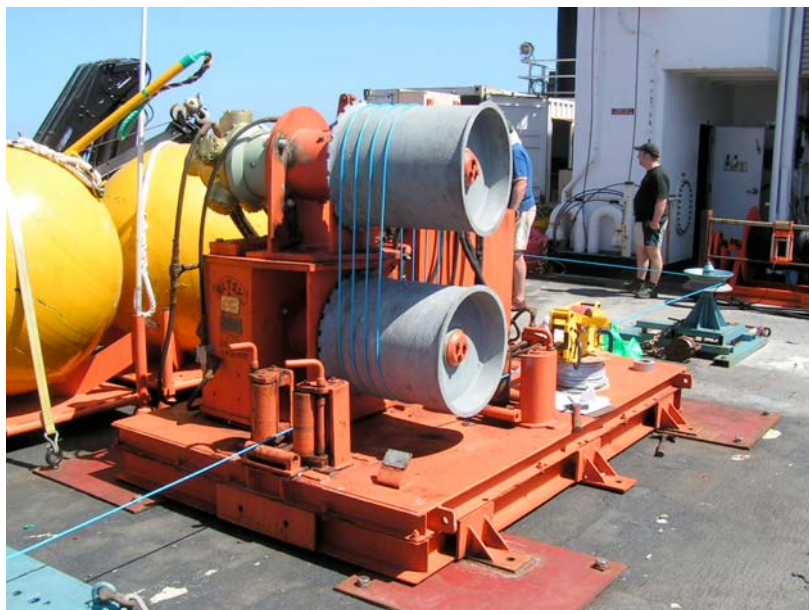
**Photograph C.2: Double Barrel Capstan winch in place with diverter sheave leading to storage reeler. (RB0602)**

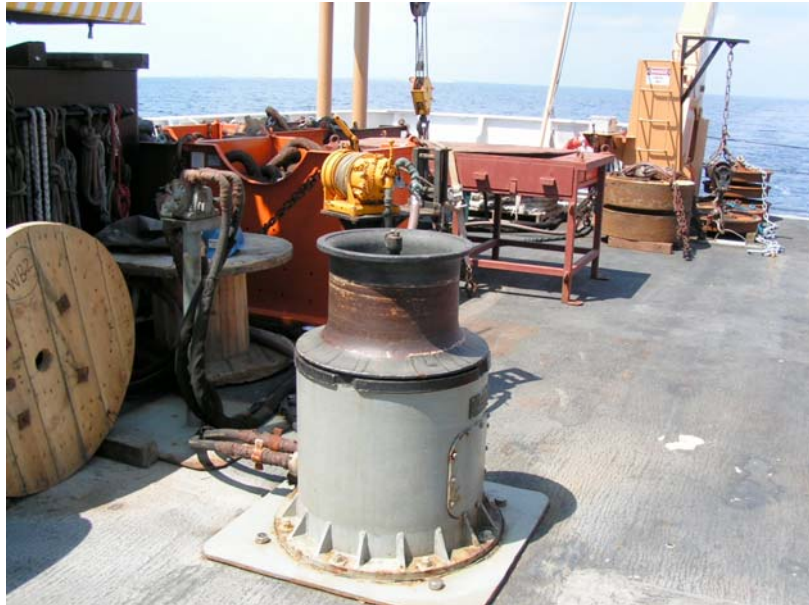
**Photograph C.3: Ships Deck capstan with air-tugger behind (yellow). (RB0602)**

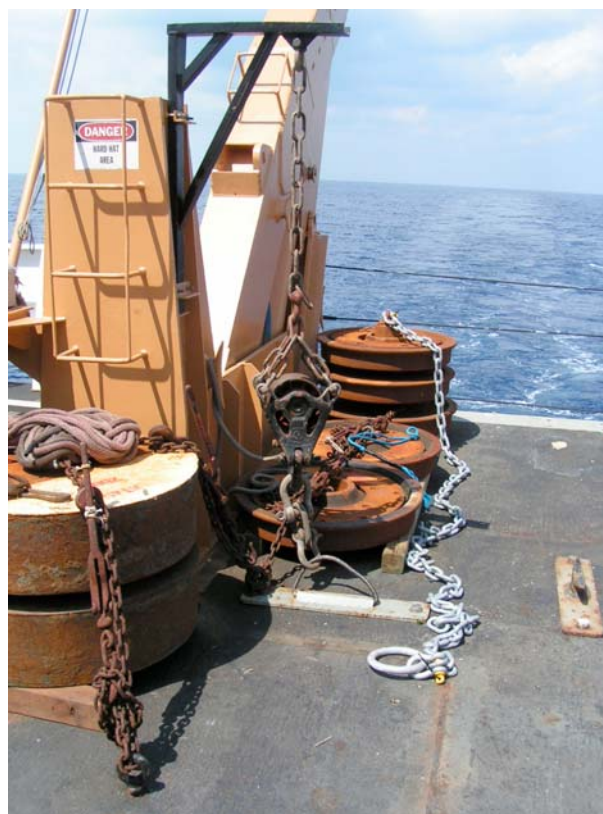
**Photograph C.4: Diverter sheave on simple gantry. (RB0602)**

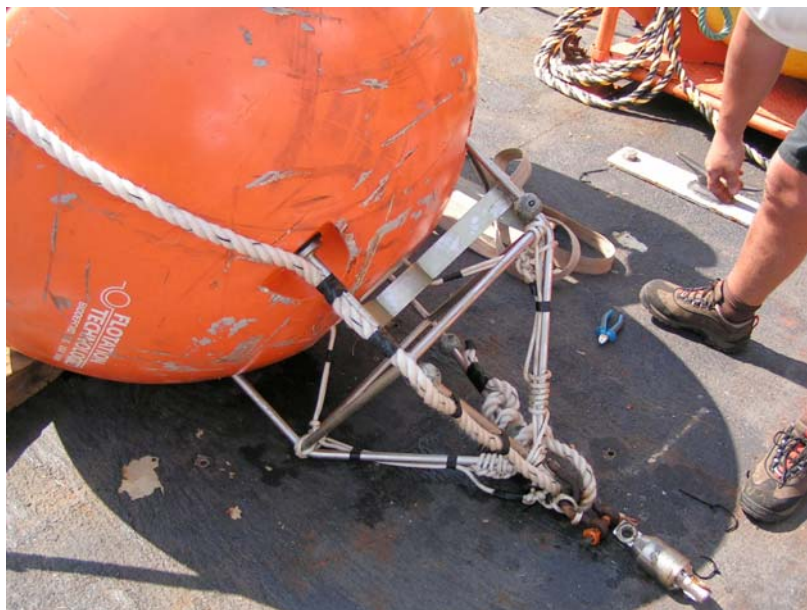
**Photograph C.6: Lower framework and swivel of buoy recovered from WBADCP.**

On inspection the buoy system and mooring was in excellent condition (see photographs C.6 and C.7 in Appendix C). This meant that the recovered buoy could be reused for deployment of the 2006 system. Anodes were in good condition with less than ten percent erosion. The hull which had to be hand carved with hammer and chisel in 2005 was as deployed.

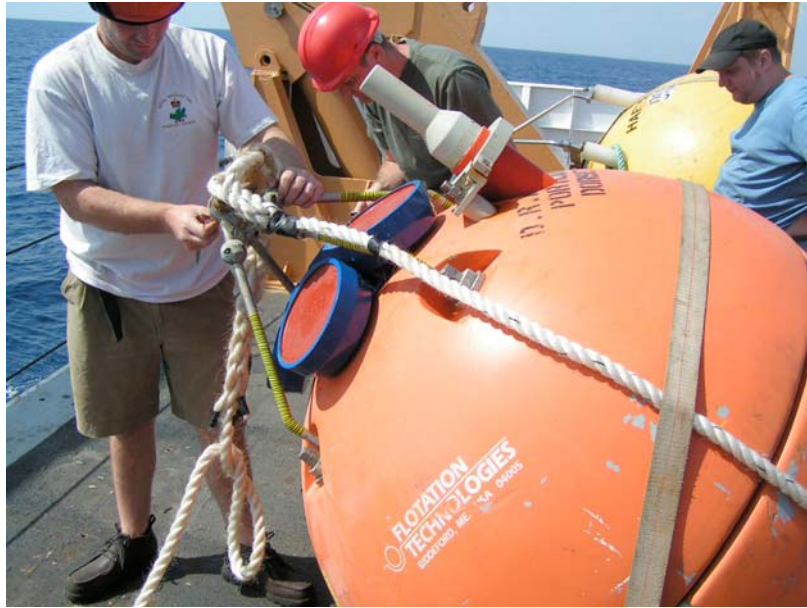
**Photograph C.7: Upper framework and ADCP transducers as recovered from WBADCP. Note little marine growth and clean transducer faces.**

Some evidence of corrosion was seen at the end cap fitting clamps on both ends of the ADCP. This was stripped down and cleaned for later detailed inspection at NOC. Data was downloaded and at first glance appeared to be a full record of good quality. Tilt appears acceptable indicating that the mooring design is OK.

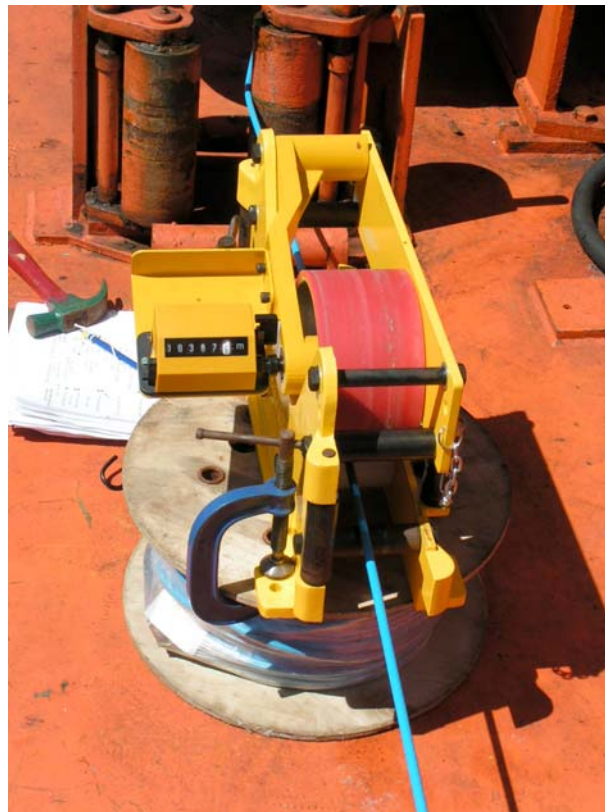
**Photograph C.8: Wire-measuring on inboard side of DBC during deployment.**

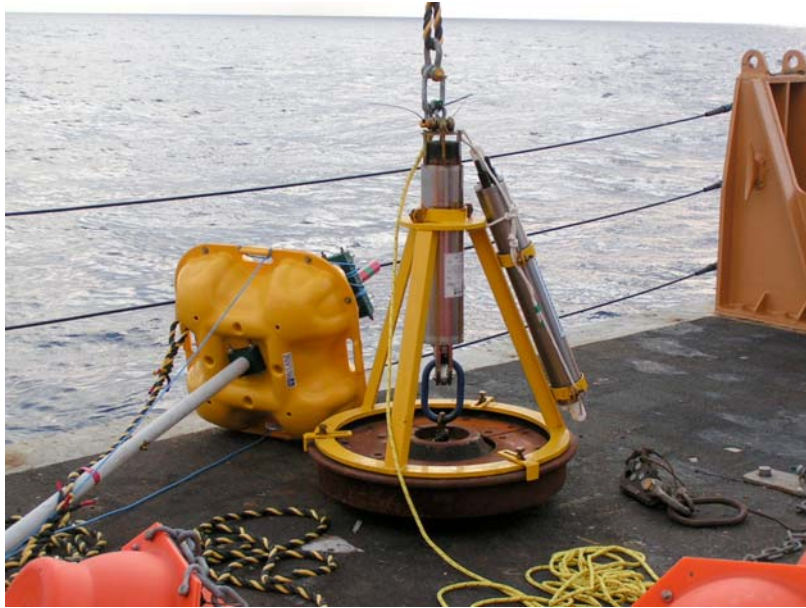
**Photograph C.9: WBL4 tripod and buoy assembly**

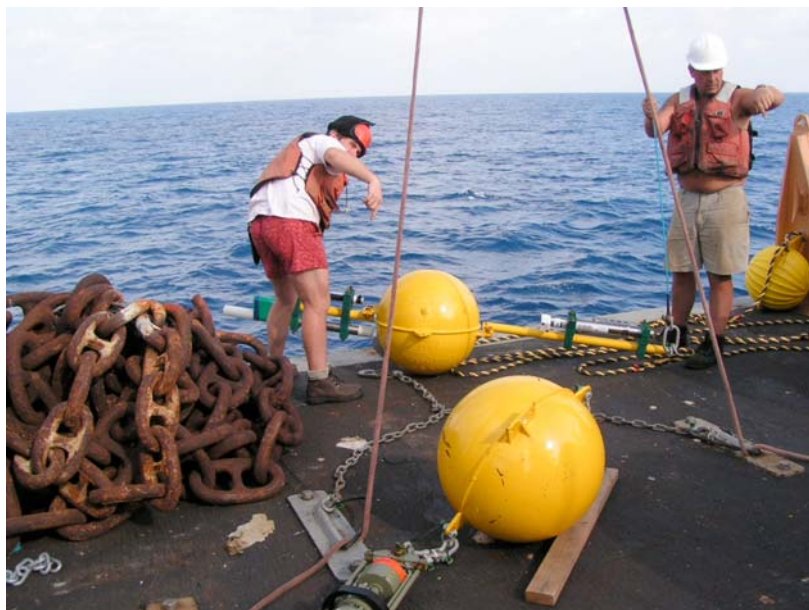
**Photograph C.10: WB2 steel spheres – showing top buoy and 100m buoy.**
