R. R. S. DISCOVERY CRUISE 83

26th May - 9th June 1977

GLORIA II Proving Trials

Cruise Report No. 61

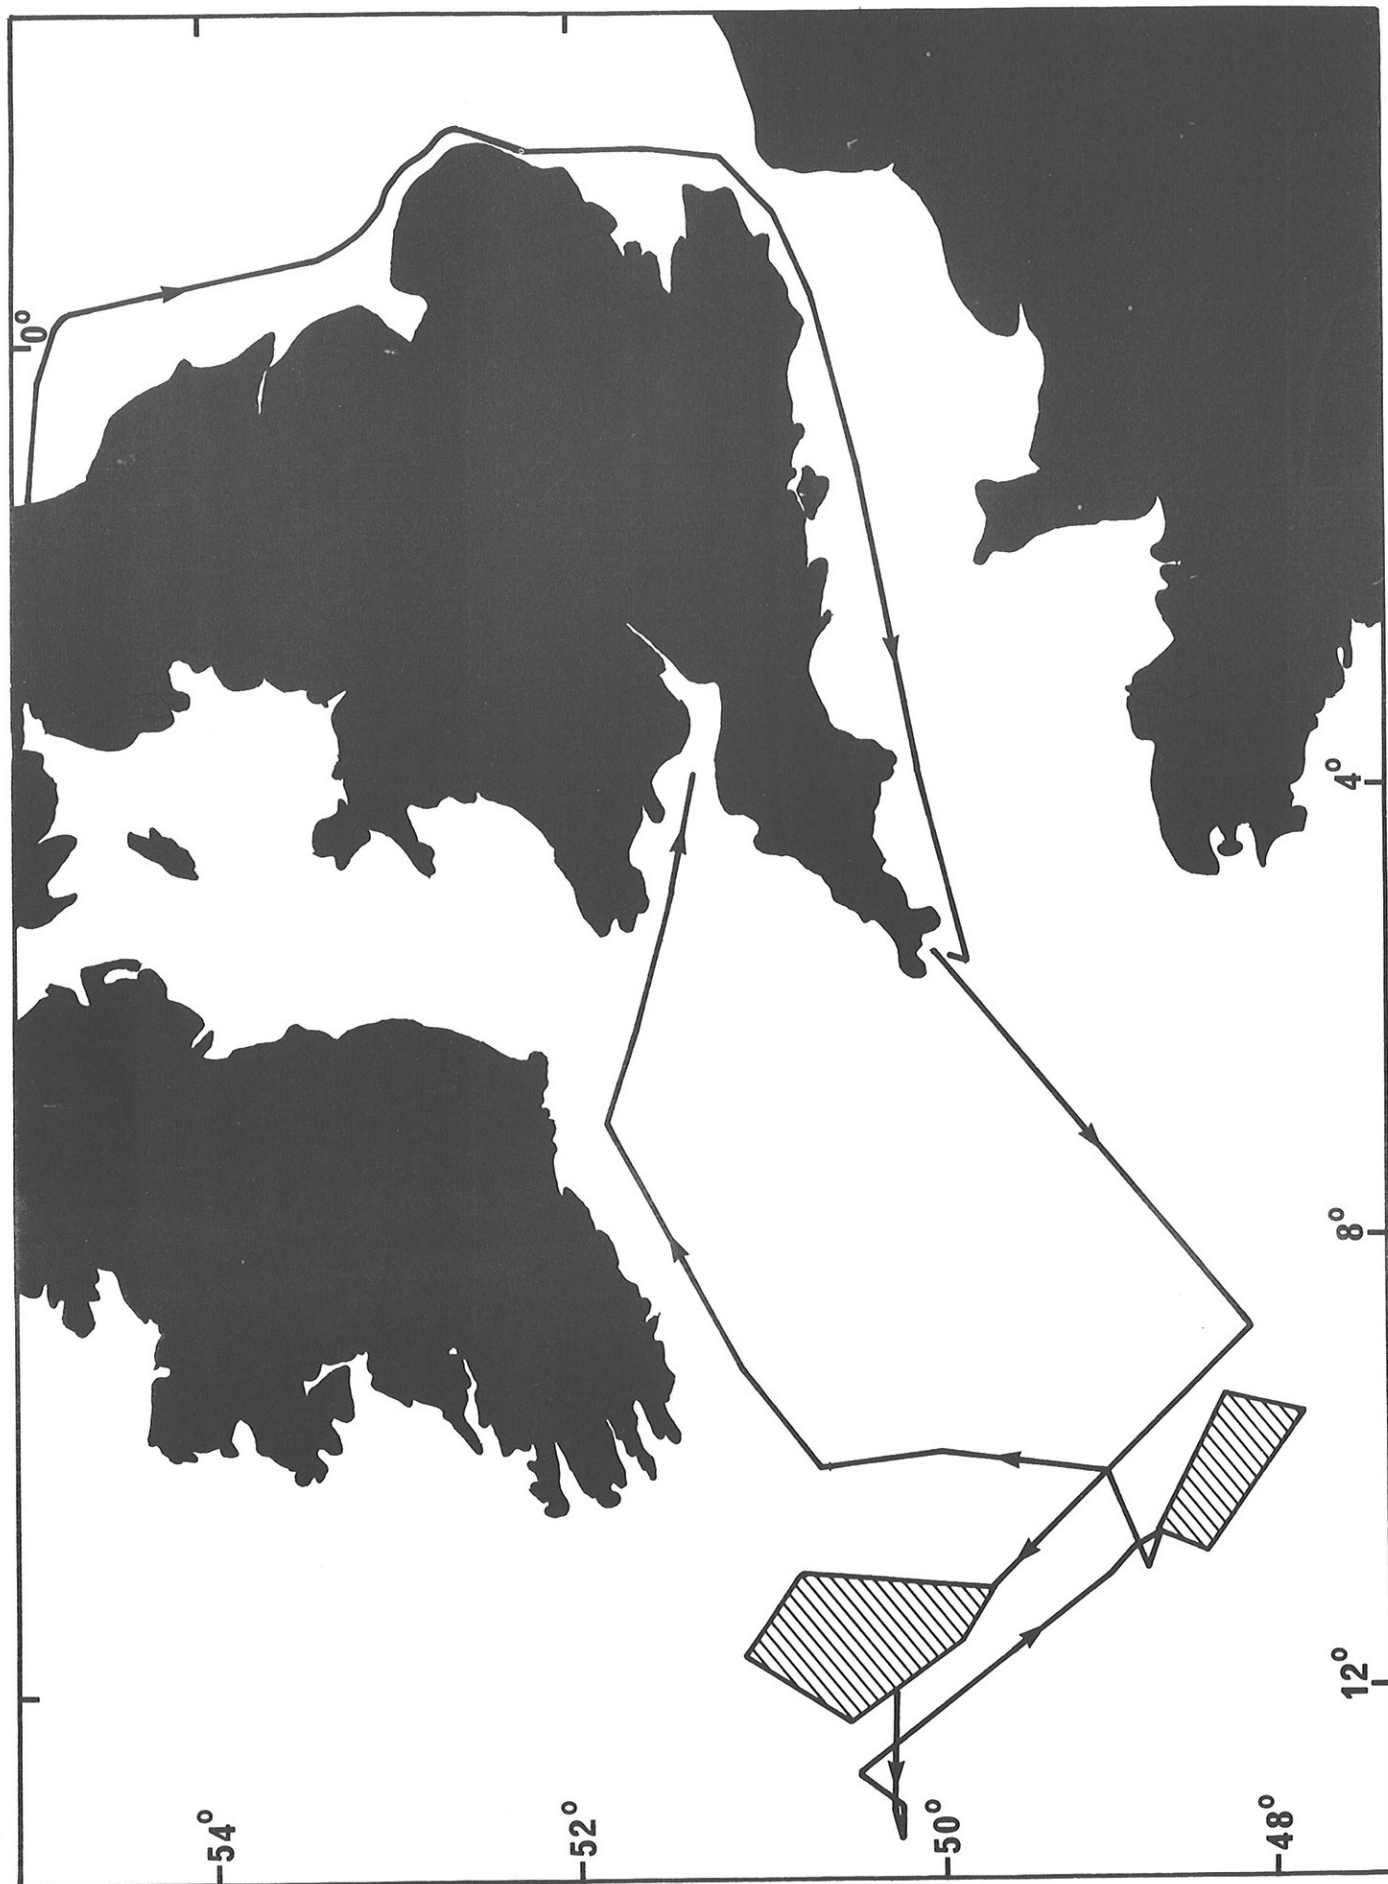
fig.1

A track chart showing the working areas is shown in Fig. 1.

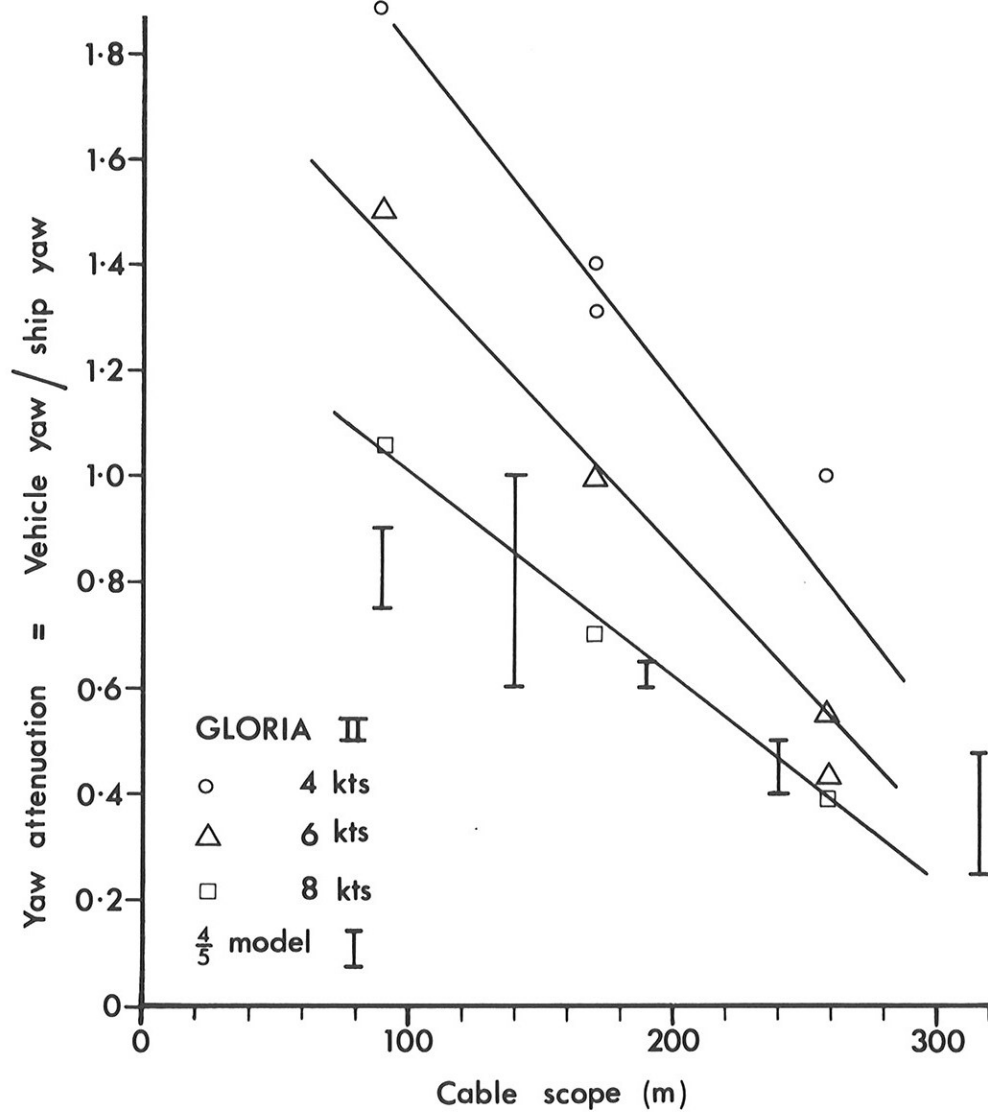
fig.3

The analogue records of yaw of the vehicle showed two distinct periodicities. The first of these corresponds to the wave encounter period, the amplitude being generally about 1° peak to peak, occasionally $1\frac{1}{2}^\circ$. Longer period excursions are produced by ship heading which is itself a complex function of the sea-state and the ship's autopilot performance. During the trials some trouble had been experienced with the autopilot, and the ship's heading was varying at times by as much as 12 or 13° peak to peak. The yaw response of the vehicle is shown as a function of ship's speed and cable scope in Fig. 3.

There is a general improvement in performance with increasing cable scope, which was expected. The performance also improves with speed. The results at 8 knots are comparable with the earlier 4/5 scale model trials, shown as bar lines in Fig. 3, (see Discovery Cruise Report No. 11, 1974), but the lower speed results are worse. This is possibly due to interaction between vehicle pitching and yaw which occurred on this cruise. On the model trial it was not observed because of the very smooth conditions which prevailed during the trials.
