DY149 Cruise Report

RRS Discovery

14th March – 30th March 2022

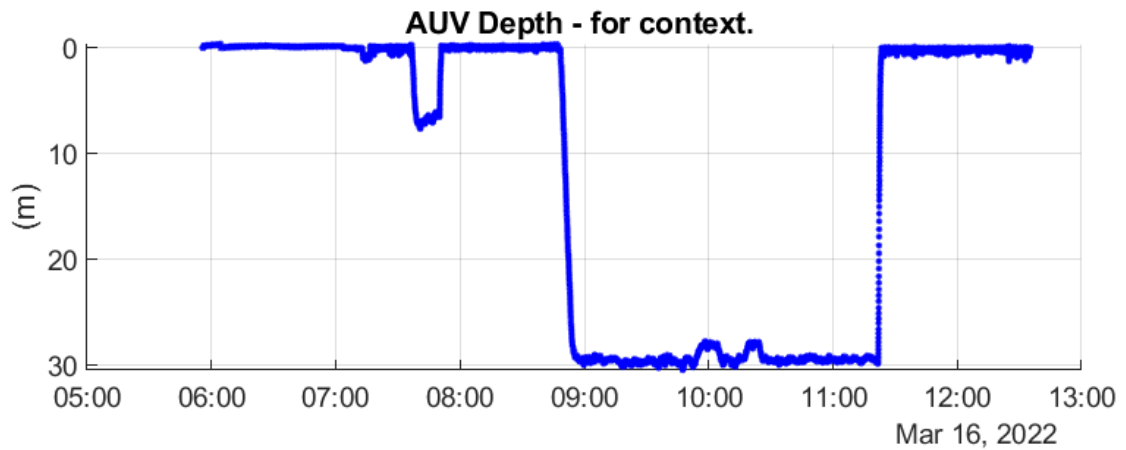
Figure 2.5: Mission 55 to 57 AUV Depth

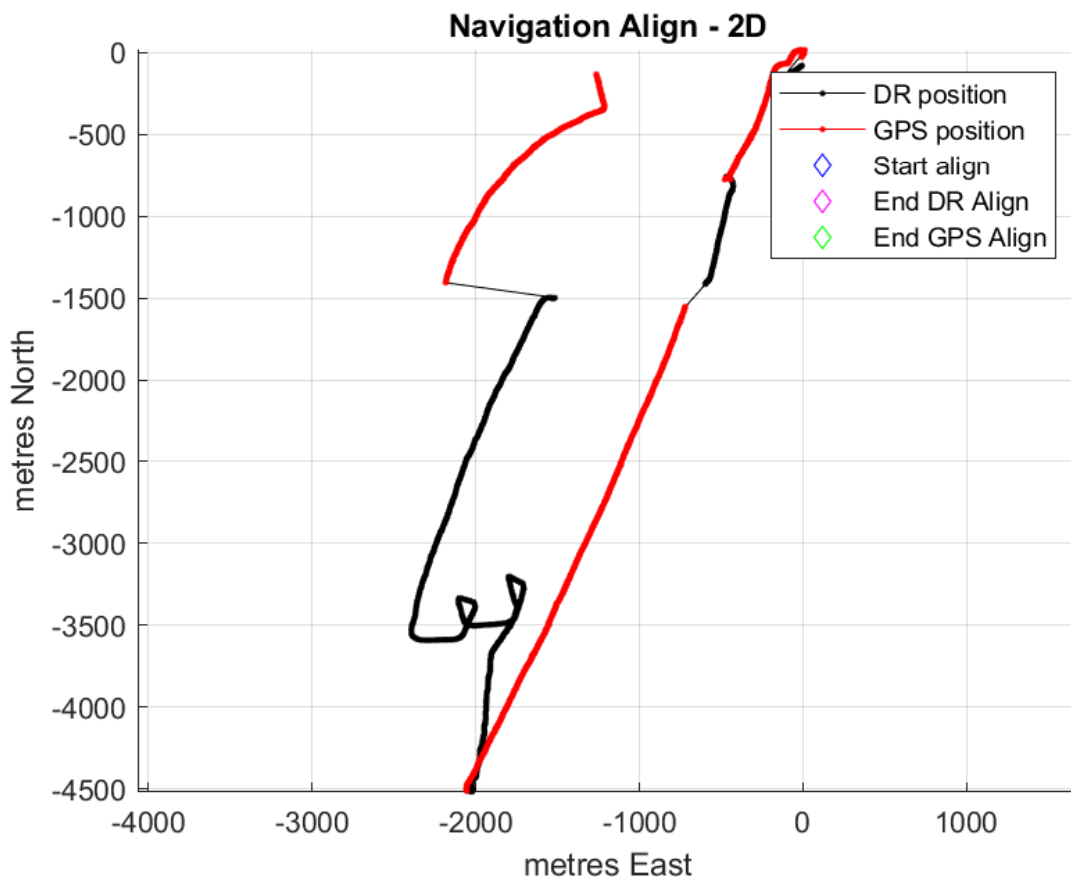
Figure 2.6: Mission 55 to 57 Navigation

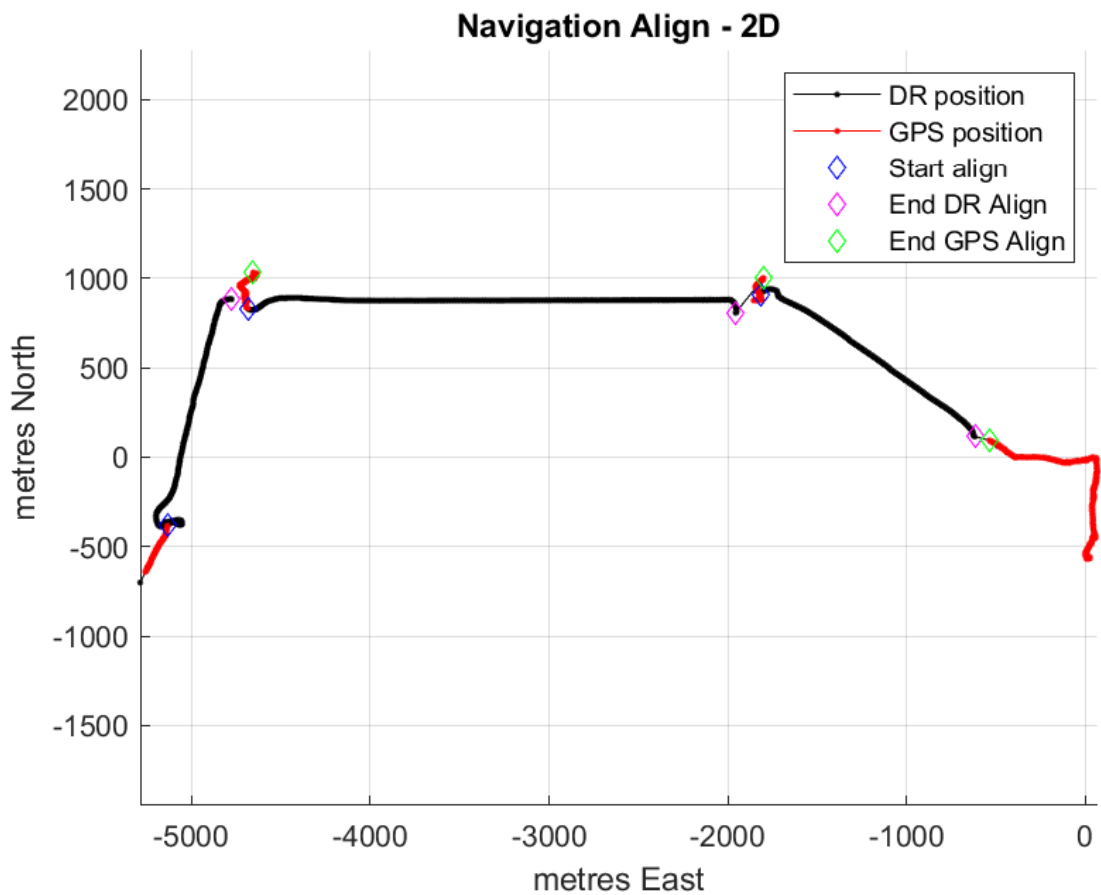
Figure 2.8: Mission 58 to 60 AUV Navigation

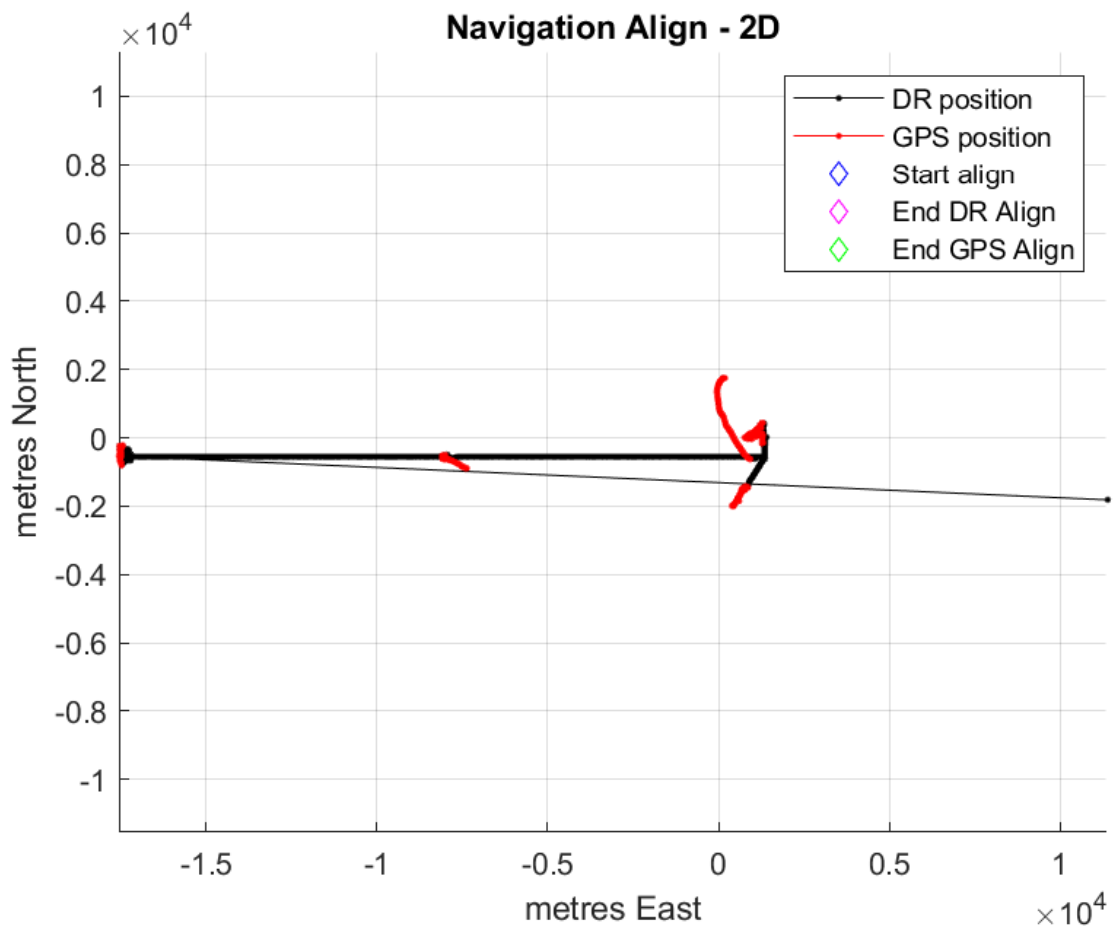
Figure 2.11: Missions 61 to 64 AUV navigation

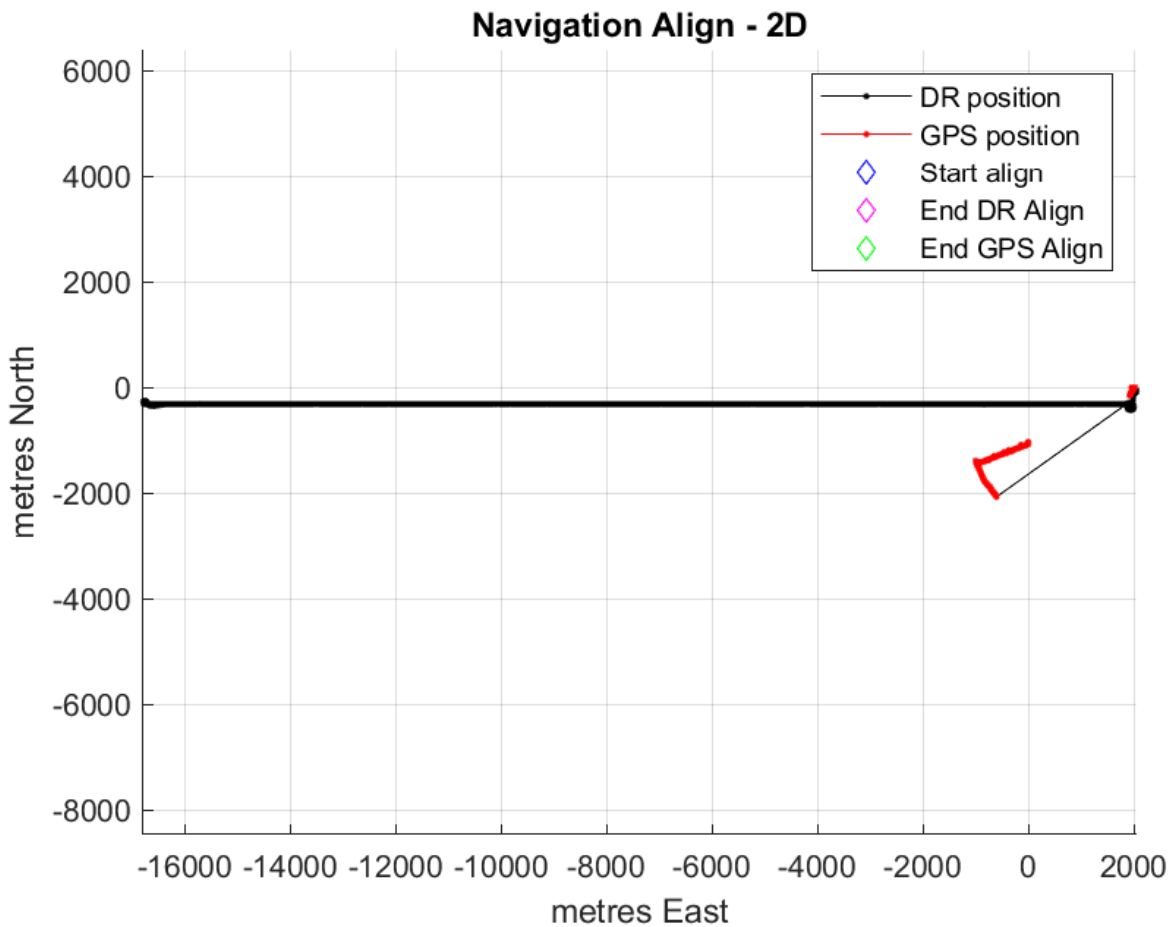
Figure 2.15: Mission 65 AUV navigation

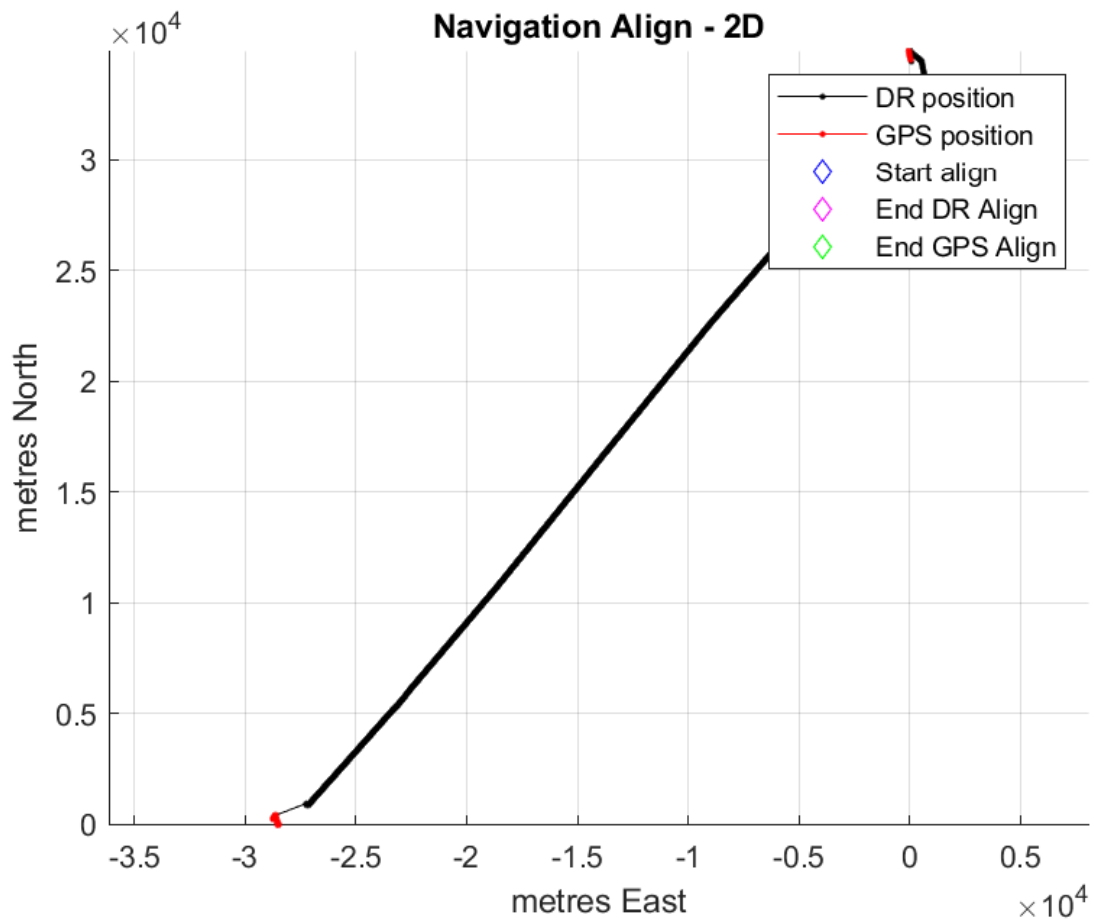
Figure 2.25: Mission M71 AUV navigation

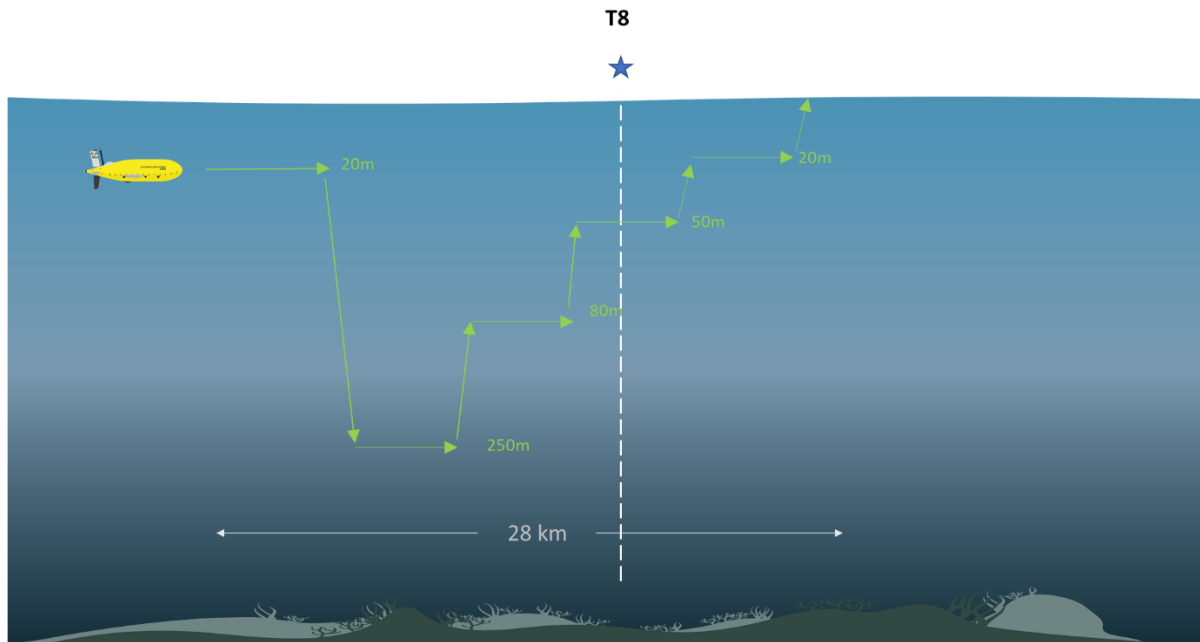
Figure 2.35: Mission M75 Reverse staircase

To allow the test dive with STAFES-APP valve arrangement and fill in a sampling gap caused by not having the ALR CTD operating during mission M73, on the steam back to port we stopped and deployed the ALR for one last mission (Figure 2.35).

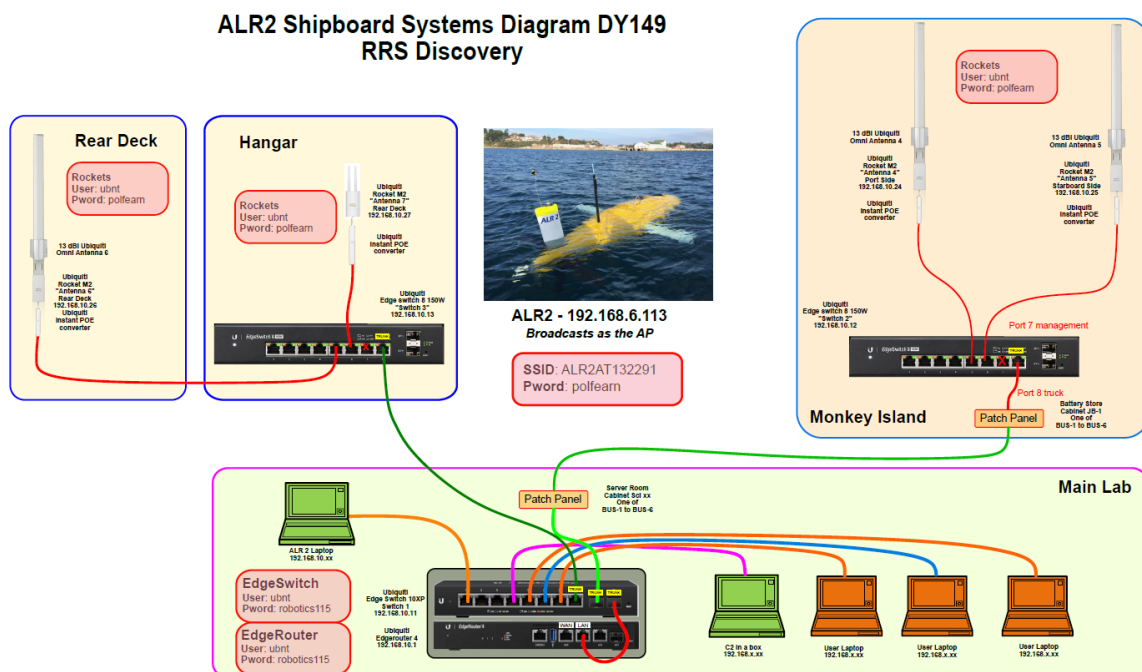
With this version of the command and control architecture WiFi networking is controlled via the C2 in a box system (C2IAB) as well as the backup Linux GUI. The GUI is also capable of communicating via a Sonardyne topside and the “Bagley Box” acoustically with the ALR. A later version of the C2IAB system (currently deployed in Antarctica) incorporates all three communications alternatives in one C2IAB system. During DY149 the WiFi system was the preferred communication method, with Iridium used when not in WiFi range. Figure 2.39 shows the network setup in the RRS Discovery.

Figure 2.39: ALR WiFi Setup

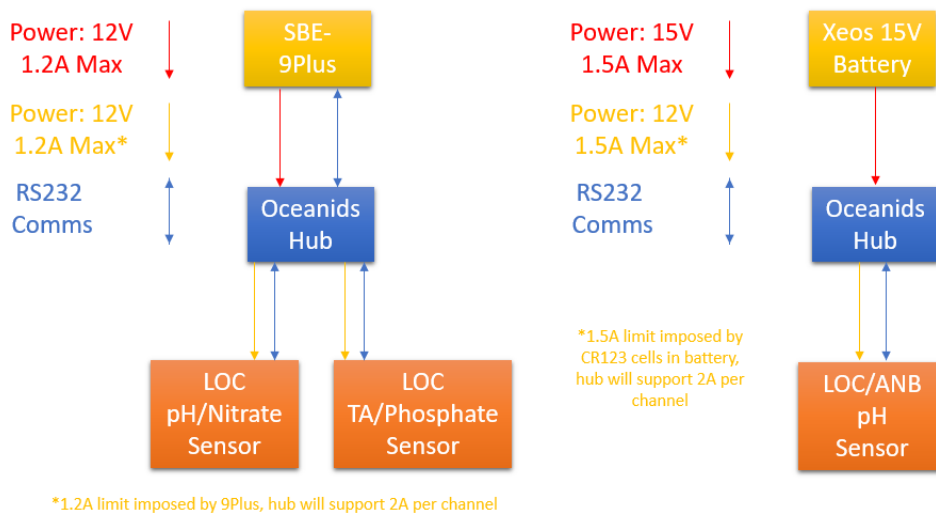
Oceanids hub was used to distribute the single power source to both sensors as shown on the left below.

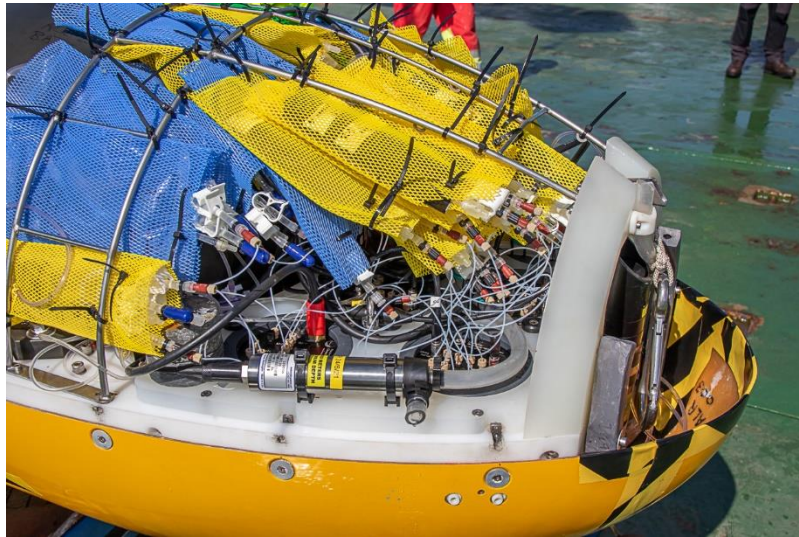
Figure 3.1: AutoNutS sensors showing reagent bags and manifold pump/outlet

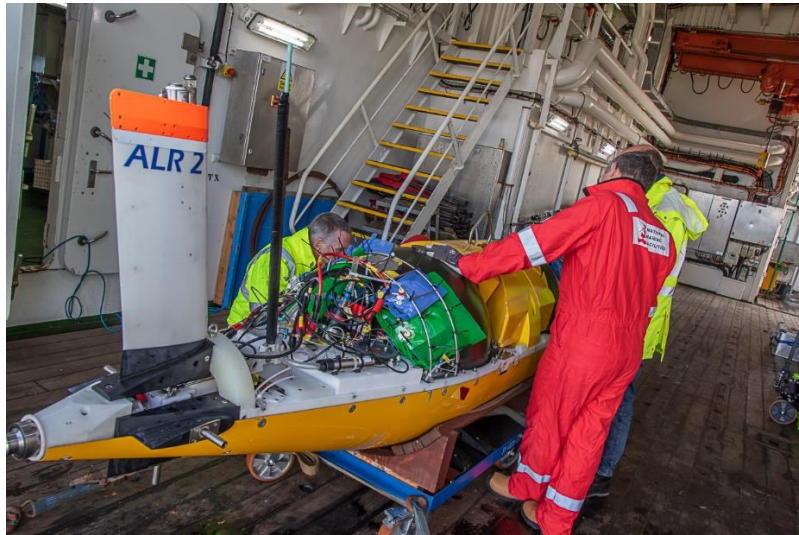
Figure 3.3: CarCASS and STAFES sensors showing CarCASS reagent bags

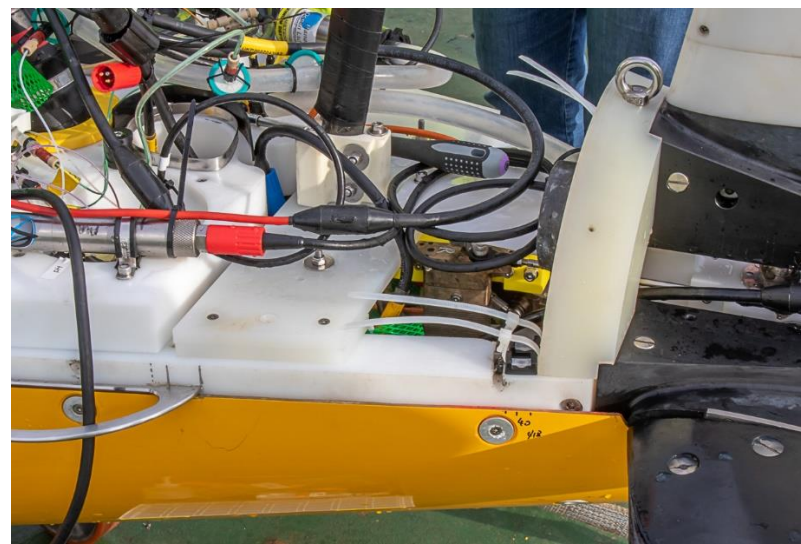
Figure 3.6: STAFES outlet hose position (2 cable ties to rear)

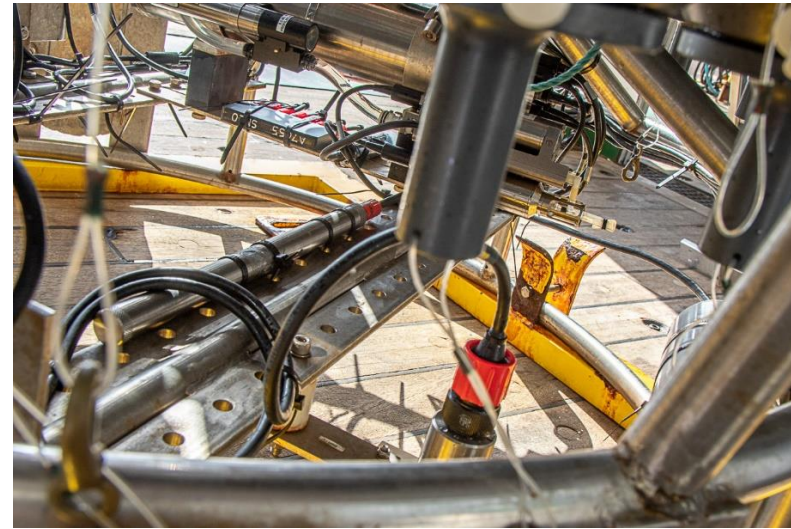
Figure 3.8: View of Xeos battery pack (left side of centre structure), Oceanids Hub (far structure under SBE-9plus) and ANB sensor to right of picture

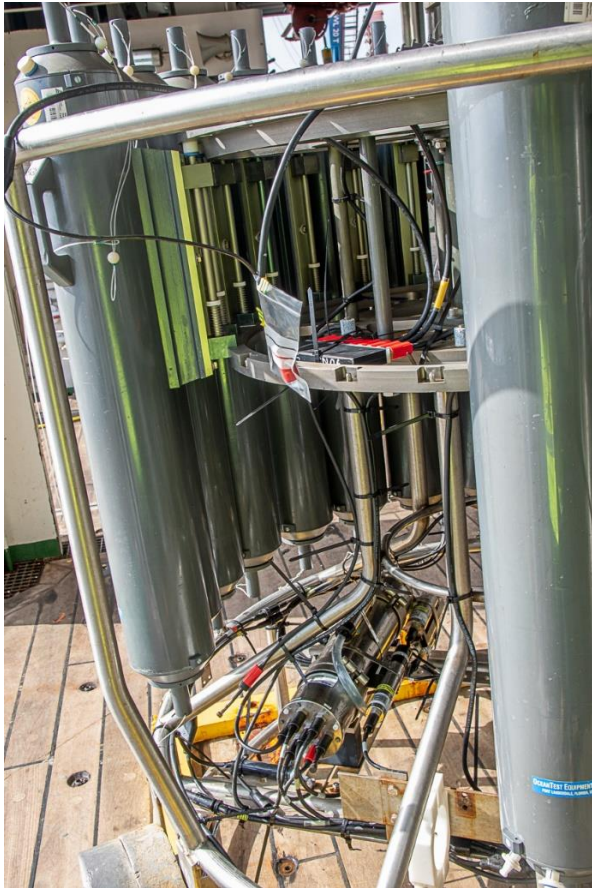
Figure 3.9: Installation of Oceanids Hub on CTD frame, taking power from CTD SBE-9Plus

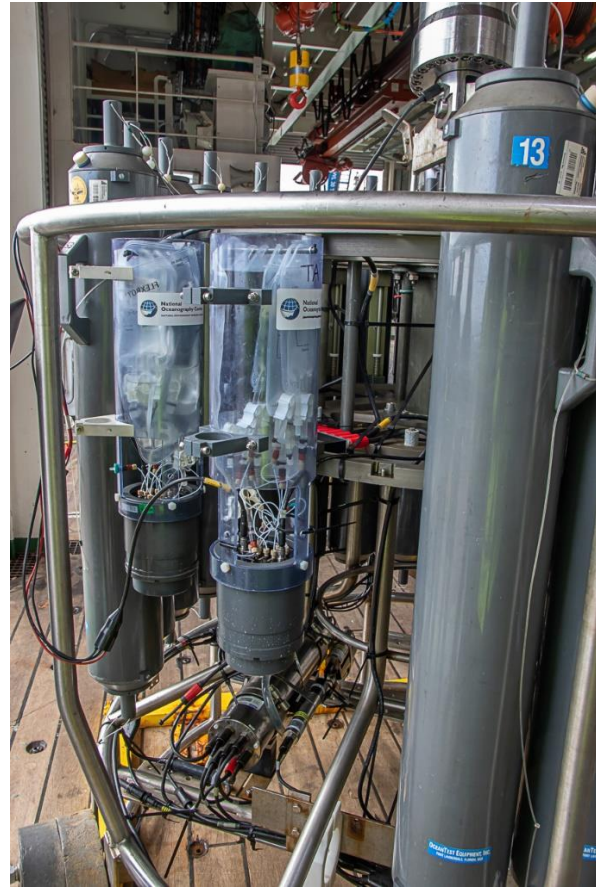
Figure 3.10: From the Oceanids Hub individual cables run to the two Wet Chemical sensors

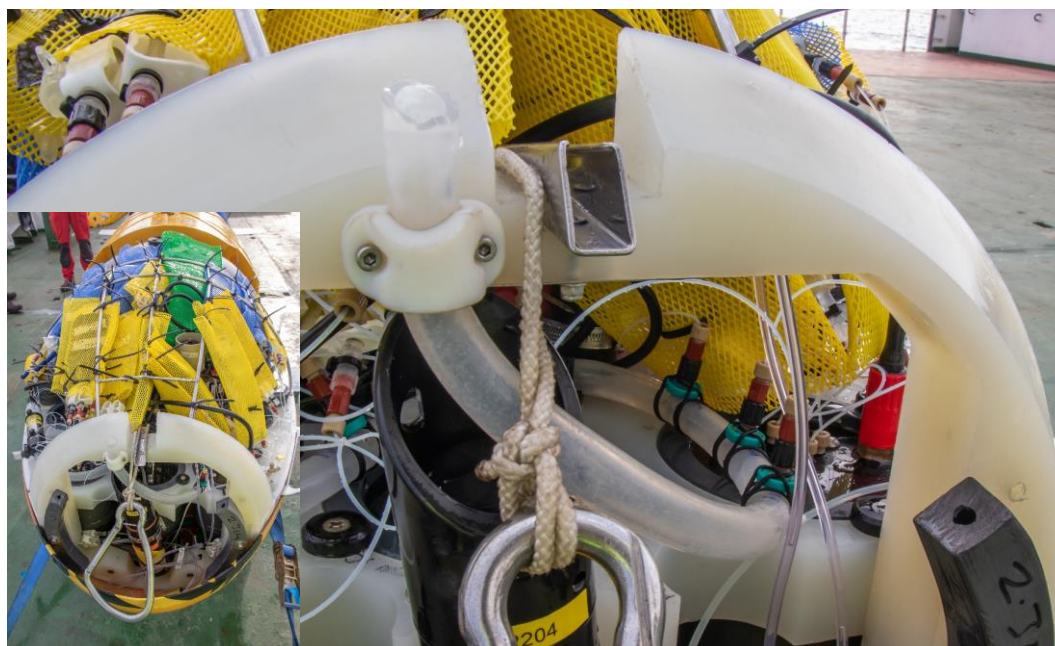
Figure 5.2: Sampling manifold for Autonuts. Inlet is in the top centre and SBE-5T pump and outlet is to the left of the image. Insert: Installation of Autonuts sensors in front of ALR.

The Autonuts sensors were housed in the front section of the Autosub Long Range (ALR). One sensor of Iron, Nitrate, Nitrite and Phosphate and two of silicate were mounted to a tray. A cage was mounted above to allow for the securing of Sartorius Flexboy bags. In order to provide fresh seawater to the sensors, a Seabird SBE-5T pump was used to pump seawater through a manifold. The pump was mounted after the manifold to not contaminate the water prior to sampling. For further information regarding the mechanical and electrical systems see the ALR and Integration section.

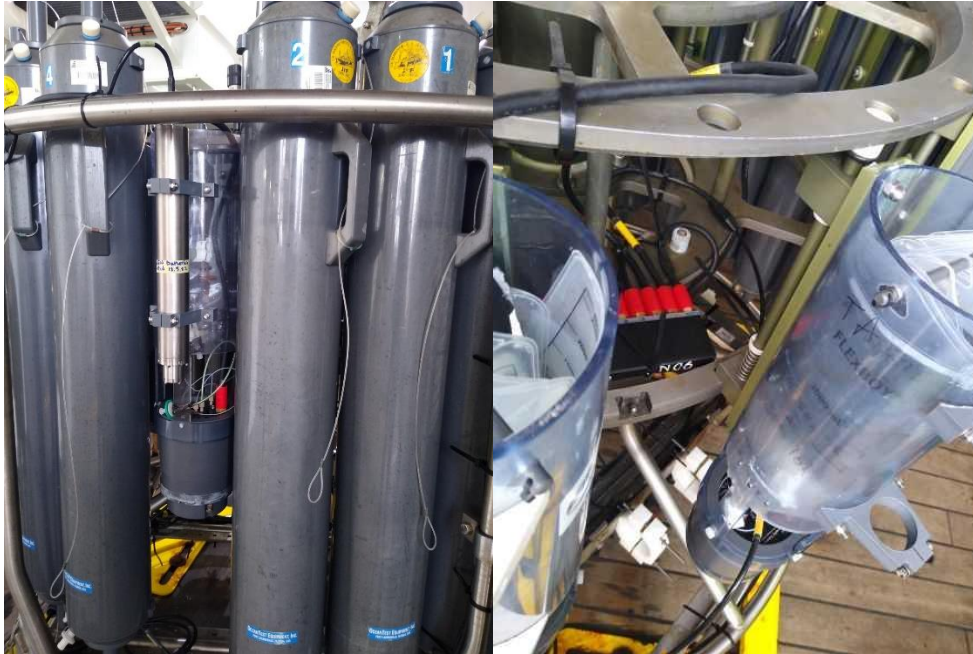
When running on the CTD, the sensors were clipped in via a standard CTD bracket. Depending on power availability, power was supplied either by a 15V supply from the CTD electronics or a battery housing to an Oceanids hub. This in turn supplied power to the sensor.

Figure 5.3: On the left, sensors battery powered, on the right, sensors powered from the Oceanids hub.

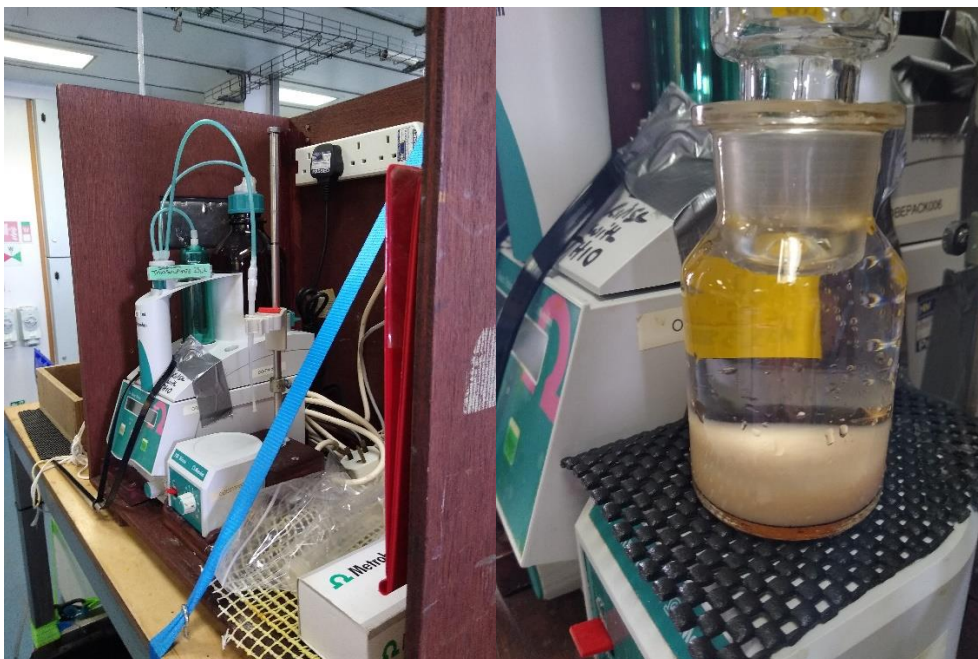
Samples were analysed the same day of collection and a 794 Basic Titrino (Metrohm) was used for the titration (Figure 5.11).

Figure 5.11: Winkler titration set up (794 Basic Titrino, Metrohm) and an oxygen sample after collection.

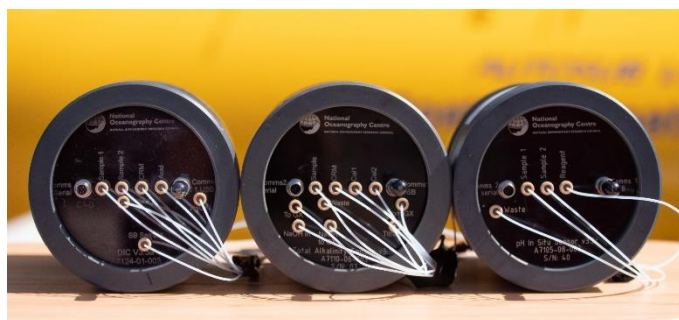
CarCASS is a combination of three autonomous Lab-on-chip (LOC) sensors measuring pH, Total Alkalinity (TA) and Dissolved Inorganic Carbon (DIC) and an electrochemical pH sensor (developed by ANB sensors).

Figure 6.1: The tree LOC sensor for the measurements of pH, TA and DIC

All four devices are connected to a communications hub which manages sensor operation and data communication between platform and sensors. The pH sensor is based on the benchtop seawater spectrophotometric pH assay using purified meta-cresol purple indicator dye. The measurement uncertainty is better than 0.010 pH units and measurement resolution is better than 0.001¹. The TA sensor is based on the single step titration method² and it involves sample degassing, followed

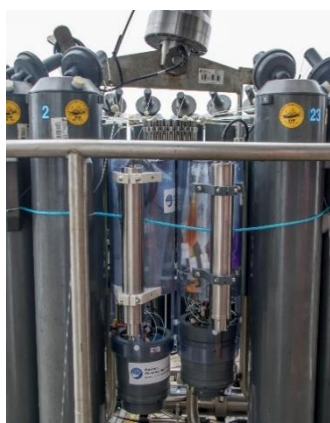
The Ocean Technology and Engineering Group's Total Alkalinity Lab on Chip sensor and pH Lab on Chip sensor were deployed for data collection on 2 different CTD casts (Table 6.4). During these CTD casts, there were stops made at various depths for a duration of 20 minutes each on the ascent. This was done to allow the sensors to take 1-2 measurements at these depth since their measurement frequency is ~10 minutes. The delay at each depth also gives the sensor time to acclimate to the current conditions – such as temperature – that impact the measured variable.

Figure 6.9: LOC Sensors deployed on CTD Rosette

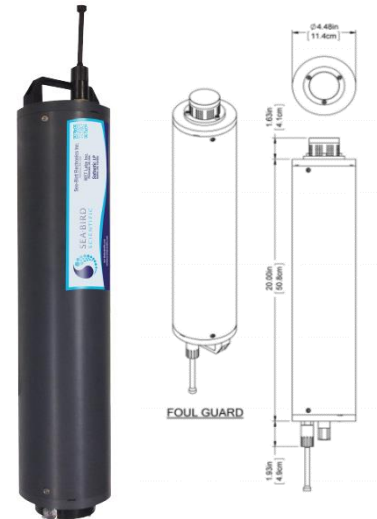
The deep SeaFET (V2 S/N 100) was clamped to the CTD frame and deployed with independent power source (12 D Cell Alkaline batteries in housing) on 16 different CTD Casts. (Table 6.4) The SeaFET measured every 2 minutes during deployments and was removed between casts to be kept submerged in seawater in the ship's lab to maintain calibration. The data collected by the SeaFET can offer another set of measurements that can be compared to by the LOC sensors and the validation water samples.

Figure 6.10: Sea-Bird Scientific™ SeaFET V2 diagram and dimensions

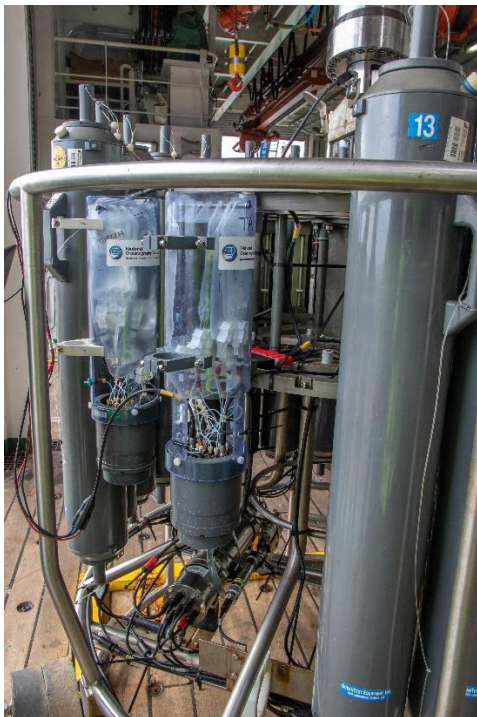
Wet chemistry sensors prior to deployment

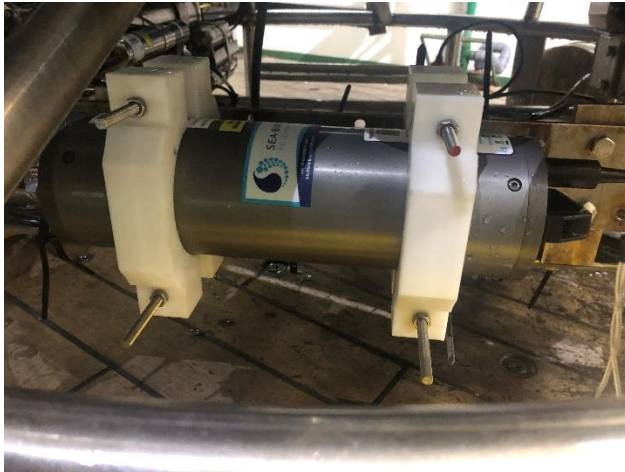
SeaFET on CTD frame

SBE SeaFET v2 was deployed on most CTD casts for CarCASS. This was positioned horizontally in clamps between the 9plus and transmissometer/fluorometer. The clamps were made during the cruise by OEG. The sensors had to be removed from the frame to keep the sensor in good condition between casts.

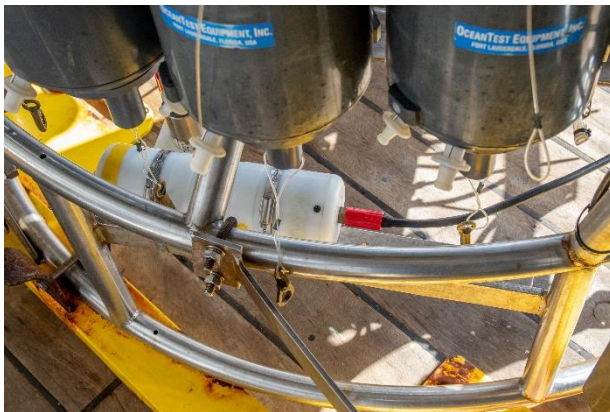
ANB pH sensor on CTD frame

ANB pH sensor was attached, with jubilee clips horizontally to the CTD frame between the 9plus and transmissometer/fluorometer opposite the SeaFET. This was to compare pH data with the SeaFET and wet chemistry pH for CarCASS. The sensor was powered by a Xeros beacon battery pack after its initial battery pack was deemed unsafe.

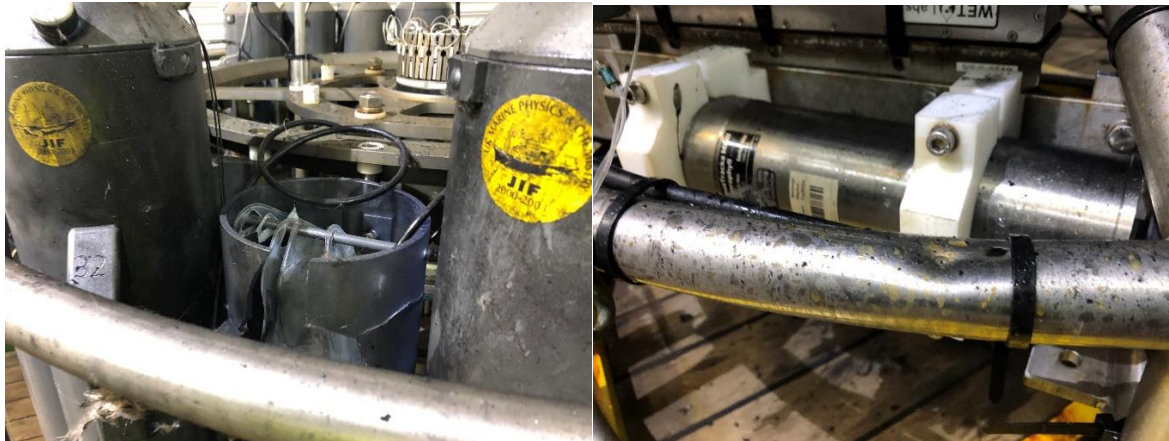
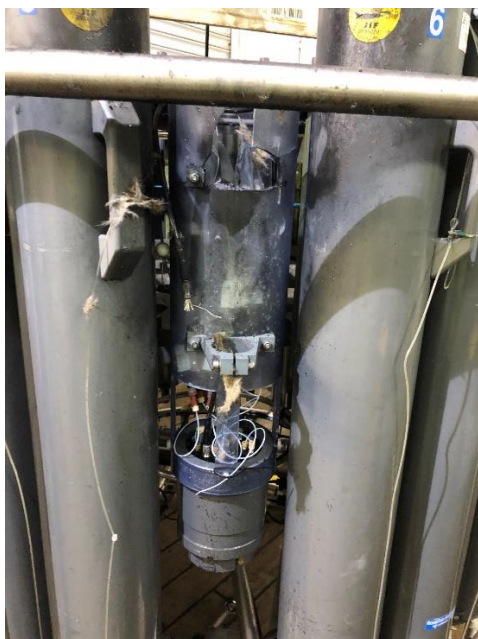
A battery pack (XPRIZE Battery Housing) suffered a catastrophic failure following deployment on cast 002. The incident happened around seven hours after the CTD was recovered to deck (~23:00 16/03/2022). It was reported after the event that a member of the science party noticed signs of water ingress on the battery pack. It is likely that salt water reacted with the lithium batteries producing gas which led to an explosion. No one was injured in the incident. There was superficial damage to the frame and water sampler 08. All similar battery packs were withdrawn for the remainder of the cruise. The CTD returned to action the following day after it was cleaned up and all sensors and cables were inspected for damage. A health and safety investigation is being carried out.

Pictures show the damaged nitrate sensor after the incident along with damage to CTD frame and water sampler

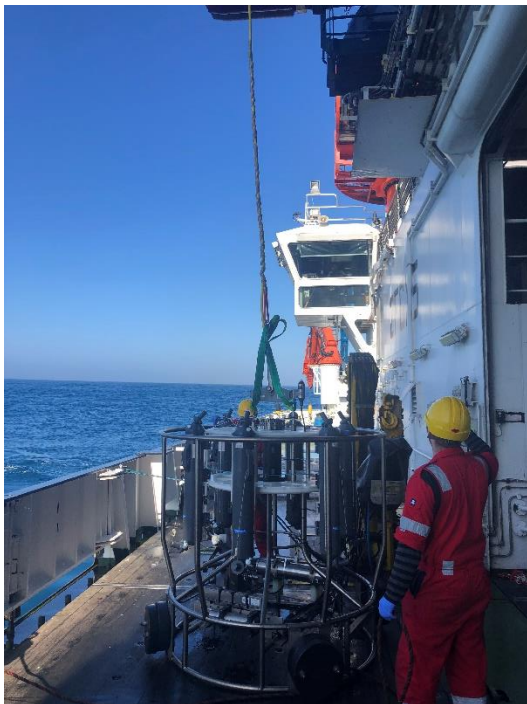
Titanium frame ready for deployment with Yalegrip as backup
