University of Plymouth - Cruise Summary Report

DEEP LINKS PROJECT

RRS James Cook, Cruise No. JC136

14th May – 23rd June, Southampton (UK) – Southampton (UK)

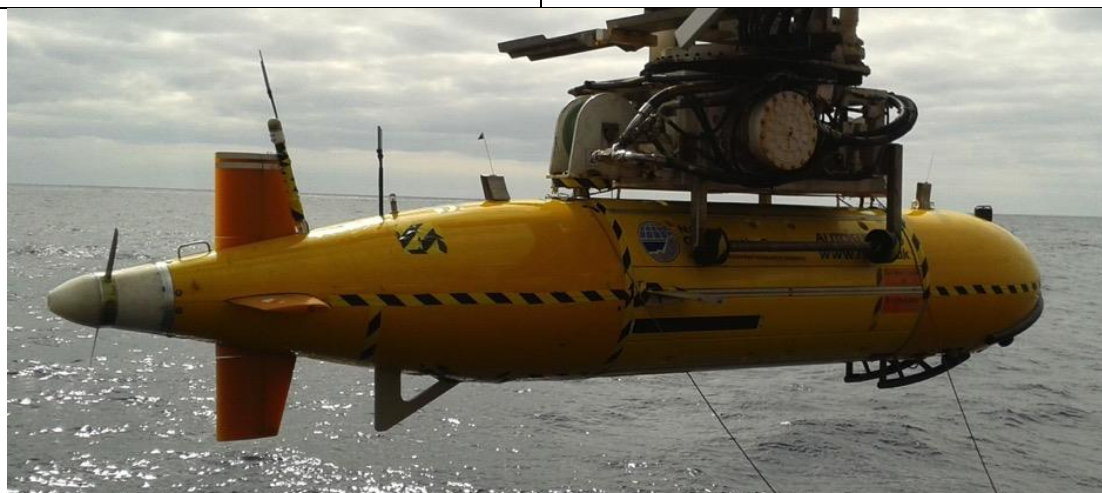
Figure 6.4: Autosub6000 on gantry before launch during the JC136 cruise.

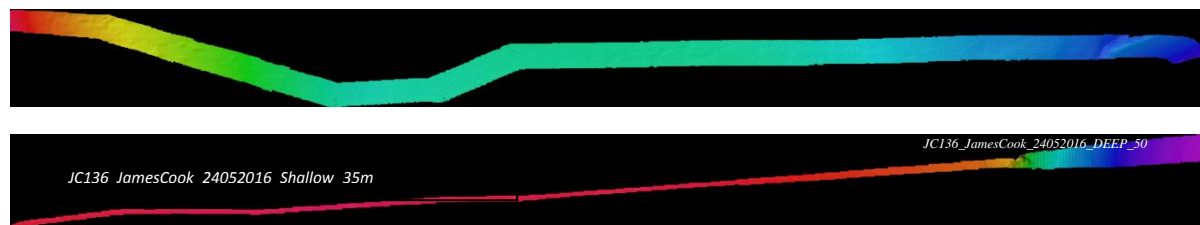
Figure 7.4: Fieldsheet names: JC136_JamesCook_24052016_SHALLOW_35m
JC136_JamesCook_24052016_DEEP_50m (CUBE, 50m, JC136_Leg_1)

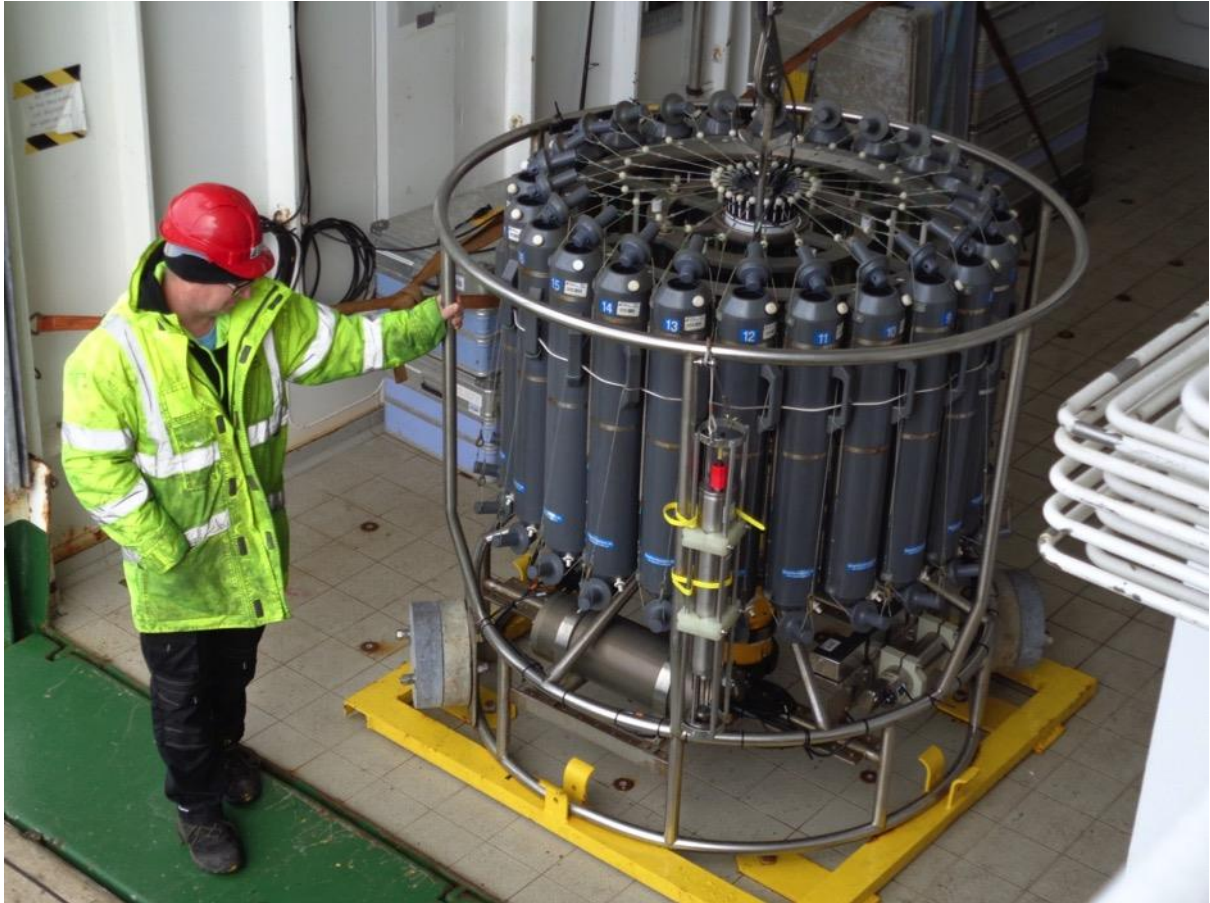
Figure 7.23: CTD zone Sea-Bird 9plus with downward-looking LADCP.

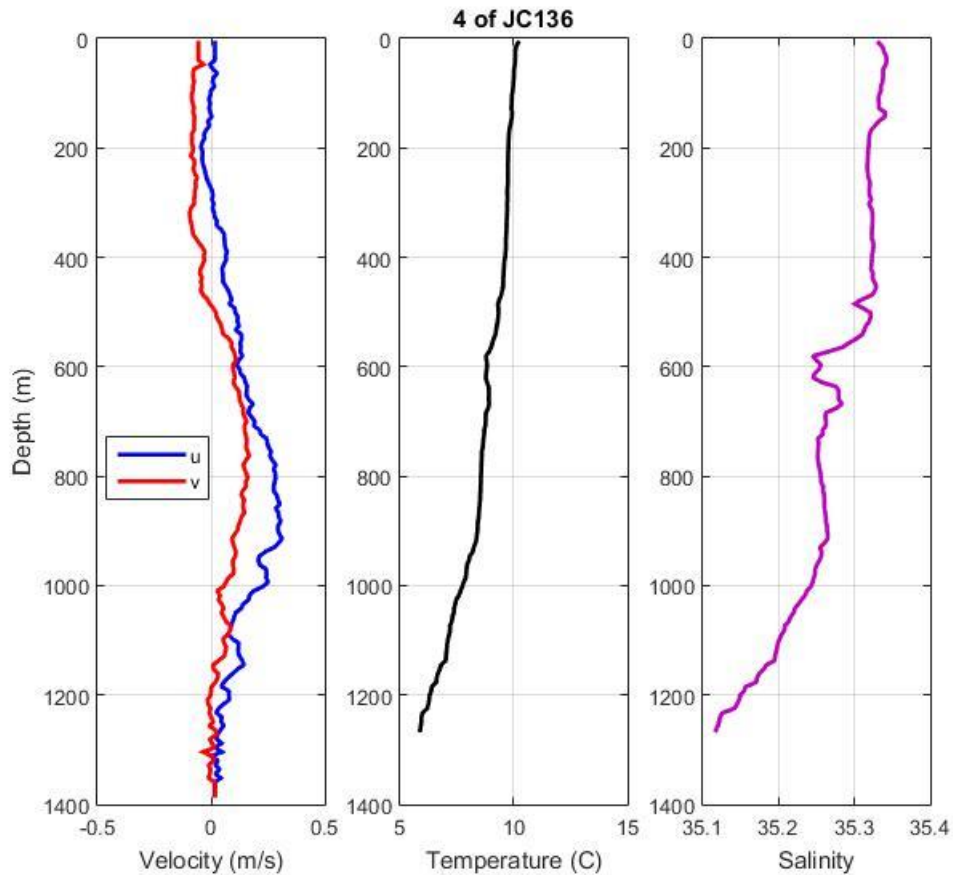
Figure 7.26: Profiles of the horizontal velocities (left), temperature (middle), and salinity (right) recorded at station 4.

CTD stations 5-19 were conducted at the same position near the shelf break in the regime of yo-yo sampling with roughly 45-50 minute time intervals between stations. In fact, the weather was bad and did not allow deployment of the ROV and AUV, and the only possible activity was CTD sampling. Comparative analysis of temperature profiles recorded over one tidal cycle has shown great baroclinic tidal activity at the depth of the shelf edge.

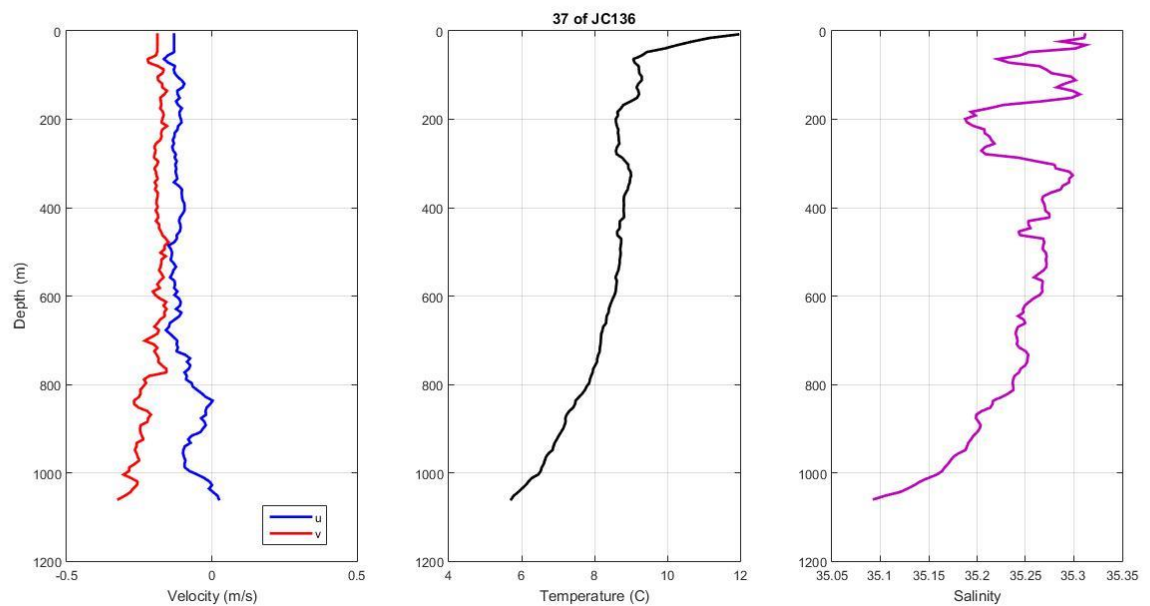
Figure 7.31: Profiles of the horizontal velocities (left), temperature (middle), and salinity (right) recorded at station 37 on 12th of June 2016.

CTD measurements here were conducted during Leg 1 (stations 22-26) and Leg 2 (stations 37-40). Comparative analysis of the water properties (see Figures 7.30 and 7.31) reveals warming of a surface 50 m layer over two weeks. The increase of temperature comprises 2°C. Below this depth, the thermohaline structure of sea water remained mostly the same, although the velocity profiles are different.

At station 24, quite a strong baroclinic signal was recorded (*v*-velocity profile resembles first baroclinic mode), whereas at station 37, which was conducted at the eastern flank of GBB, the baroclinic signal is weak, but strong barotropic west-south current is obvious, which occupies the whole water column. It is interesting that the current keeps its characteristics stable in time. It was recorded at the very same position two days later at station 38, with nearly the same strength and direction (see Figure 7.32).

Interpretation of this current requires further scrutiny. It looks like a barotropic one that occupies the whole water depth but its tidal origin is under question. The TPXO inverse tidal model predicted for the neap tide (12-15th June) maximum tidal currents at the level of 3 cm/sec, which is well below LADCP measured velocities shown in Figures 7.31 and 7.32.
