LOIS RACS(C) Core Programme Tweed 3 Fieldwork report

Vessel:

R.V. Tamaris & semi-rigid inflatable

October 12-18, 1996

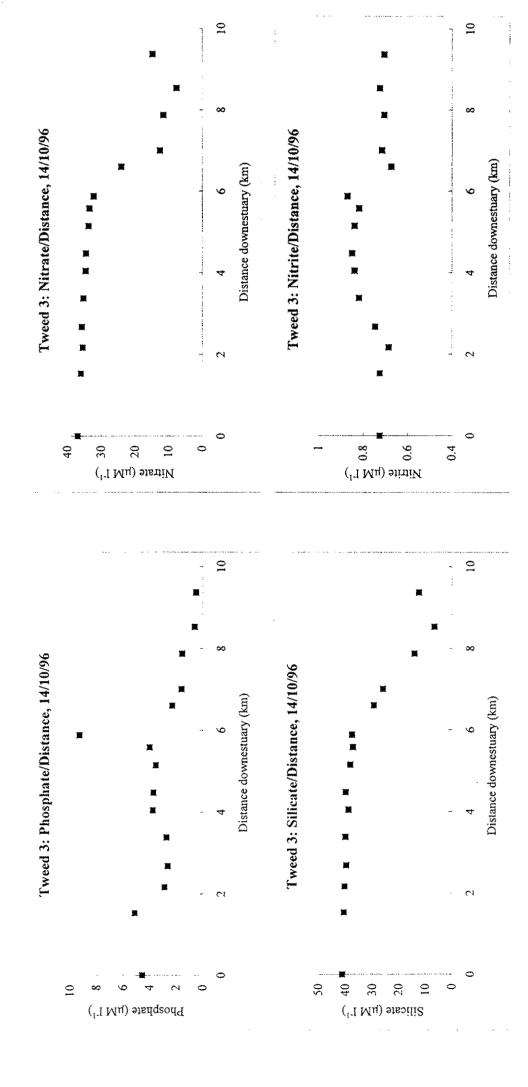
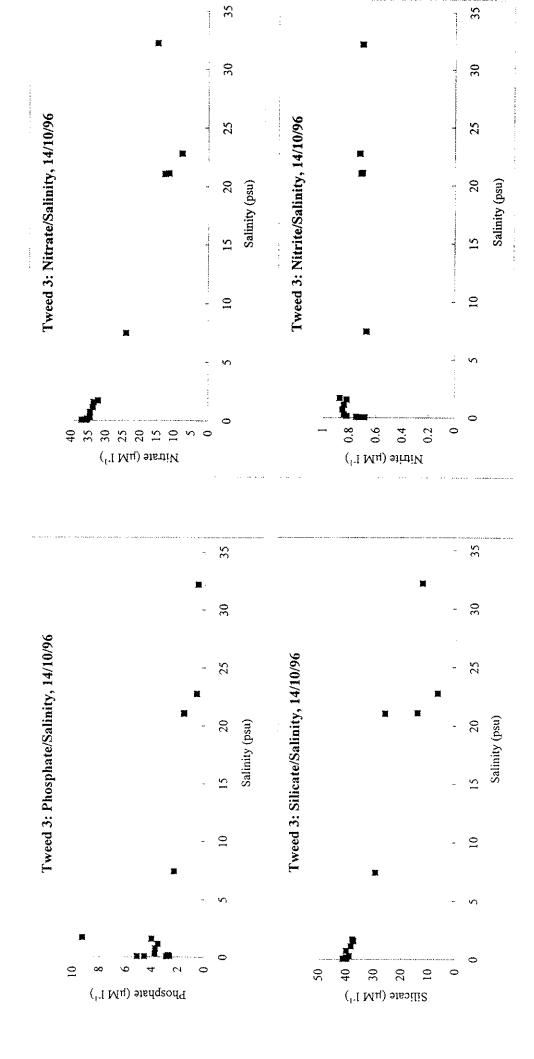
Figures 2,3,4-a show nutrient (P,Si,NO3 & NO2) distributions against distance downestuary from the Chain Bridge (station 20).

Figures 2,3,4-b show nutrient (as 'a') distributions against salinity.

Figures 2,3,4-c show distributions of salinity, temperature, pH and turbidity against distance downestuary.

Salinity intrusion in the surface waters (see figures 2c, 3c and 4c)to just upestuary of the A1 road bridge, except on 16/10 when, following increased run-off, it only reached Station 8 see figure 4c).

Surface water temperatures in the estuary were decreased by about 1°C on the final day due to the increased, colder freshwater input. The temperature maximum between 1-4km downestuary on 15/10 is probably due to warming by the sun in this very shallow (<1.5m) section.

pH generally covaries with salinity.

Levels of suspended particulate material are generally low, varying between 5-30 ntu. The highest levels are found in the outer estuary where a small turbidity maximum at times of greatest tidal currents is evident.

There is clear evidence of strong nutrient inputs in the area between stations 8 (6.6km downestuary) and station 12 (4.48km downestuary). Station 8 is just downestuary from the sewage outfall and station 12 is just above the confluence with the R. Whiteadder.

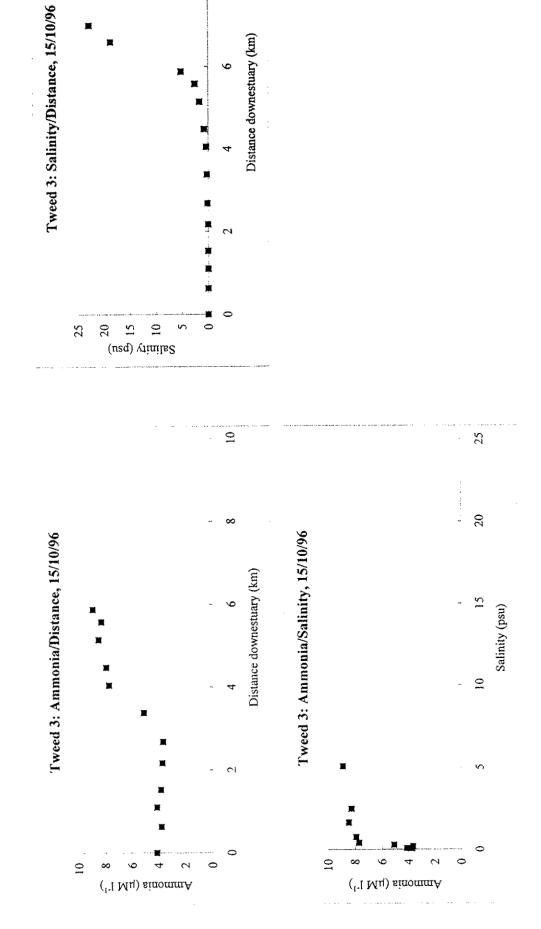
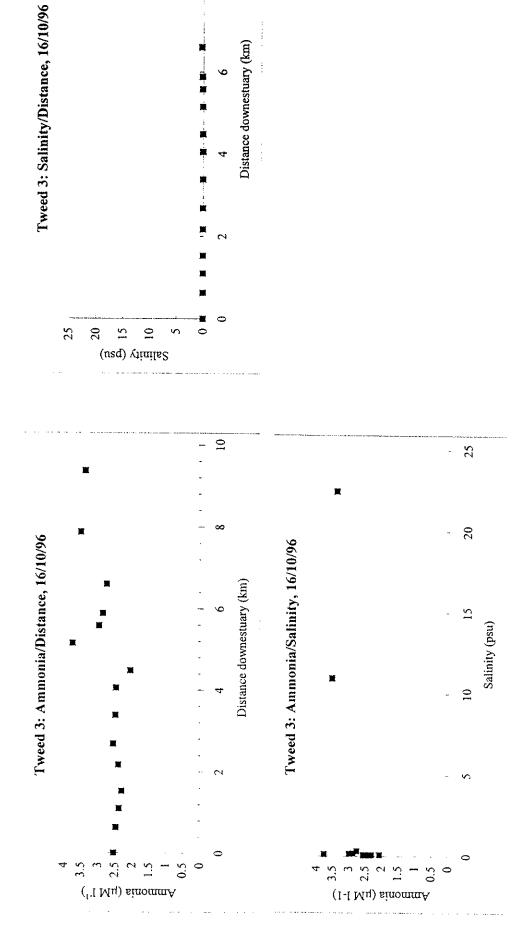
Figures 5-a & b show distributions of ammonia against salinity and distance downestuary on 15/10 and 16/10.
