## Research Cruise Report [2021825]: FV “Vikingbank” Catch Control in the Blue Whiting Pelagic Trawl Fishery.

*Mike Breen, Jostein Saltskår, Sigurd Hannaas, Liz Kvalvik, Olafur Ingolfsson  
(Institute of Marine Research).*

*Dagfinn Lilleng (Norwegian Fisheries Directorate).*

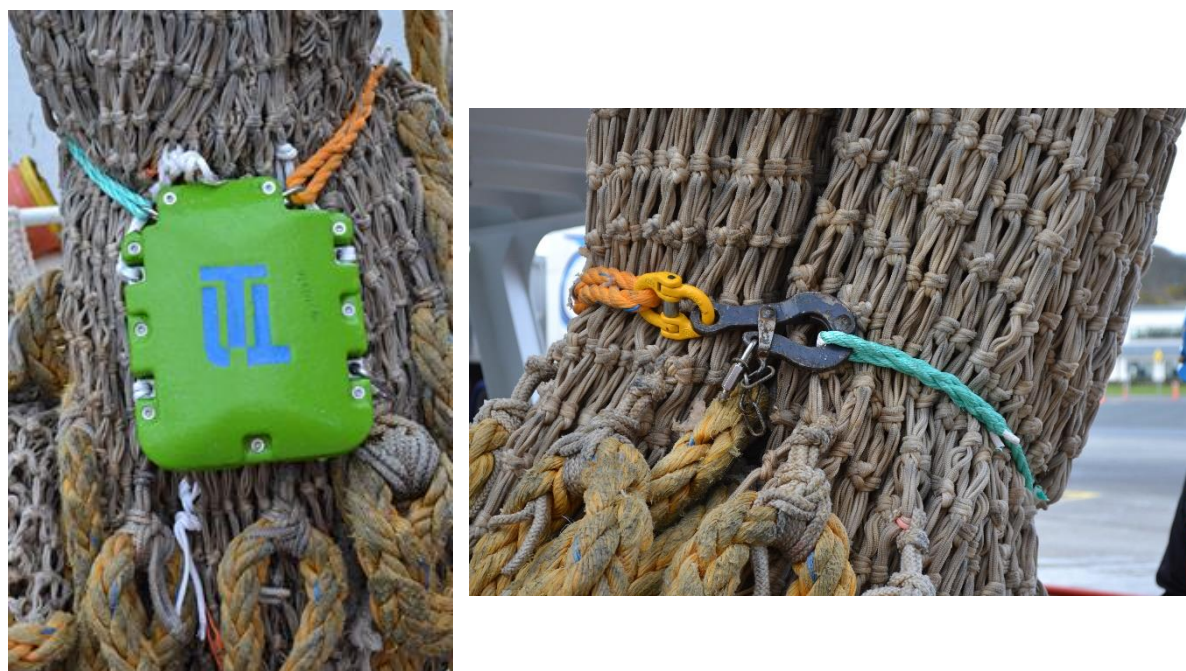
Figure 13: FossTech's prototype Catch Limitation Release (CLR). Left: CLR unit fitted to codend. Right: restrictor line and fastenings.

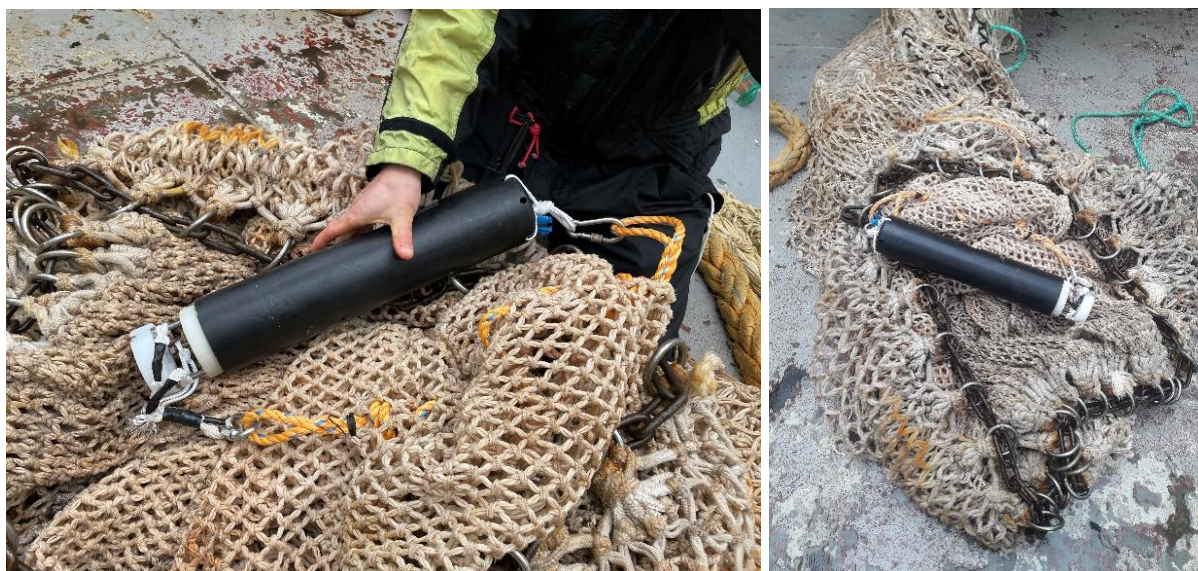
Figure 23 – Rinko oxygen logger, inside protective housing, being fitted inside the codend skirt before was coupled with the fish pump during Haul 03.

To monitor oxygen concentrations in the pumped catch, a Rinko 1D oxygen logger (inside a protective housing) was fitted inside the codend skirt during pumping in haul 03. This provided oxygen concentrations (% saturation and mg/l), as well as temperature (°C) and depth (m), every second.
