# **RRS James Clark Ross**

## **JR99 Cruise Report**

**Cruise JR99**

**Equipment trials (swath bathymetry, TOPAS sub-bottom profiling, SSU,  
magnetometers)**

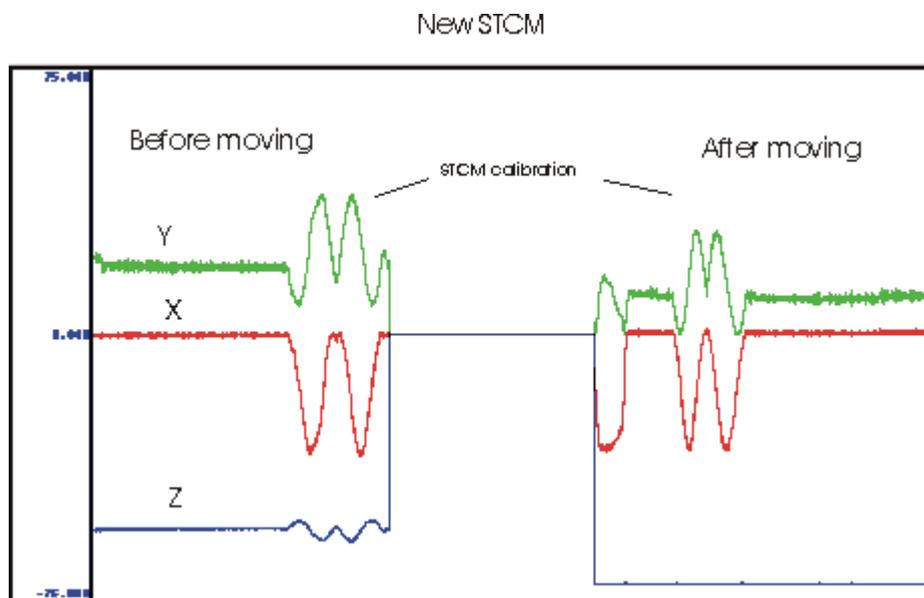
On the last day of the cruise it was decided to transfer the new STCM sensor to the superior position on the monkey island formerly occupied by the old one. When this had been done the Z (vertical) channel gave a very high (? saturated) constant signal (fig. 7, below) and in the time available it was not possible to identify the cause of this.

Thus there is thus currently no useable STCM on the JCR. Whilst the availability of a towed magnetometer reduces the need for an STCM somewhat, it is not always practical or desirable to tow a fish and the three component instrument provides a useful backup. Steps should be taken to restore one of the instruments to proper working order.

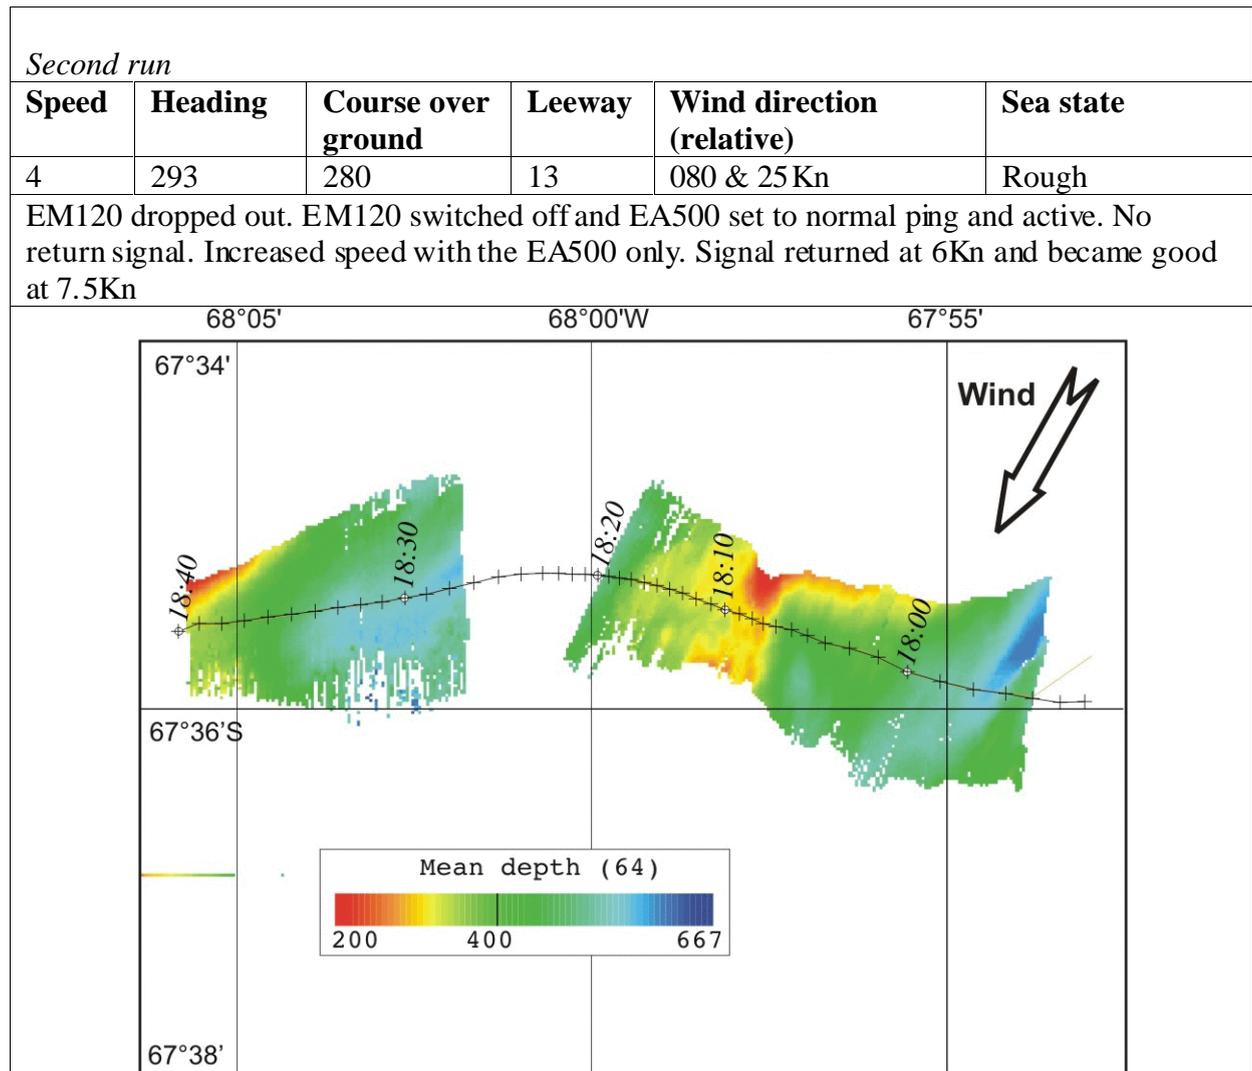
Good response from the EA500 in these conditions when in normal ping mode and active. EM120 lost signal.

The EM120 and the EA500 display similar performance problems when the ship is running with 10° or more of leeway. Reducing the amount of leeway causes the instruments to perform more reliably.

All PSOs should be informed that conditions producing more than 10° of leeway make the EM120 unreliable.
