**National Oceanography Centre
Cruise Report No. 56
RRS *James Cook* Cruise JC166-167**

19 JUNE – 6 JULY 2018

CLASS – Climate-linked Atlantic System Science
Haig Fras Marine Conservation Zone AUV habitat monitoring,
Equipment trials and staff training

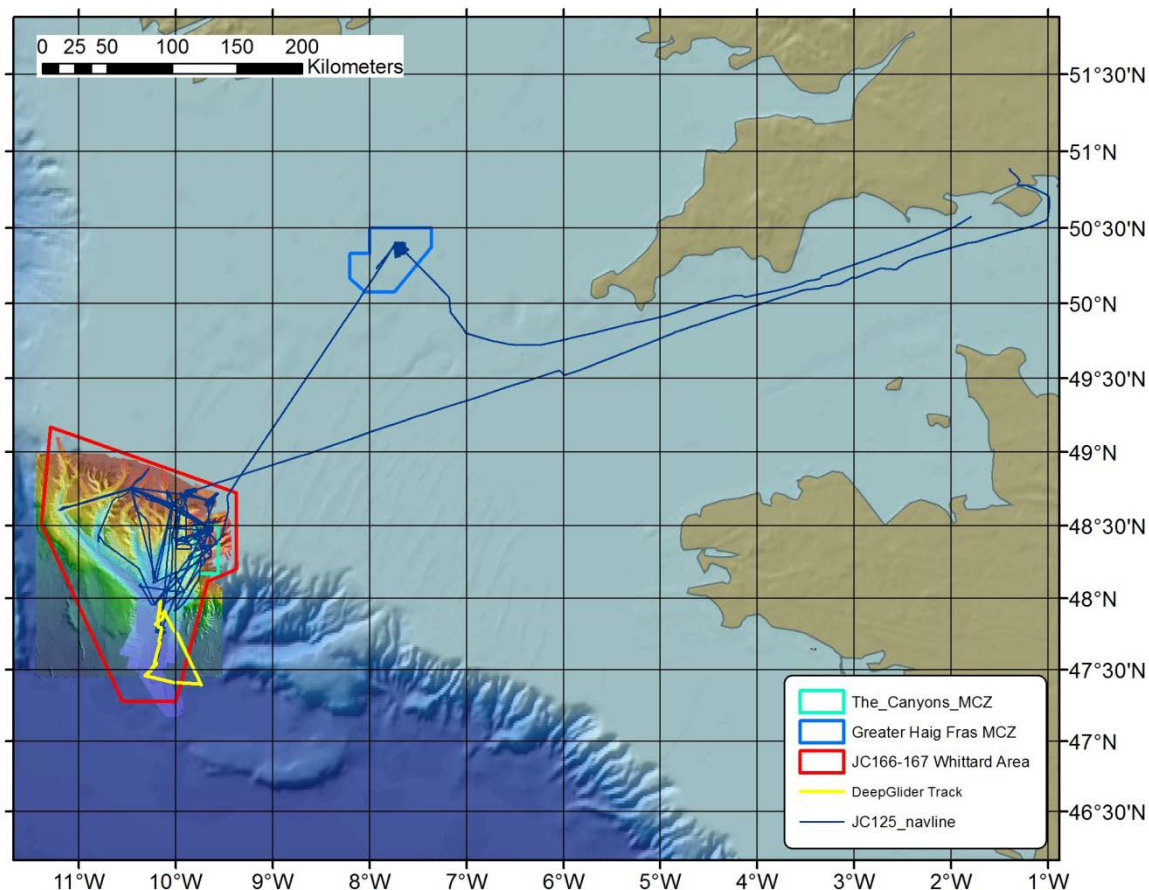
Fig. X.1 Cruise track plot

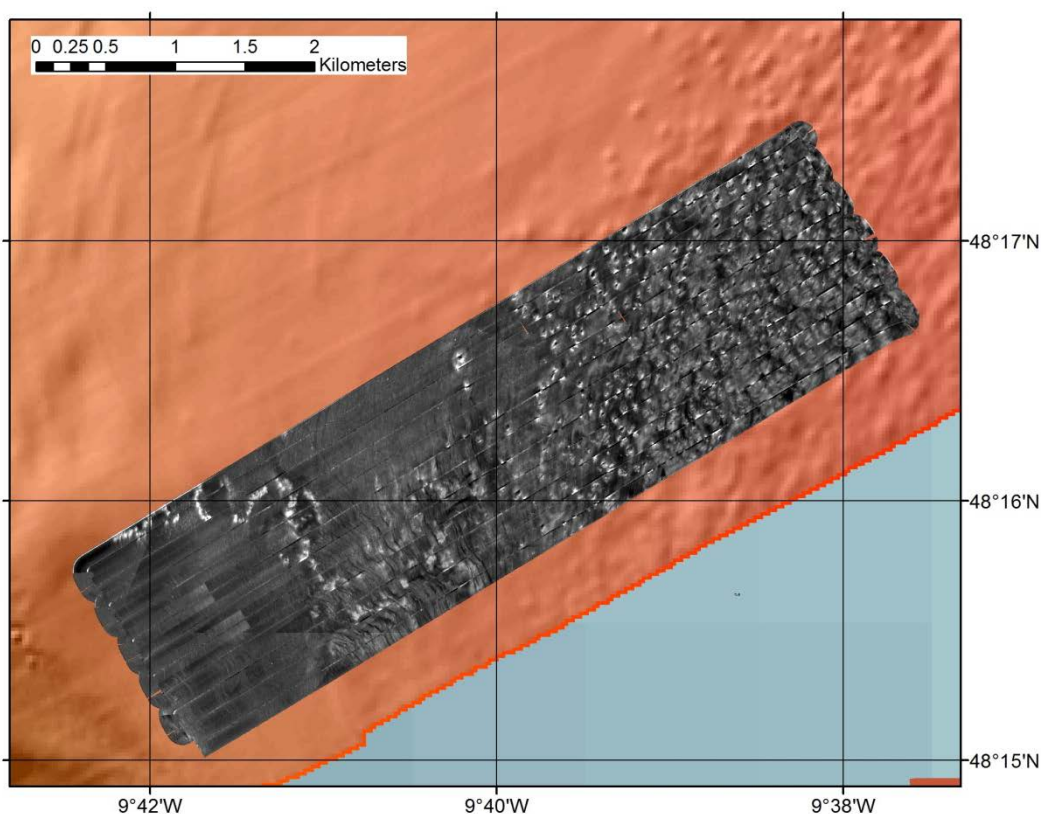
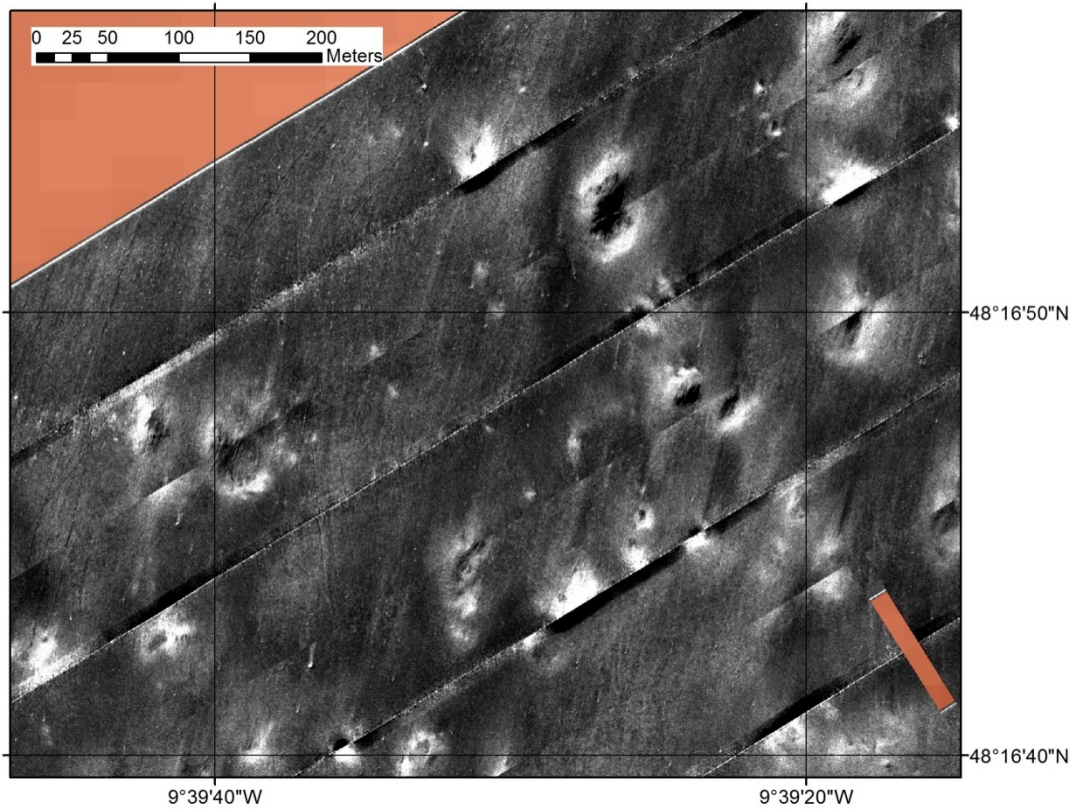
Fig. X.5 Autosub 6000 sidescan sonar map of minimounds area (top), with zoomed-in section (bottom) illustrating the high density of trawl marks in the area. Data collected during JC125.

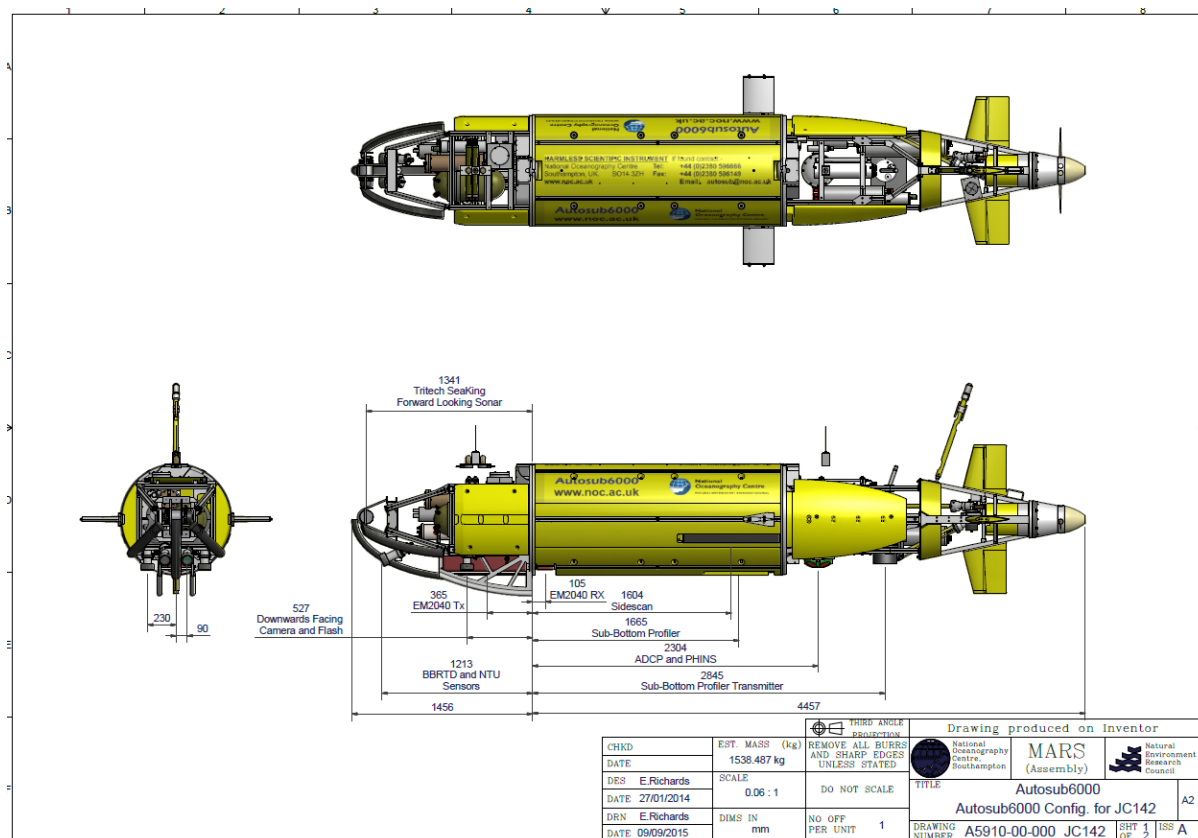
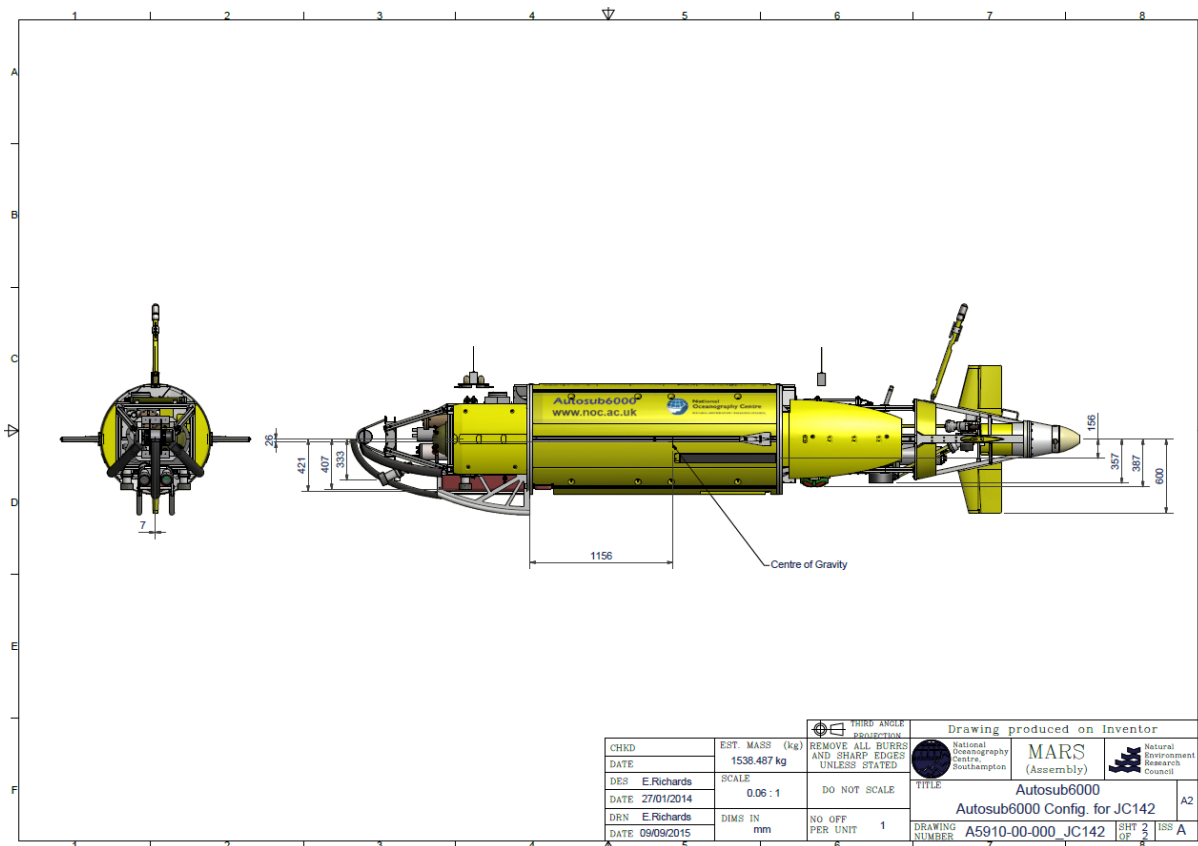
1.2. AUV sensor configuration

The AUV configuration is shown with all relevant dimensions in the drawings below.

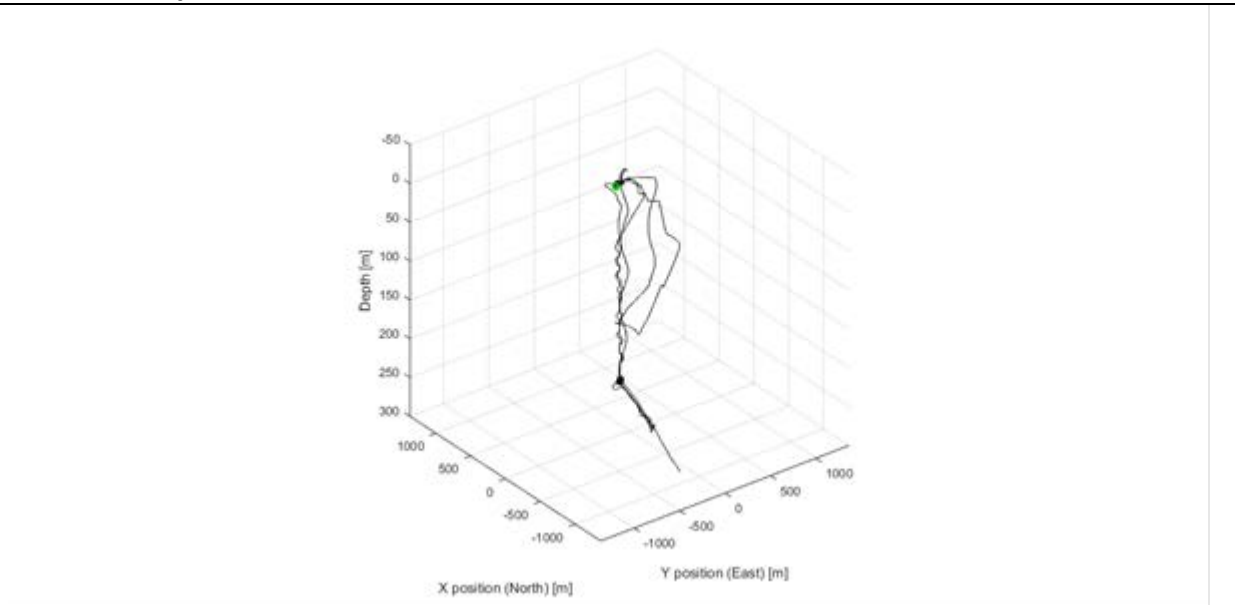
Mission Map

The AUV was launched and recovered successfully and monitored via the ships USBL and the Linkquest throughout the mission. The AUV first dived and performed a short NESW box at differing depths before returning to the surface where the engineering data were analysed. All data seemed good so the AUV was sent to perform the power and deceleration runs to test the performance of the re-wound motor. The AUV then returned to the surface and the engineering data inspected. All data looked good and the AUV was commanded to dive and perform the side scan and camera surveys. The tracks were completed successfully although on surfacing it became clear that the main logger had stopped functioning and the camera logger had stopped logging images. However, it appeared the cameras were still working and able to capture images. The Edgetech recorded throughout the survey as it did not receive the message to stop (due to logger malfunctioning)

Waypoint	Position
WP1	N:48:25.9360, W:9:37.8660
WP2	N:48:25.1840, W:9:38.2860
WP3	N:48:24.6950, W:9:38.5480

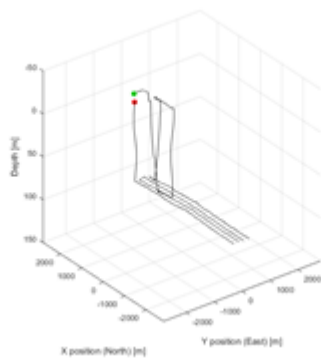
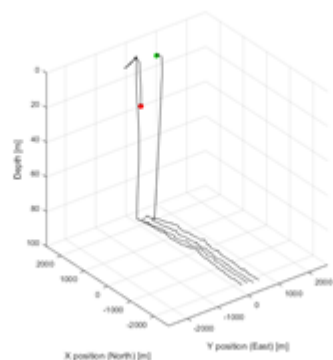
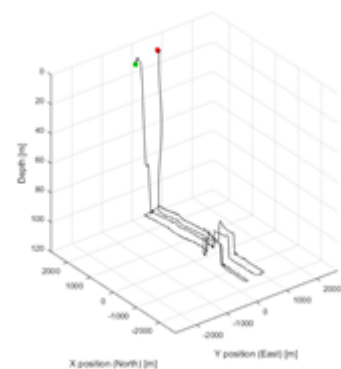
Mission Map

The AUV was deployed and recovered successfully. The first section of the mission was performed without issue and inspection of the loggers showed all to be normal. During the second section of the mission, the first camera survey, the main logger appeared to hang almost immediately after the AUV dived and the camera logger appeared to stop 2 hours later. The next section of the mission,

second side scan survey appeared to complete successfully. Before sending the AUV on the remaining camera survey the main logger was restarted and the camera logger was changed to start on booting of the camera logger, both actions were to try to limit the possibility of failure of the camera survey. On recovery the camera survey appeared to have completed successfully.

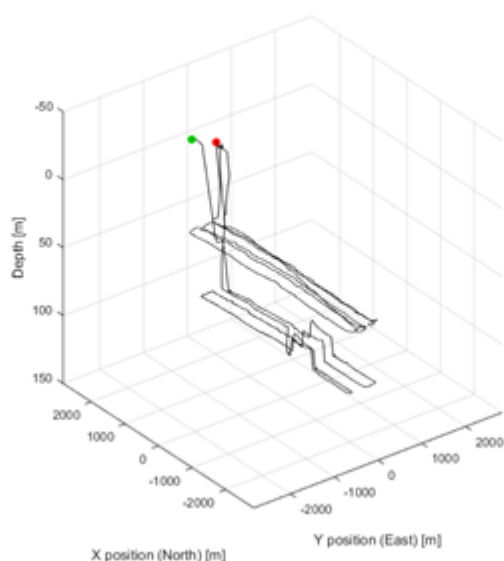
Mission Map

AUV was launched and recovered without incident. The AUV dived and performed a camera survey at ~2.5m altitude and then surfaced. The loggers and camera images were examined and found to be working although later inspection showed that the camera logger had rebooted during the descent to the seabed, however no images of the seabed were lost. The AUV then dived again and performed the multi-beam survey. This was completed successfully although inspection of the data suggests the EM2040 did not pick up the correct sound speed profile for the dive but this should be able to be rectified in post-processing. On this survey it also looked as though the AUV was affected by strong currents producing some odd tracks at the beginning and ends of the survey lines.

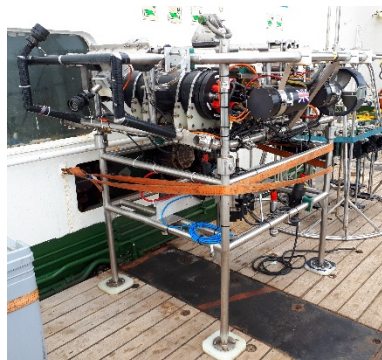
Fig. 3.1 HyBIS on deck

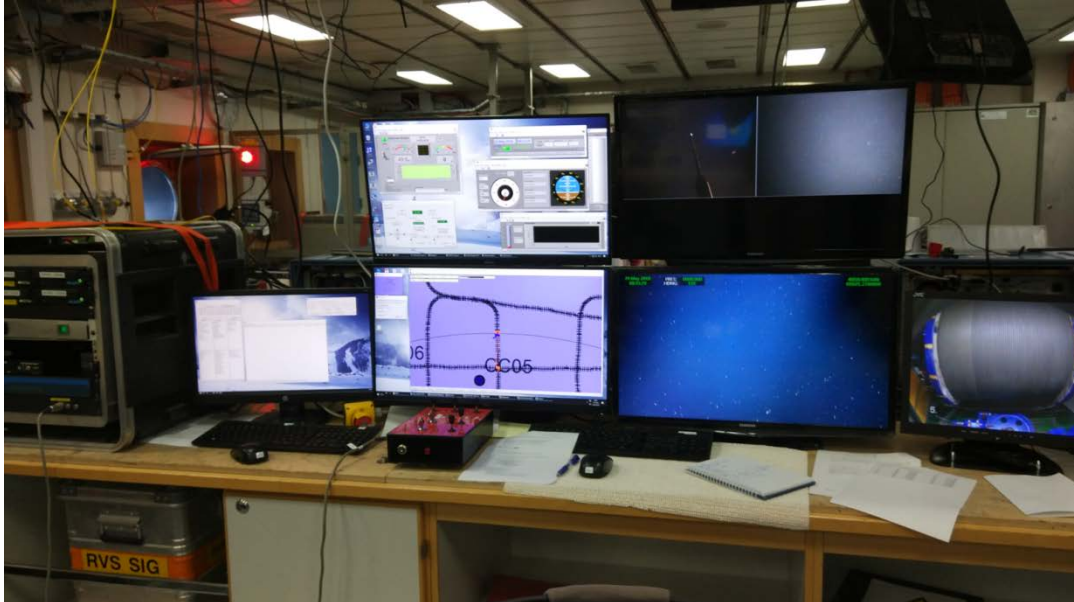
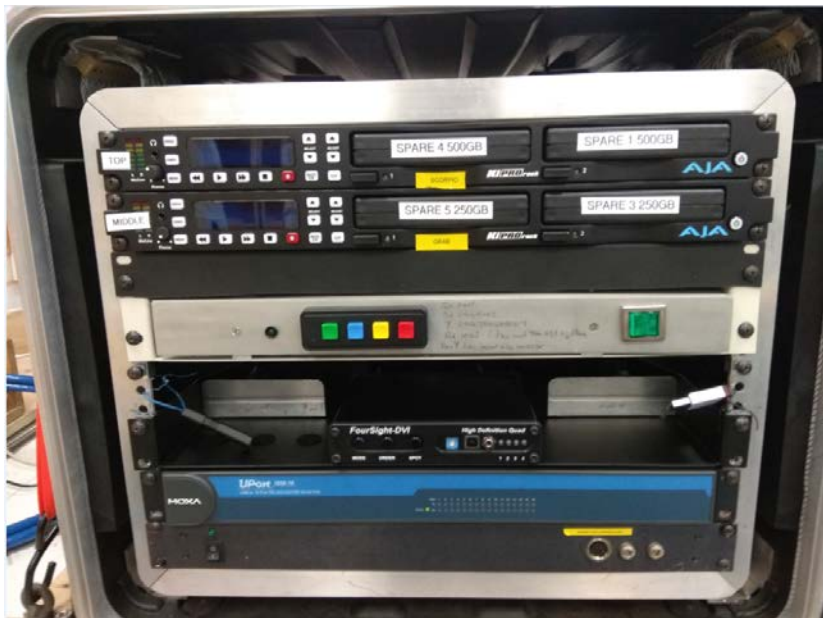
The rack unit was upgraded to a more compact version to facilitate transport and have integrated new W10 computers (Fig. 3.2).

Fig. 3.2 HyBIS topside set-up

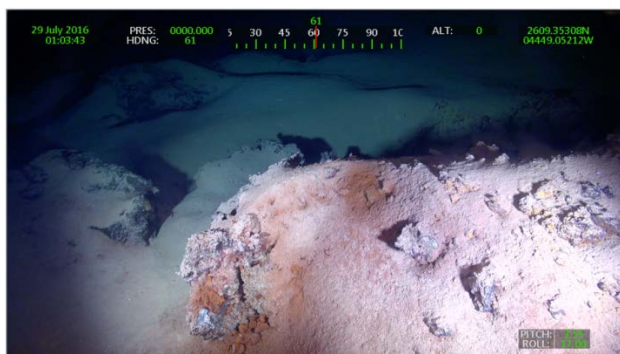
The HYBIS video overlay allows the HYBIS topside system to show real time data in one of the HDMI video feeds. The data can come directly from the vehicle or from the ship, GPS or other scientific sensors.

Fig. 3.3 A typical 1080i with overlay framegrab

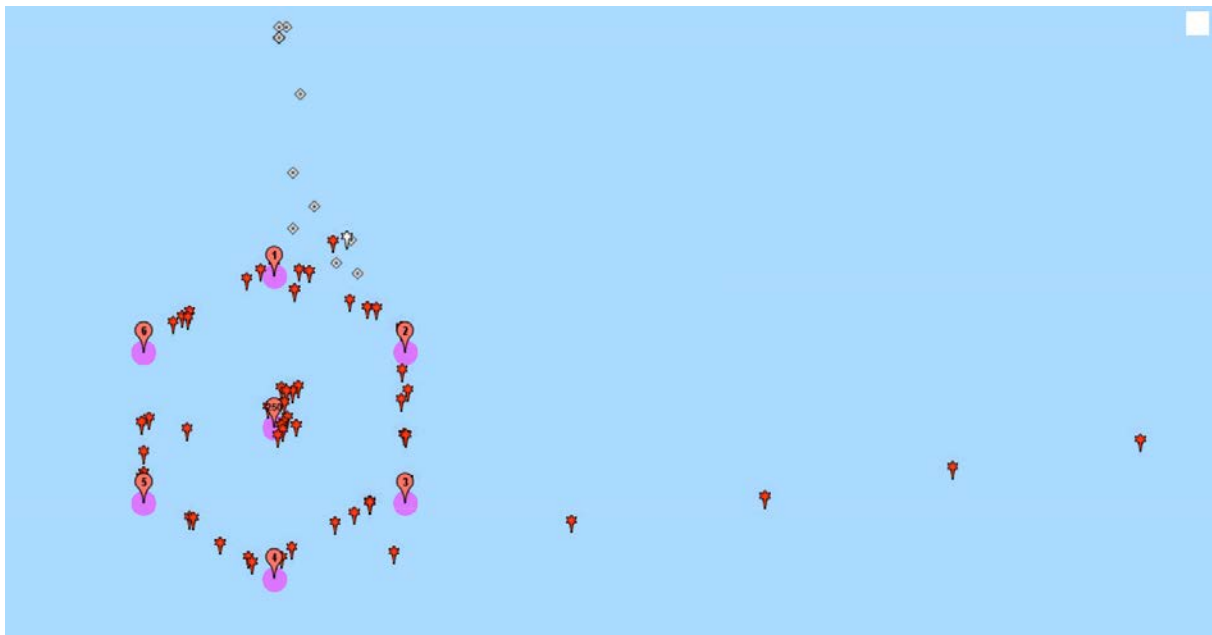
The Waveglider was deployed 1 mile East of the ALR Echosounder deployment location, and directed West and then into a holding pattern of 6 waypoints (1-6) spaced 250m from a central point (waypoint 251; Fig. 4.1).

Fig. 4.1 Waveglider holding pattern on 250m radius (using PID line-following)

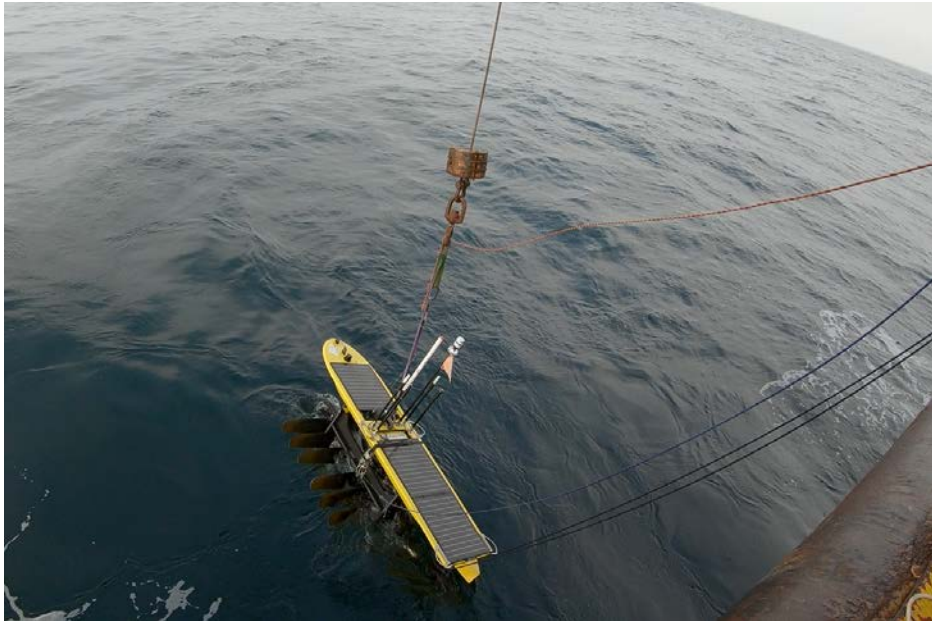
The Waveglider was deployed off the stern using the starboard deck crane (Fig. 4.2). The vehicle was released using a Seacatch and the sub unit was deployed using a quick-release ratchet strap. However, the deployment was made difficult by the lack of strengthening bracket on the 'pod' housing the GPCTD sensor underneath the sub unit. This forced the quick-release ratchet strap to be fastened near the rear of the vehicle, and led to the two parts working free before reaching the water. The deployment was successful in this case, but this issue could easily have led to problems, and is likely to be especially challenging in rough weather.

Fig. 4.2 Waveglider deployment

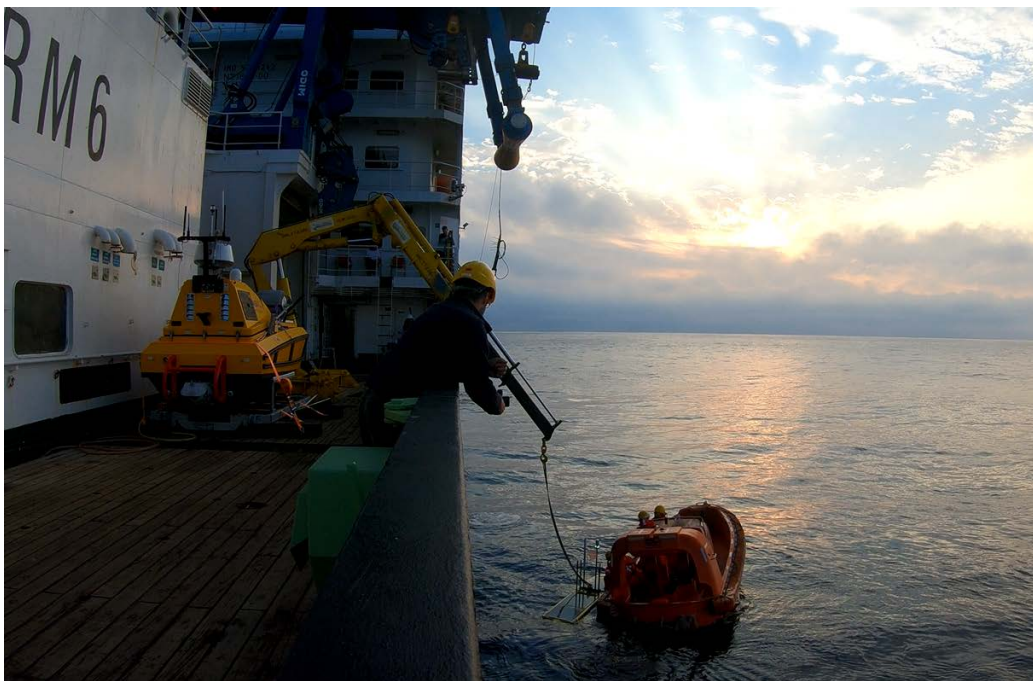
During the recovery the Waveglider was brought into position using the MOB workboat. The glider was held against the side of the MOB boat and towed into position. This approach caused considerable difficulties as the Waveglider was continually pulled underwater. Once in position the float unit hooked onto the starboard hi-ab crane. The float was hauled to bulwark level and a messenger drop weight was used to attach to the sub unit whilst it was still underwater. The sub unit was hauled on-board using the starboard p-frame Rexroth winch and then the float unit was recovered to the deck. This was possible in the benign conditions seen during the cruise, but would be more challenging and dangerous in bigger seas (Fig. 4.3).

Fig 4.3 Waveglider recovery

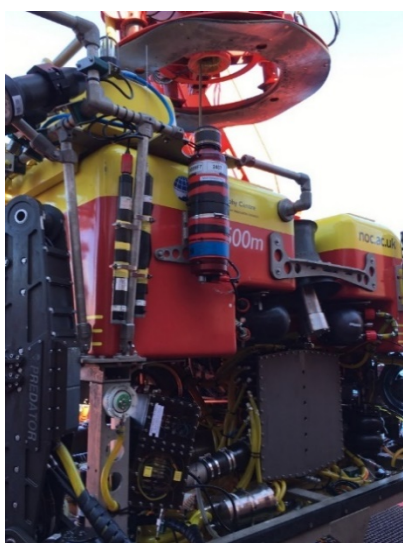
Sonardyne's High Power AvTrak Beacon ID 4907 was attached to the ROV (see photo Fig. 4.4); serial communications to the surface were via the umbilical.

Fig. 4.4 Sonardyne AvTrak Beacon installed on the Isis ROV

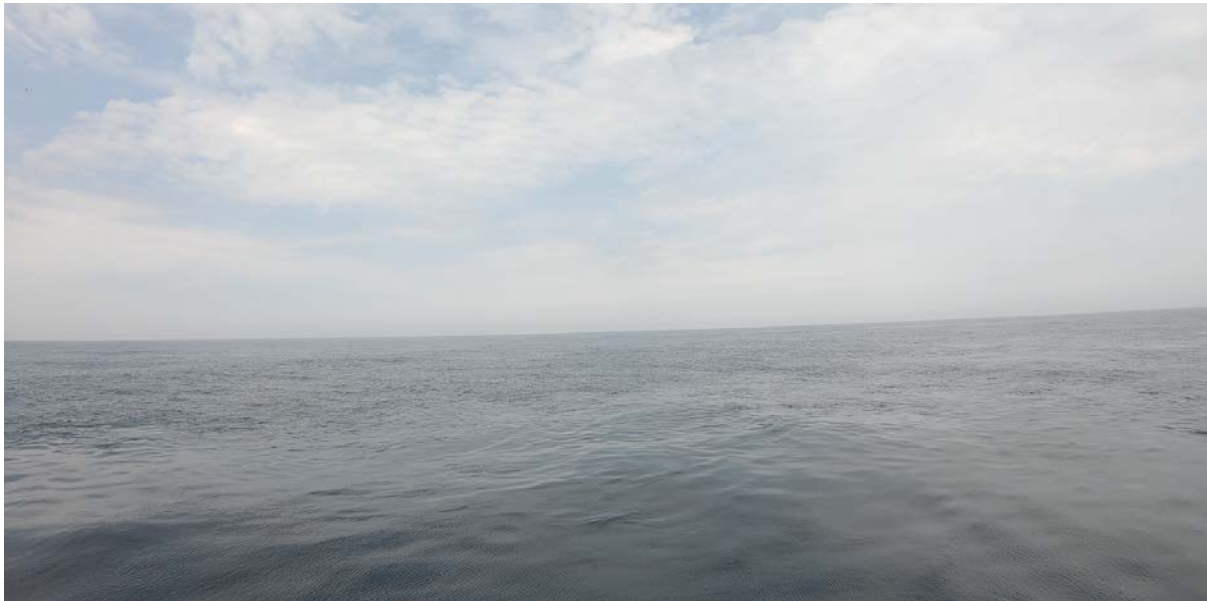
The Waveglider was deployed at Whittard Canyon (station 46) on the 3rd July 2018 at 06:53 UTC, 47° 46.317N, 10° 08.671W. The water depth was 4156m and the weather conditions were excellent (Fig. 4.5), wind 8 knots @ 310°, sea state 1 – see image below.

Fig. 4.5 Waveglider Mission 2 deployment and test conditions

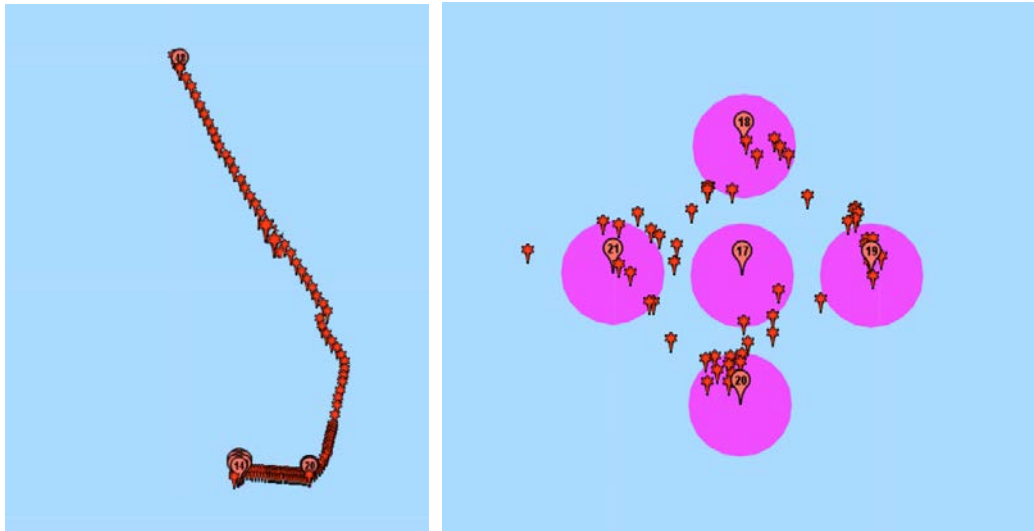
Fig. 4.6 Waveglider holding pattern on 50m radius (using PID line-following)

Once the Waveglider had been successfully launched it was directed into a holding pattern of six waypoints (11-16) spaced 250m from a central point (waypoint 67). The ROV was launched and once communication had been established between the Waveglider and the ROV, the Waveglider was sent East to new location and directed into a holding pattern (Fig. 4.6) of four waypoints (18-20) spaced 50m from a central point (waypoint 17). The track was offset by about 650m from the ROV to minimise any possible interference between the ship and the waveglider. The waveglider continued to circle as the ROV descended to the sea floor at a depth of 3870m. When the ROV had reached the seabed the Waveglider was sent on a transit taking it away from the ROV, and messages sent until the communication link started to fail.

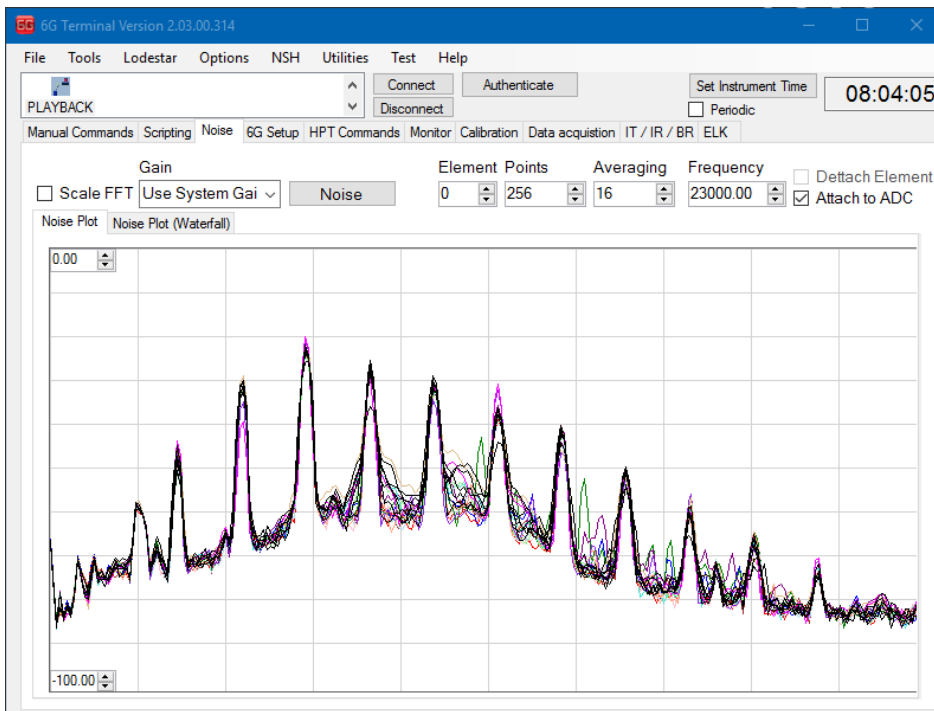
Periodic analyses of the acoustic noise spectrum were taken from the AvTrak at various depths as the ROV descended. The noise spectrum did not change appreciably with depth. The results were taken with the hydraulics powered off, and with the thrusters running at about 80% of full power. The graph below (Fig. 4.7) shows the ROV noise spectrum at 3870 meters.

Fig. 4.7 Noise spectrum for the Isis ROV with the hydraulics off, and thrusters at 80% power

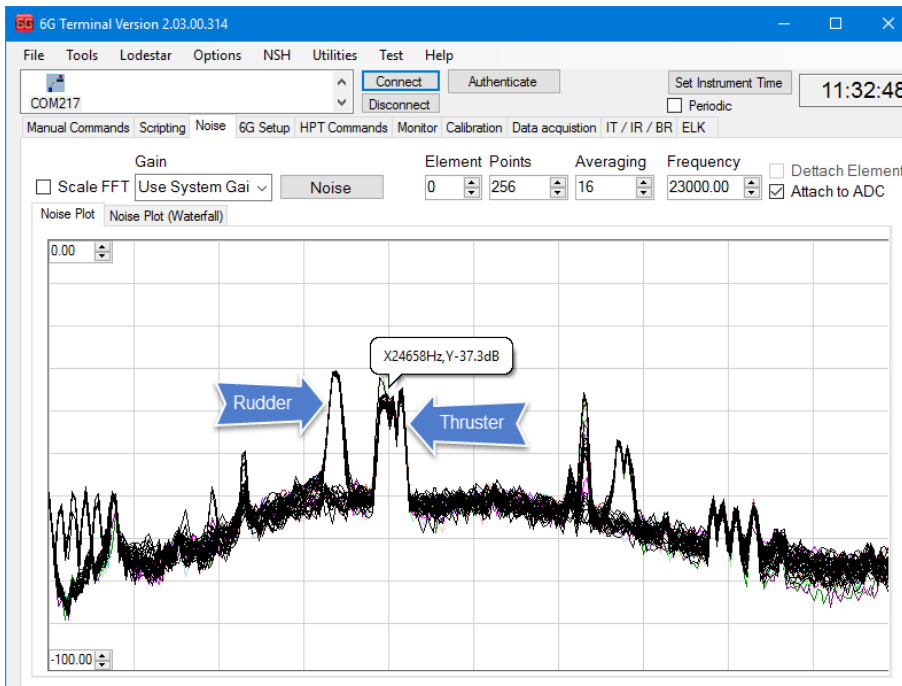
The graph below (Fig. 4.8) shows the noise spectrum of the Waveglider, showing noises sources from the thruster and rudder.

Fig. 4.8 Noise spectrum for the Waveglider Waimea with the rudder and thruster signatures highlighted

The testing also showed that turning on the Waveglider's thruster caused a significant deterioration in signal quality, due to the higher background noise seen by the acoustic modem. Thus, it is not recommended to run the thruster while attempting to use long range acoustic coms.

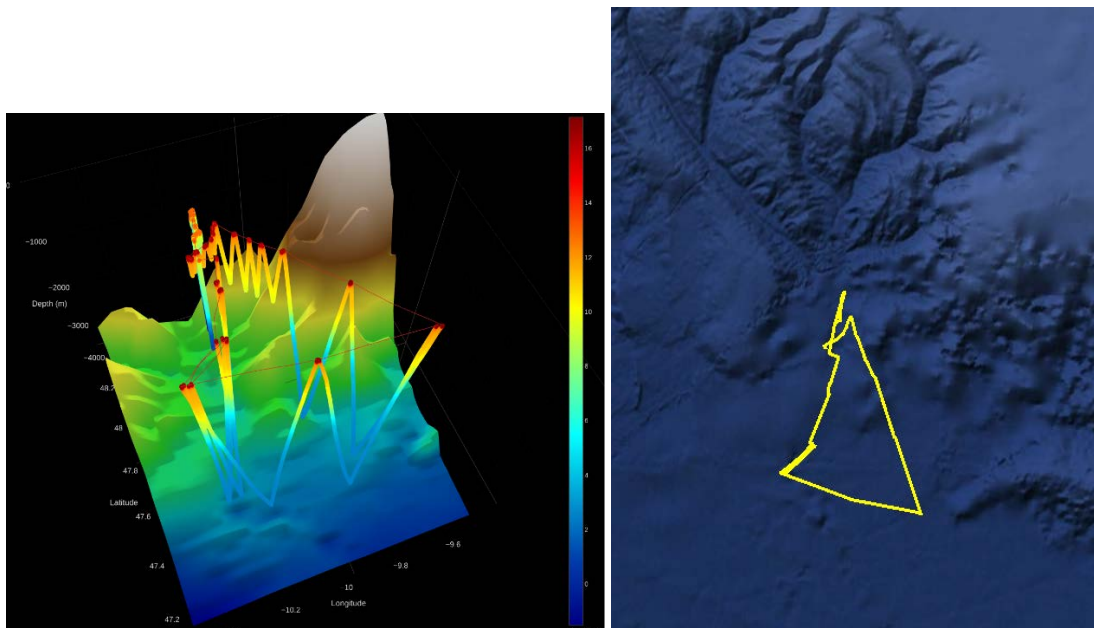
Fig. 5.1 Glider deployment track and temperature with overlaid bathymetry

The Deepglider was launched on 23rd June and recovered on 3rd July, a total of 10 days. During that time it completed 40 dives, with 8 dives deeper than 1000m and 5 dives deeper than 4000m. The deepglider initially headed south into deep water at the mouth of Whittard Canyon, then east before returning north for recovery (Fig. 5.1). The maximum depth achieved = 4336m (dive 24), and a total of 4 consecutive dives to 1000m were made to assess its comparability to the Seaglider (Kongsberg M1).

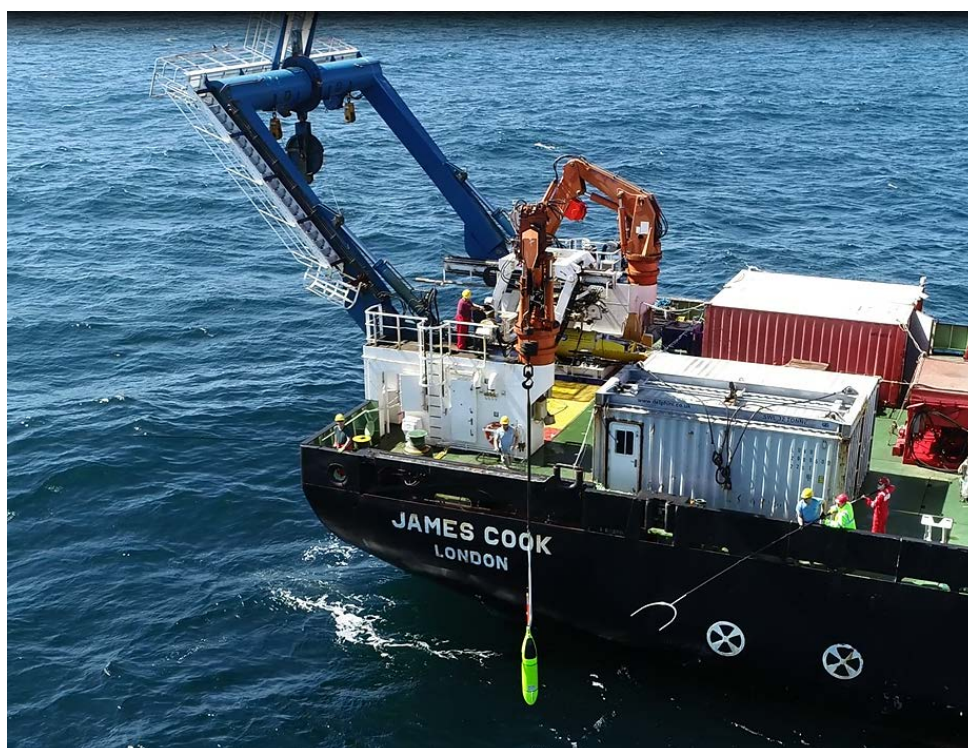
The deepglider was launched using the starboard quarter crane (Fig. 5.2). The deployment used a rigid rope rig to prevent damage to the antenna, and a pole was used to fend the glider away from the ship. The recovery used an aluminium recovery hoop on a 10m carbon fibre telescopic pole (Fig. 5.3). The glider was hooked by the starboard waist and hauled on-board using the starboard p-frame Rexroth winch.

Fig. 5.2 Deepglider deployment

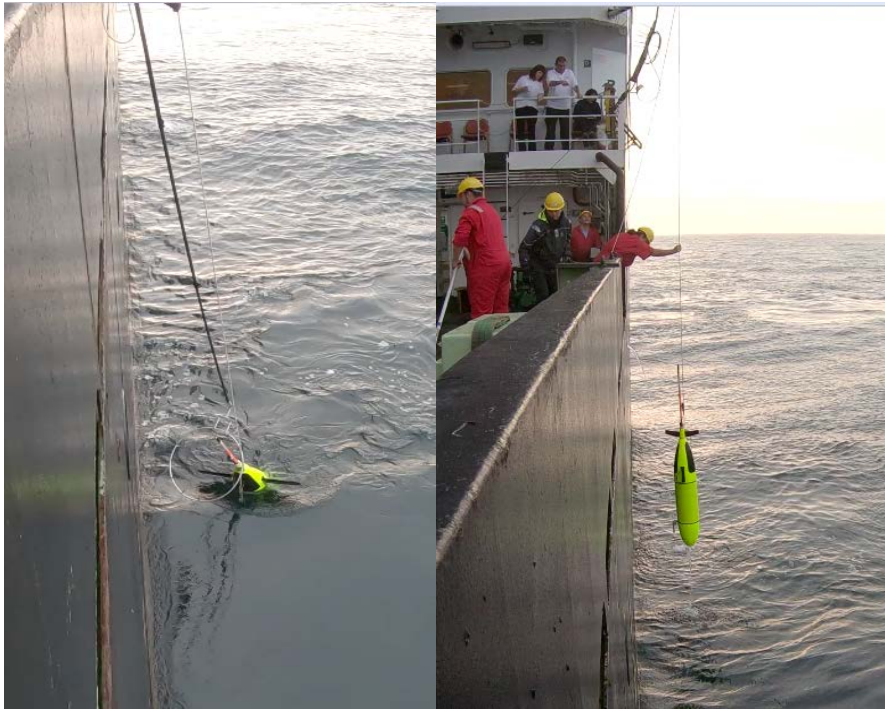
Fig. 5.3 Deepglider Recovery

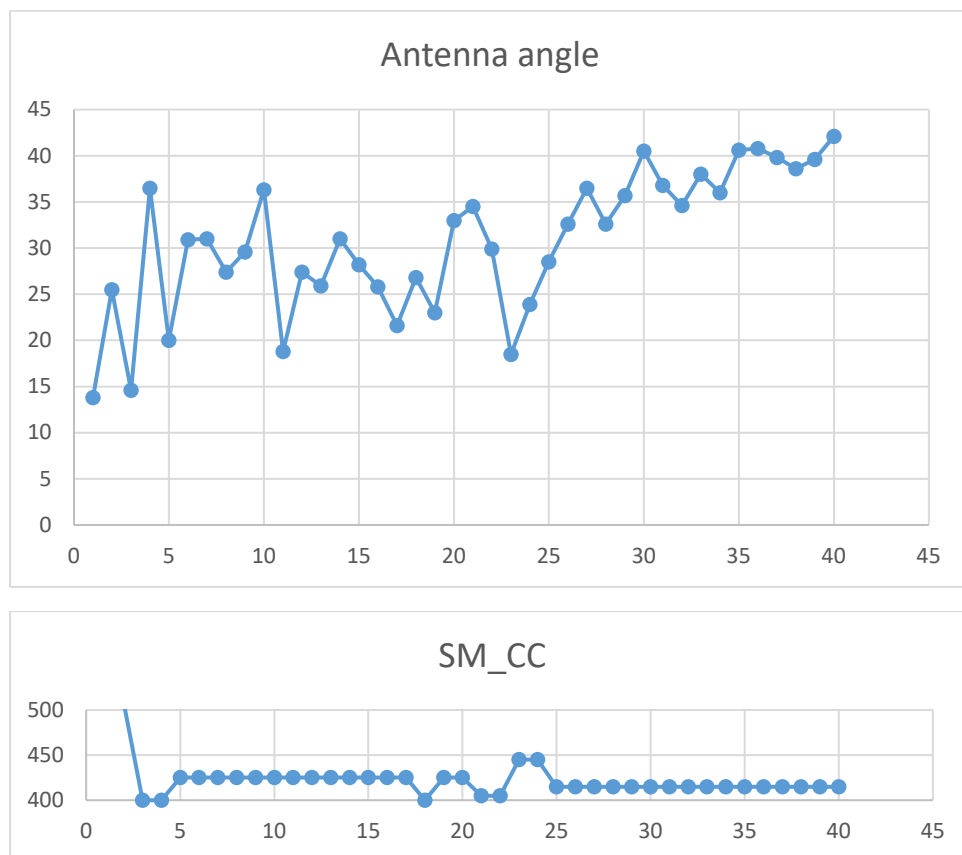
Plotting antenna angle vs. SM_CC is not conclusive, see Fig. 5.4 below. There were two main values used, 415 and 425. 405 and 400 were also tried but the initial angle was not noticeably different. 440 was used for 2 dives and did not produce as good an angle as any when using 415. Overall, 415 produced a better antenna angle than 425, but the way it increased over time suggests that there is an underlying factor at work as well, or even instead. There was no great difference between deep and shallower dives, so sea surface temperature or even sunlight may be the factor.

Fig. 5.4 Antenna angle and oil volume pumped in bladder at the surface

In conclusion, an SM_CC of 415 works well. Lower values may improve matters, but may not. Higher values do not make the angle any better.

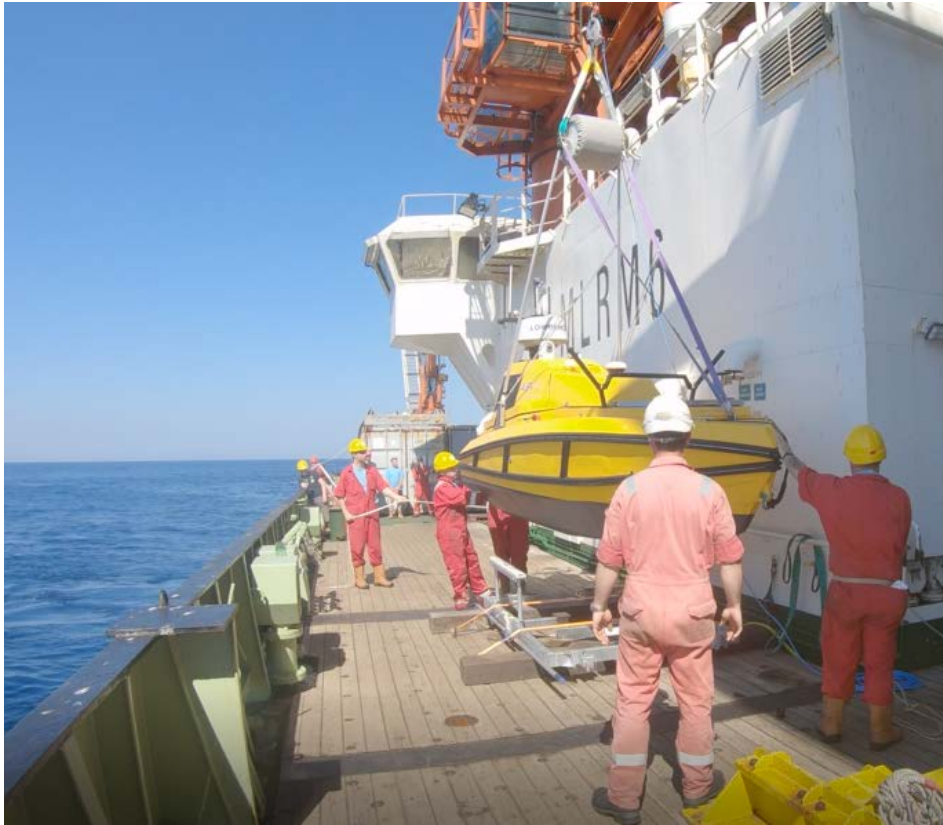
The C-Worker 4 had recently been delivered for the trial from L3 ASV. It included a Sonardyne USBL beacon, forward camera systems, and a prototype launch and recovery lifting bridle for deployment from the *RRS James Cook*. The C-Worker 4 was lashed to the deck in the CAMEL transport trolley on the starboard side working area, as seen in the image below (Fig. 6.1).

Fig. 6.1 C-Worker 4 with its custom lifting bridle, and the CAMEL transport trolley strapped to the deck

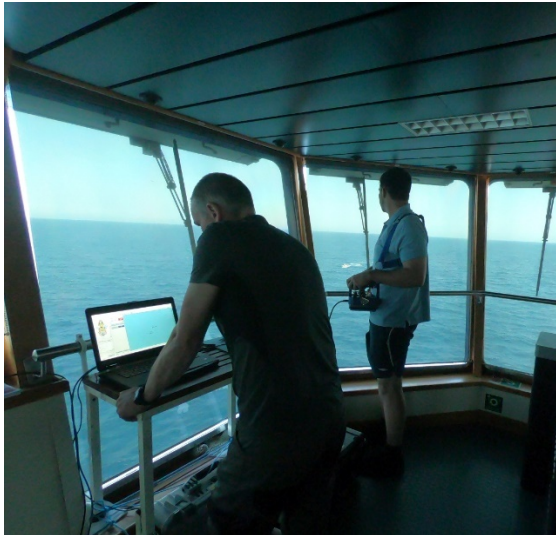
Helm and Laptop for controlling the C-Worker were located on the Bridge (Fig. 6.2). This was necessary because the antennas for the C-Worker were fixed to the Monkey Island and there was a limited cable length between the antennas and the control box. Although this setup worked well once the C-Worker was underway as it gave both the ship's officers and the C-Worker 4 pilot a good view of operations it was very restrictive during the recovery phase (Fig. 6.3). The image below was taken by a camera from the Bridge, with the camera hard up against the window facing down. However, this would be an unnatural position for the helm operator and therefore once the C-Worker 4 was against the Fenders in the recovery position the helm operator could not see the C-Worker 4.

Fig. 6.2 C-Worker Control setup on the Bridge

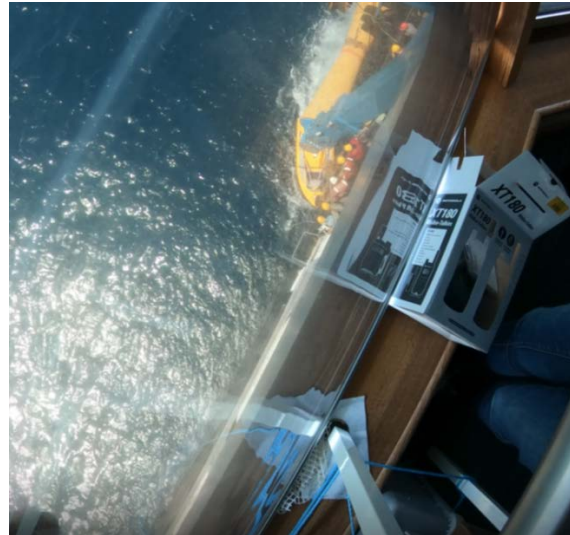
Fig. 6.3 Restricted View of the C-Worker 4 during the recovery phase

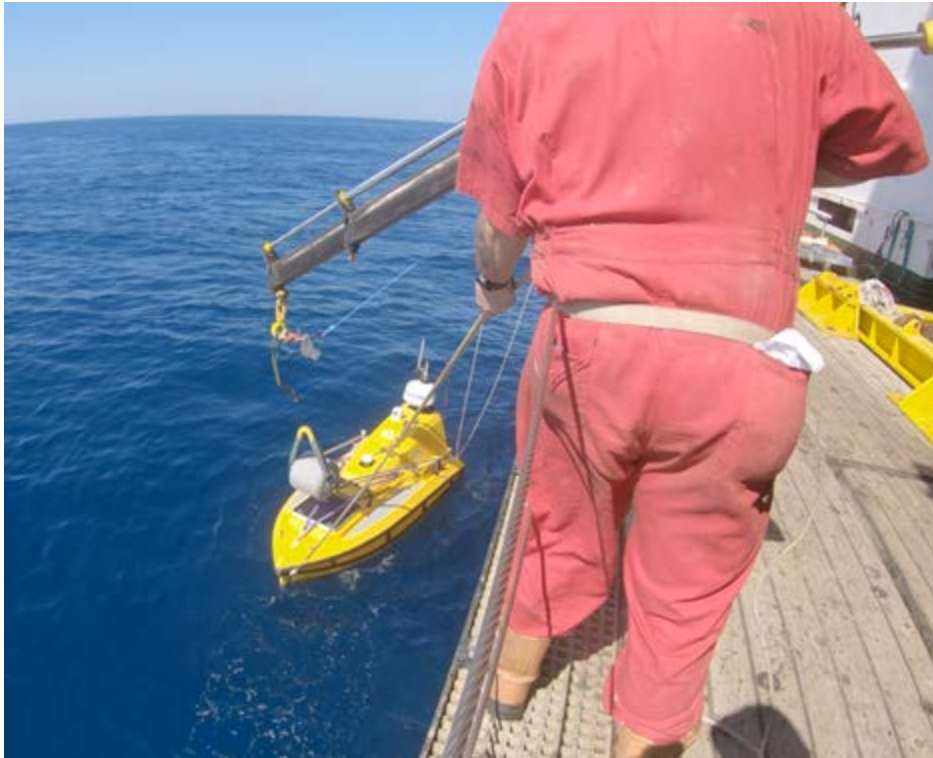
Steadying lines were attached to the Fore and Aft of the C-Worker, and the USV was attached to the hook of the yellow HIAB crane and lifted over the side (Fig. 6.4). Once in the water the engine was started (Pause mode) and basic helm checks were conducted (Fore, Aft, Port, and Starboard). The steadying lines were released and C-Worker 4 was driven away from the ship under helm control from the Bridge

Fig. 6.4 C-Worker 4 Launch. Tag lines still attached.

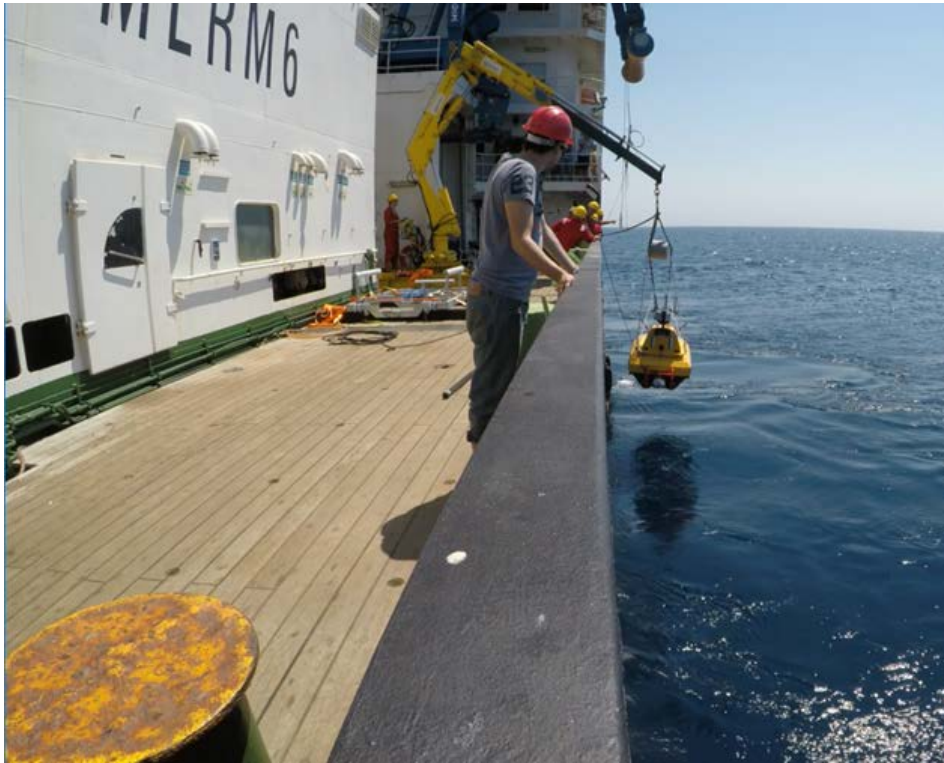
The snap hook was then attached to the C-Worker 4 lifting strop, and the USV was lifted using the P-Frame while being held against the fenders on the side of the ship (Fig. 6.5). Once the C-Worker was raised sufficiently the weight was transferred to the yellow HIAB crane and the vehicle was swung out away from the ship, and then brought back on board and landed on the deck.

Fig. 6.5 C-Worker 4 recovery. Just after the transfer from the P-Frame to the Yellow HIAB

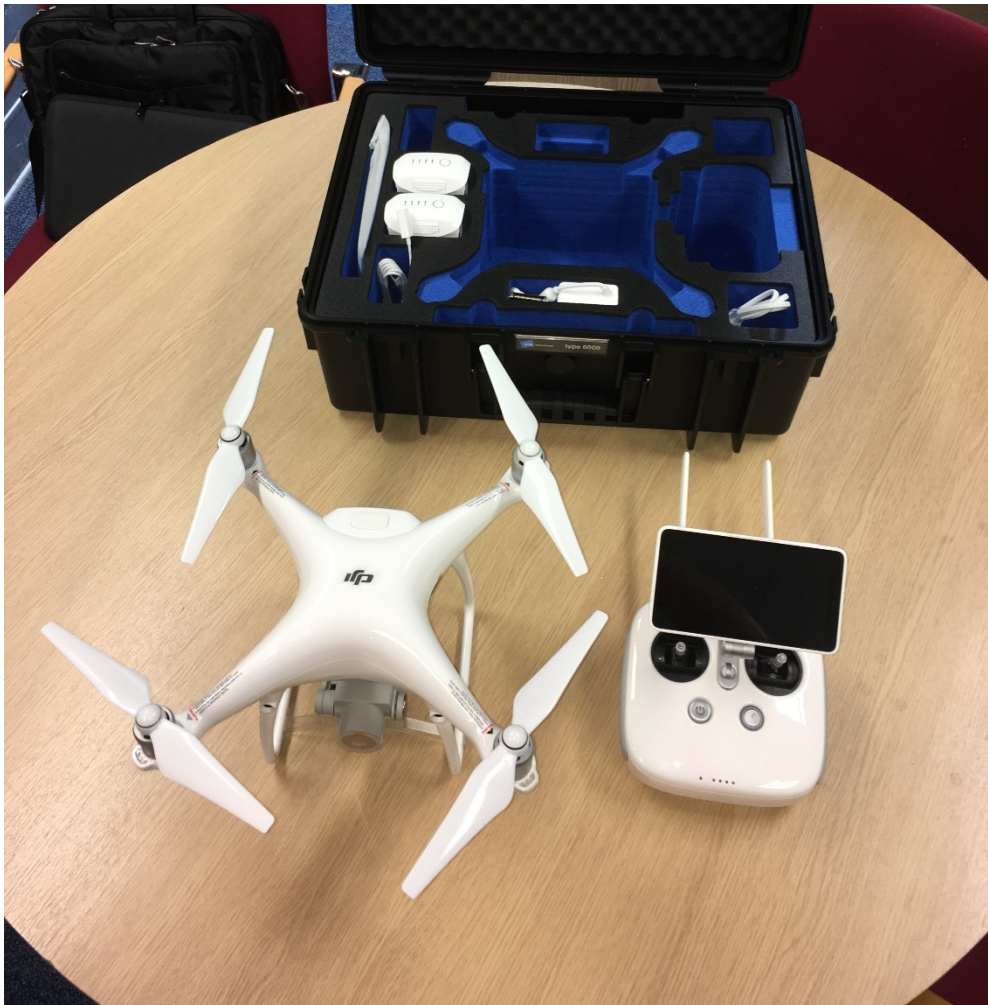
The drone used was a DJI Phantom 4 Pro+. Two spare batteries were taken to maximise the flight time. The quadcopter, its controller and carry case are shown in the image below (Fig. 8.1). The drone itself has a ~30 minute flight time, a gimbal stabilised 20 MP camera, and can film in 4k. The vehicle also has obstacle avoidance capabilities and return to base functionality.

Fig. 8.1 Phantom 4 Pro+ drone used during JC166-167
