**National Oceanography Centre
Cruise Report No. 56
RRS *James Cook* Cruise JC166-167**

19 JUNE – 6 JULY 2018

CLASS – Climate-linked Atlantic System Science
Haig Fras Marine Conservation Zone AUV habitat monitoring,
Equipment trials and staff training

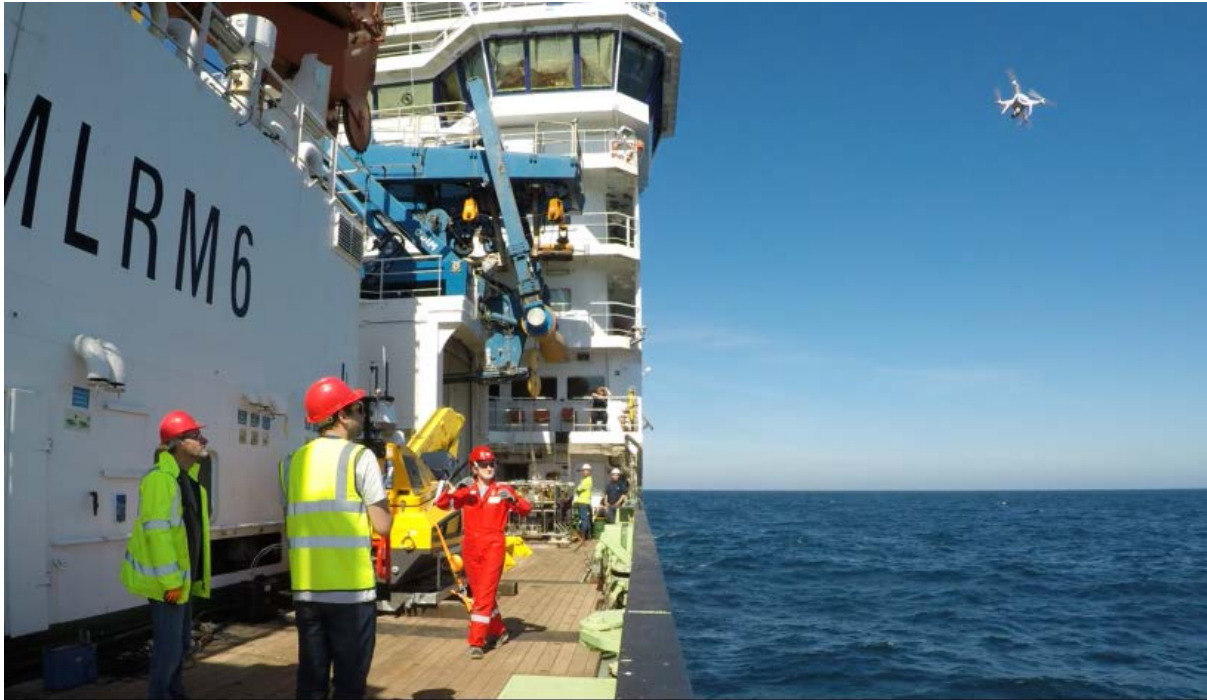
Once the initial testing had been completed and the team had confidence in operating the drone from the ship. The drone was also launched from the starboard deck amidship to film the launch of the deepglider. This used the hand-launch and catch technique practised on the foredeck, and proved to be highly successful. The drone was driven up and out from the starboard side to miss the ships infrastructure, as shown in the following image (Fig. 8.3).

Fig. 8.3 Launching the drone from the starboard side

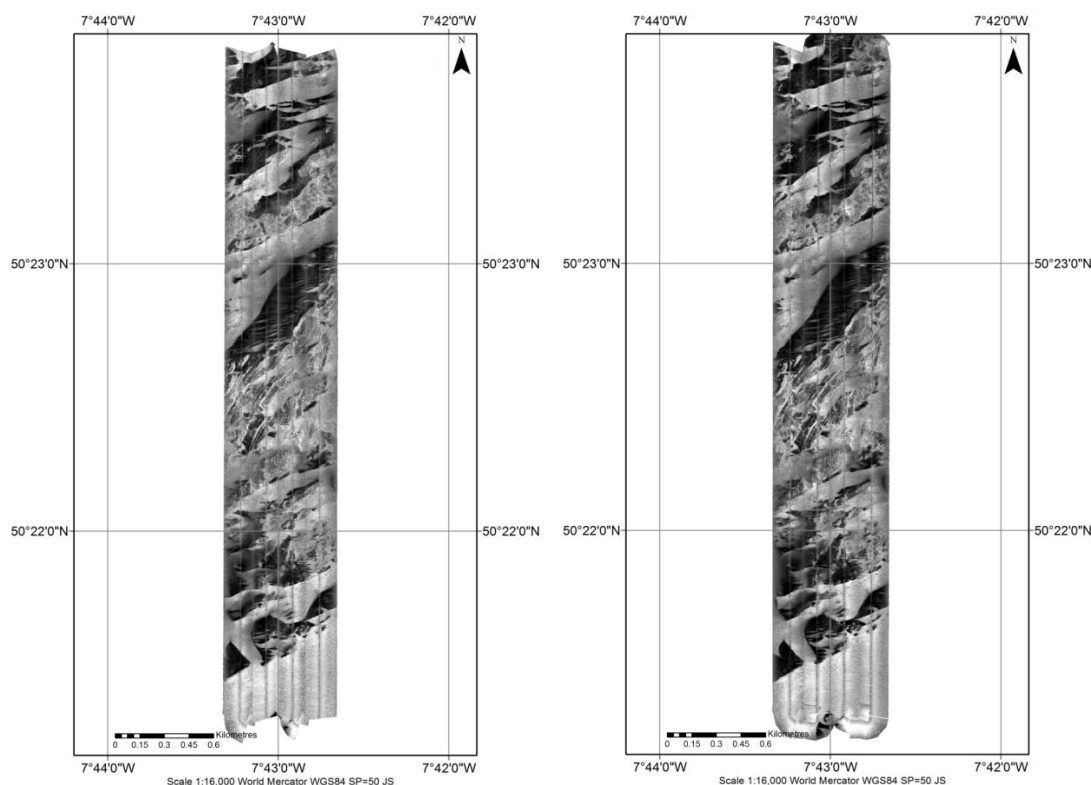
All side scan sonar XTF files were processed in SonarWiz (v7). Each line of data was bottom-tracked and underwent empirical gain normalisation. The amount of overlap between lines was minimised to reduce averaging artefacts (fuzzy areas between lines). All individual lines were exported from SonarWiz as rasters (Erdas Imagine format). Rasters were imported into ArcMap. Side scan sonar sections forming a single line within a station were mosaicked together, generating single rasters for each complete line across a station. Drift in the Doppler-based Autosub6000 navigation meant that offsets were apparent when lines were aligning together. Consequently, all full-length lines were georeferenced in ArcMap to produce a complete, internally consistent raster. The final site rasters (Fig. 9.1) were subsequently georeferenced to a SSS raster produced in 2015.

Figures 9.1a and 1b. Side scan sonar imagery for Haig Fras collected by Autosub during M143, before (left) and after (right) the night-time photography.

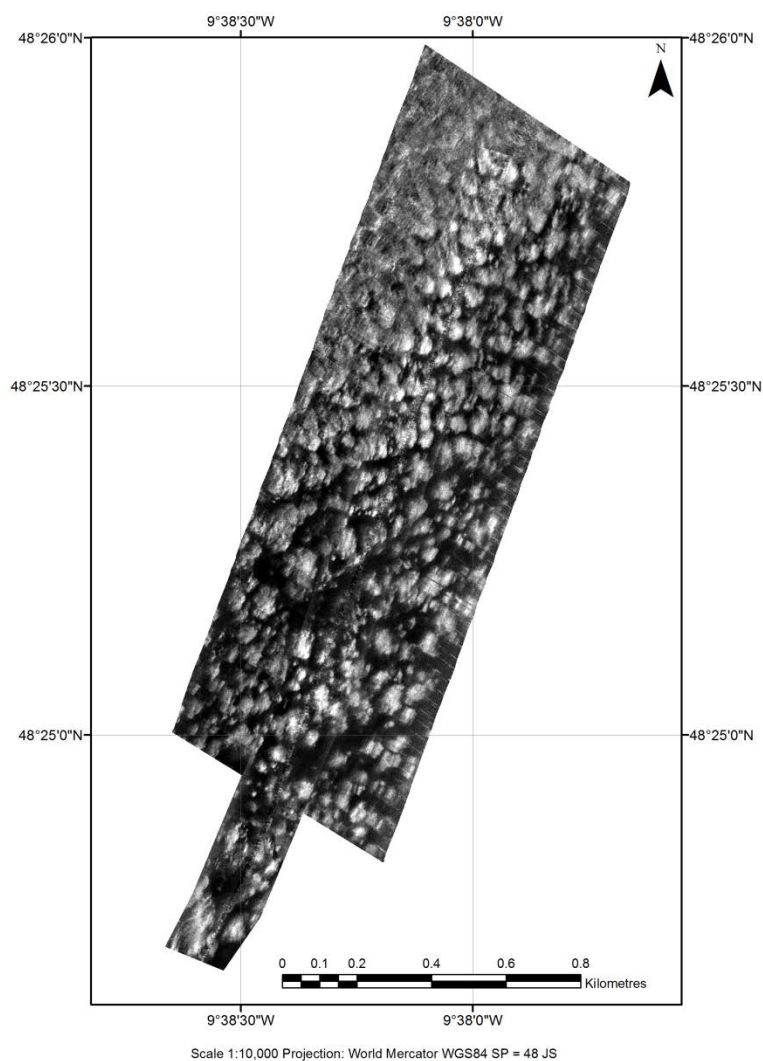
Autosub6000 M142 collected both high and low frequency side scan sonar. To obtain the clearest image of the potential mini-mounds, a raster combining both data types was produced. The central section (running along the nadir) of the high frequency image was superimposed over the low frequency image. This process provided a final image combining the extensive coverage of the low frequency imaging with the high level of detail captured by the high frequency system along the nadir (Fig. 9.2).

Figure 9.2. Side scan sonar composite (high and low frequency imagery) of an inter-flume area near Whittard Canyon. Collection by Autosub 6000 on JC166.

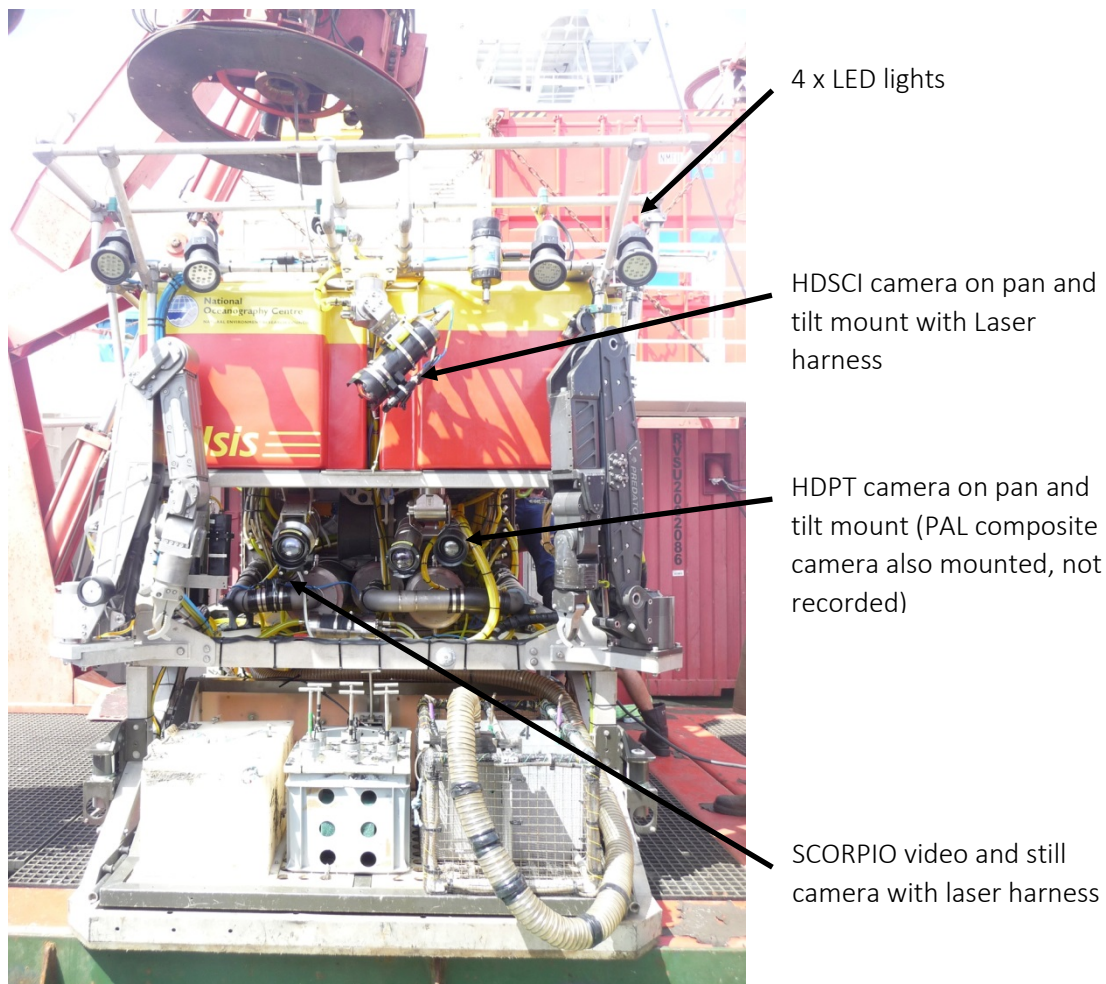
The video and photography set-up during JC166 was the same in principle as during JC125, although different camera types were tested during JC166 (see section 2.7.7.2). Imaging and lighting equipment (Fig. 10.2) carried by the *Isis* ROV included three optically corrected High-Definition (HD) cameras mounted to the front of the vehicle.

Fig. 10.2. *Isis* ROV video camera configuration

Four LED lamps provided illumination for the cameras on a fixed-mount lighting bar at the front of the vehicle (Fig. 10.2). To provide a fixed scale in images, two sets of lasers were mounted 0.1m apart parallel to the focal axis of the HDSC and SCORPIO cameras.

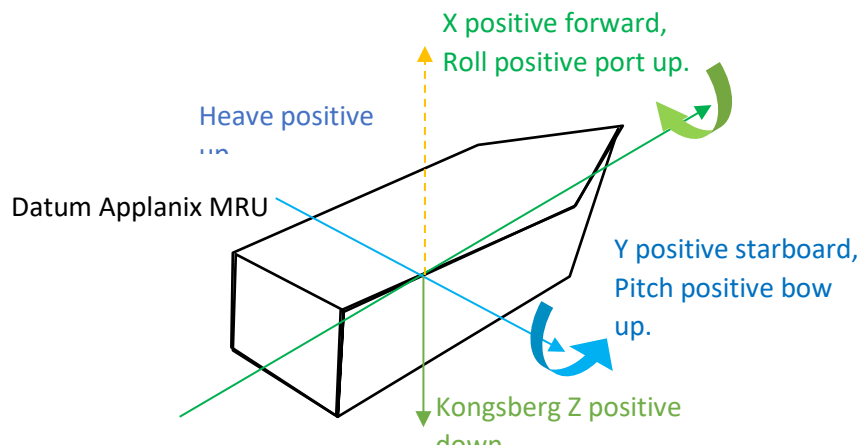
1. Roll positive port up,
2. Pitch positive bow up,
3. Heading true,
4. Heave positive up.

Figure 11.1 Conventions used for position and attitude.

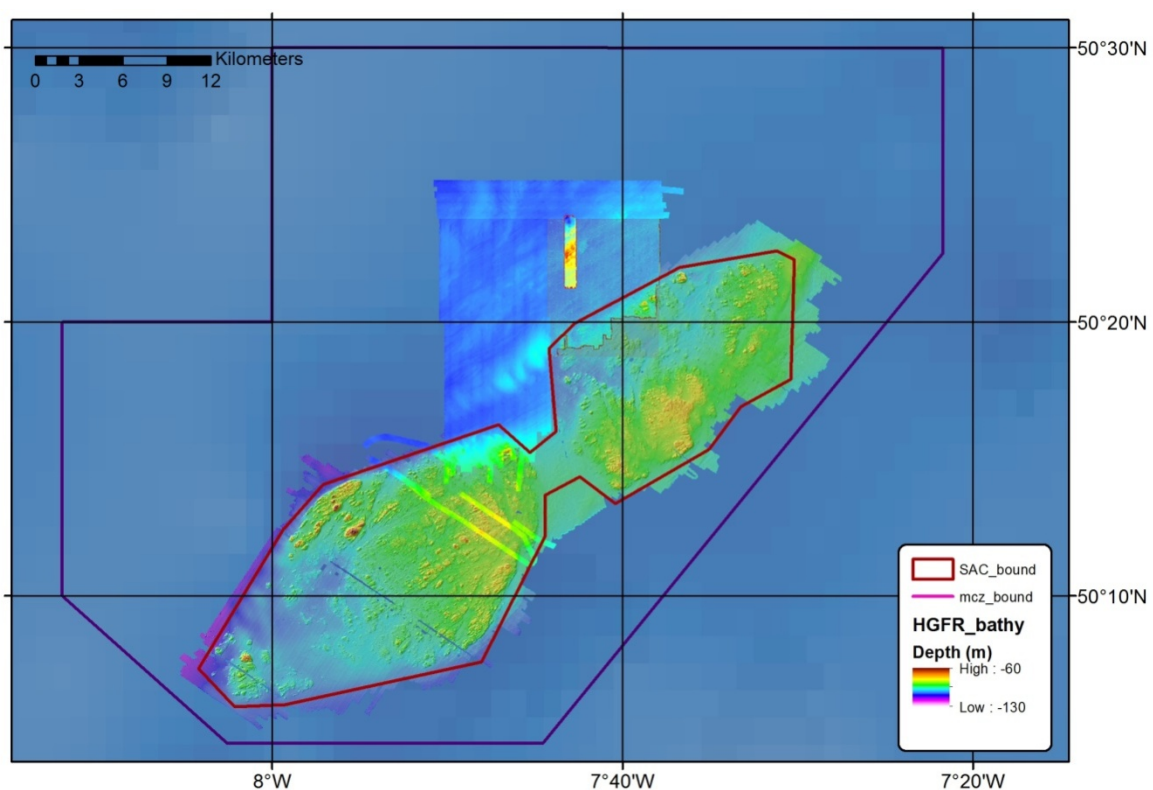
Over the course of the cruise, the ship-based multibeam bathymetry data coverage over the Greater Haig Fras was extended considerably compared to the coverage obtained during JC124 (Fig. R.1). A significant offset between the dataset from JC124 and JC166 was noted, and was attributed to the fact that the draft correction was applied twice in the processed data of JC124. Corrections were applied retrospectively.

Fig. R.1 Extension of bathymetry data coverage obtained during JC166 (non-shaded bathymetry to the north and west of coverage obtained during JC124)

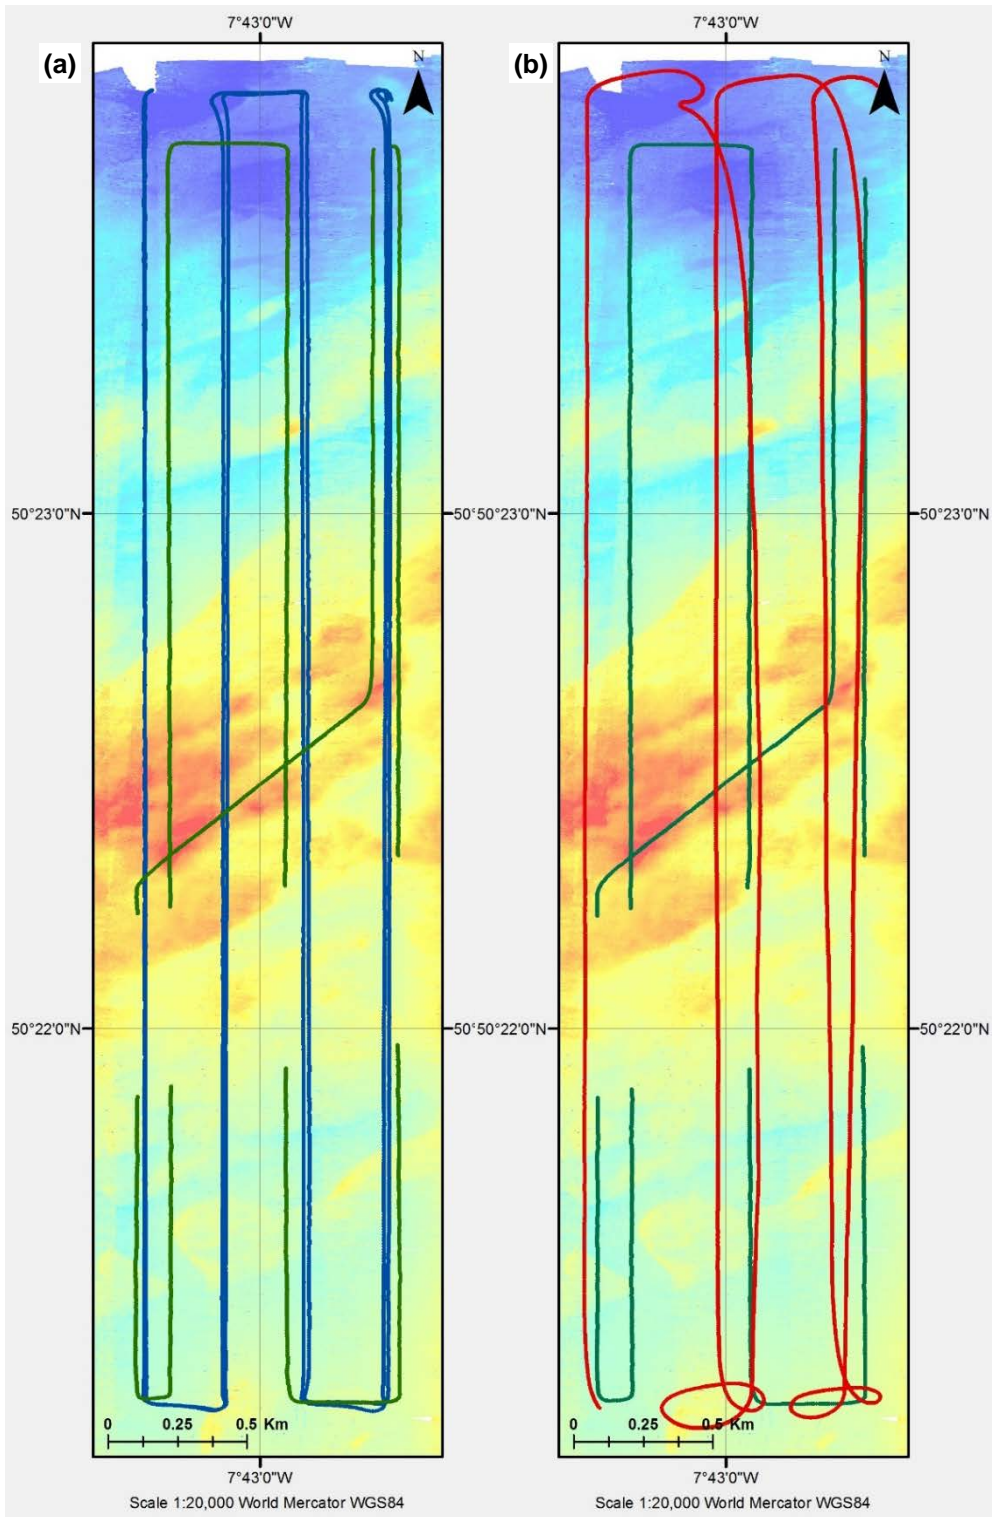
Fig. R.2. Track lines for Autosub6000. (a) Mission 143 dives 2, 4 (sidescan sonar backscatter, blue), and 5 (day-time photography, green). Note the absence of M143 dive 3 (night-time photography) track lines because no navigational data were recorded. (b) Mission 144 dives 1 (night-time photography, green) and 2 (bathymetry, red). Note the gaps on M143 and M144 photographic track lines correspond to the area surveyed around the seafloor telecommunication cable observed in 2012 and 2015 photographs. Track lines are overlaid on ship-based multibeam swath bathymetry map from previous JC124 cruise.

Issues with M143 AUV raw data logger. Day vs. night-time photographic surveys were planned to occur during mission 143. However, both the ADCP and the AESA camera system raw data logger sensors failed to record navigational data during mission 143 dive 3 (i.e. night-time). In addition, the AESA camera systems stopped recording photographs before the end of the survey track (i.e. at 01:52 GMT). For this reason, a second night-time photographic survey was programmed during mission 144 c. 48 h later.

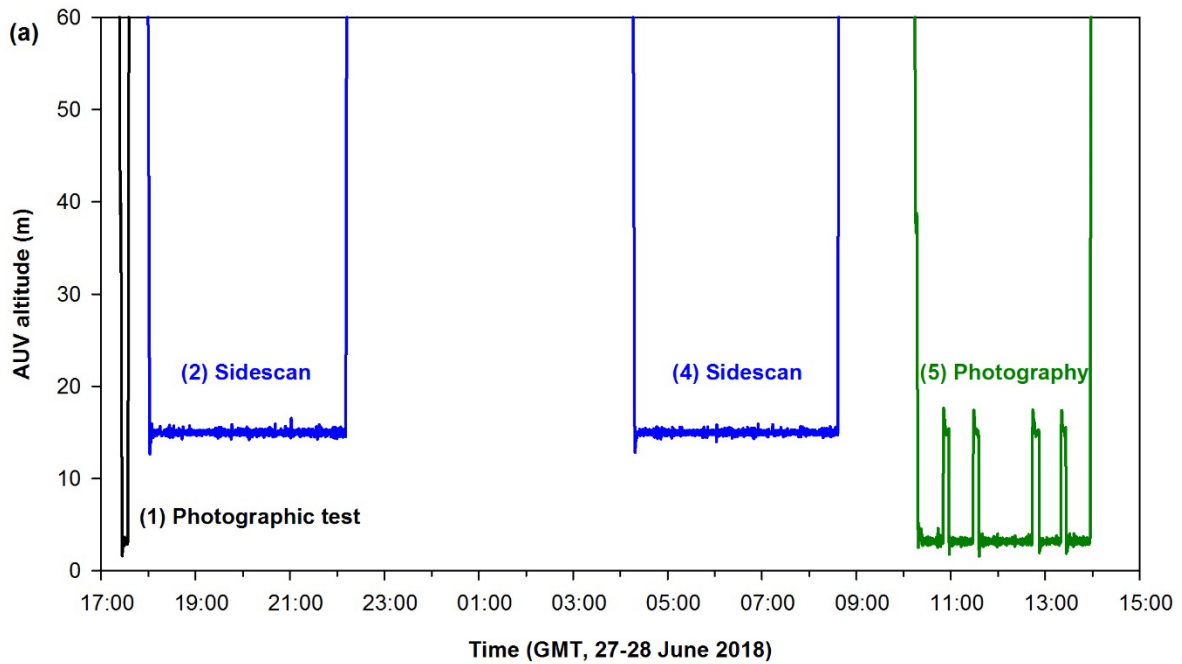
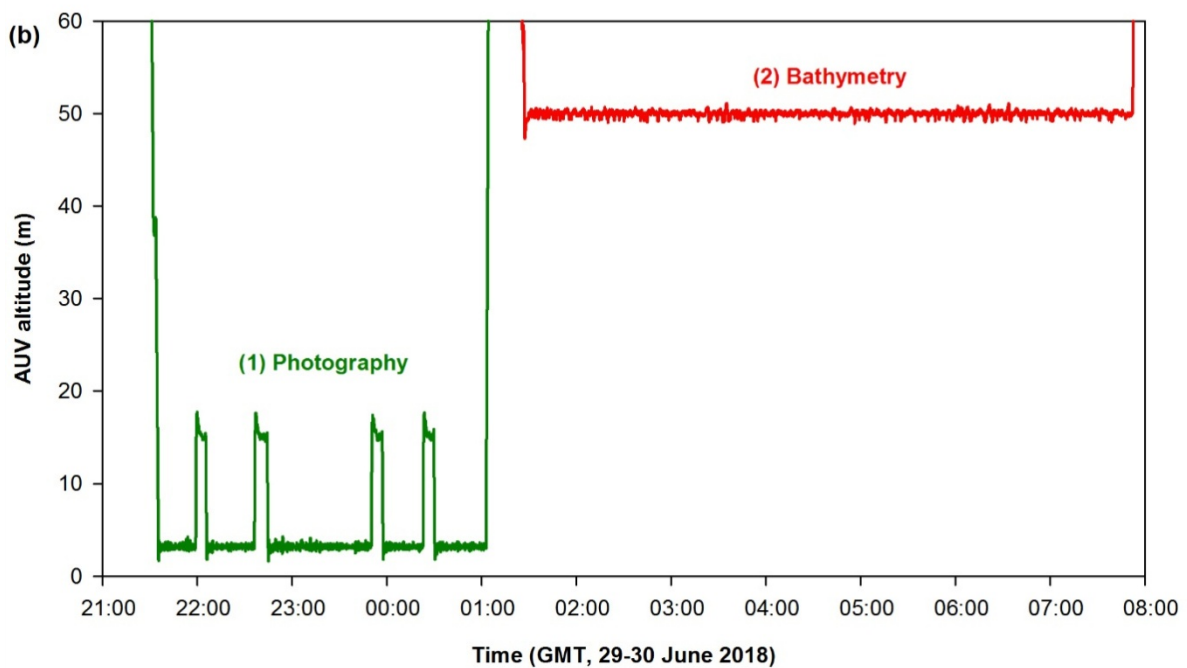
Fig. R.3. Dive profiles for Autosub6000 as vehicle altitude against time. (a) Mission 143 (dives 1, 2, 4, 5). Note the absence of M143 dive 3 (night-time photography) profile because no navigational data were recorded. (b) Mission 144 (dives 1-2). Note the four peaks on the photographic profiles (M143 dive 5, M144 dive 2) at c. 15 m altitude correspond to the area surveyed around the seafloor telecommunication cable observed in 2012 and 2015 photographs.

For the sidescan sonar surveys (M143 dives 2 and 4), *Autosub6000* was flying at c. 15 m above the seabed and followed five c. 4.7 km transect lines separated by c. 180 m resulting in a total area mapped of c. 3.9 km² (Figs. R.2a, R.3a, R.4). Very little difference can be observed between the c. 24h-spaced sidescan sonar backscatter survey maps. In general terms, the sidescan data shows alternating bands of higher and lower backscatter having a broadly similar southwest to northeast trend that may be interpreted as changes from coarser mixed sediments (high backscatter) to finer more homogeneous sediments (low backscatter). Finer-scale details are apparent on close inspection of these data, particularly areas of sinusoidal striations on the central high region that correspond to outcropping rock strata (also observed in AUV photographs; Benoist et al. revised submission May 2018).

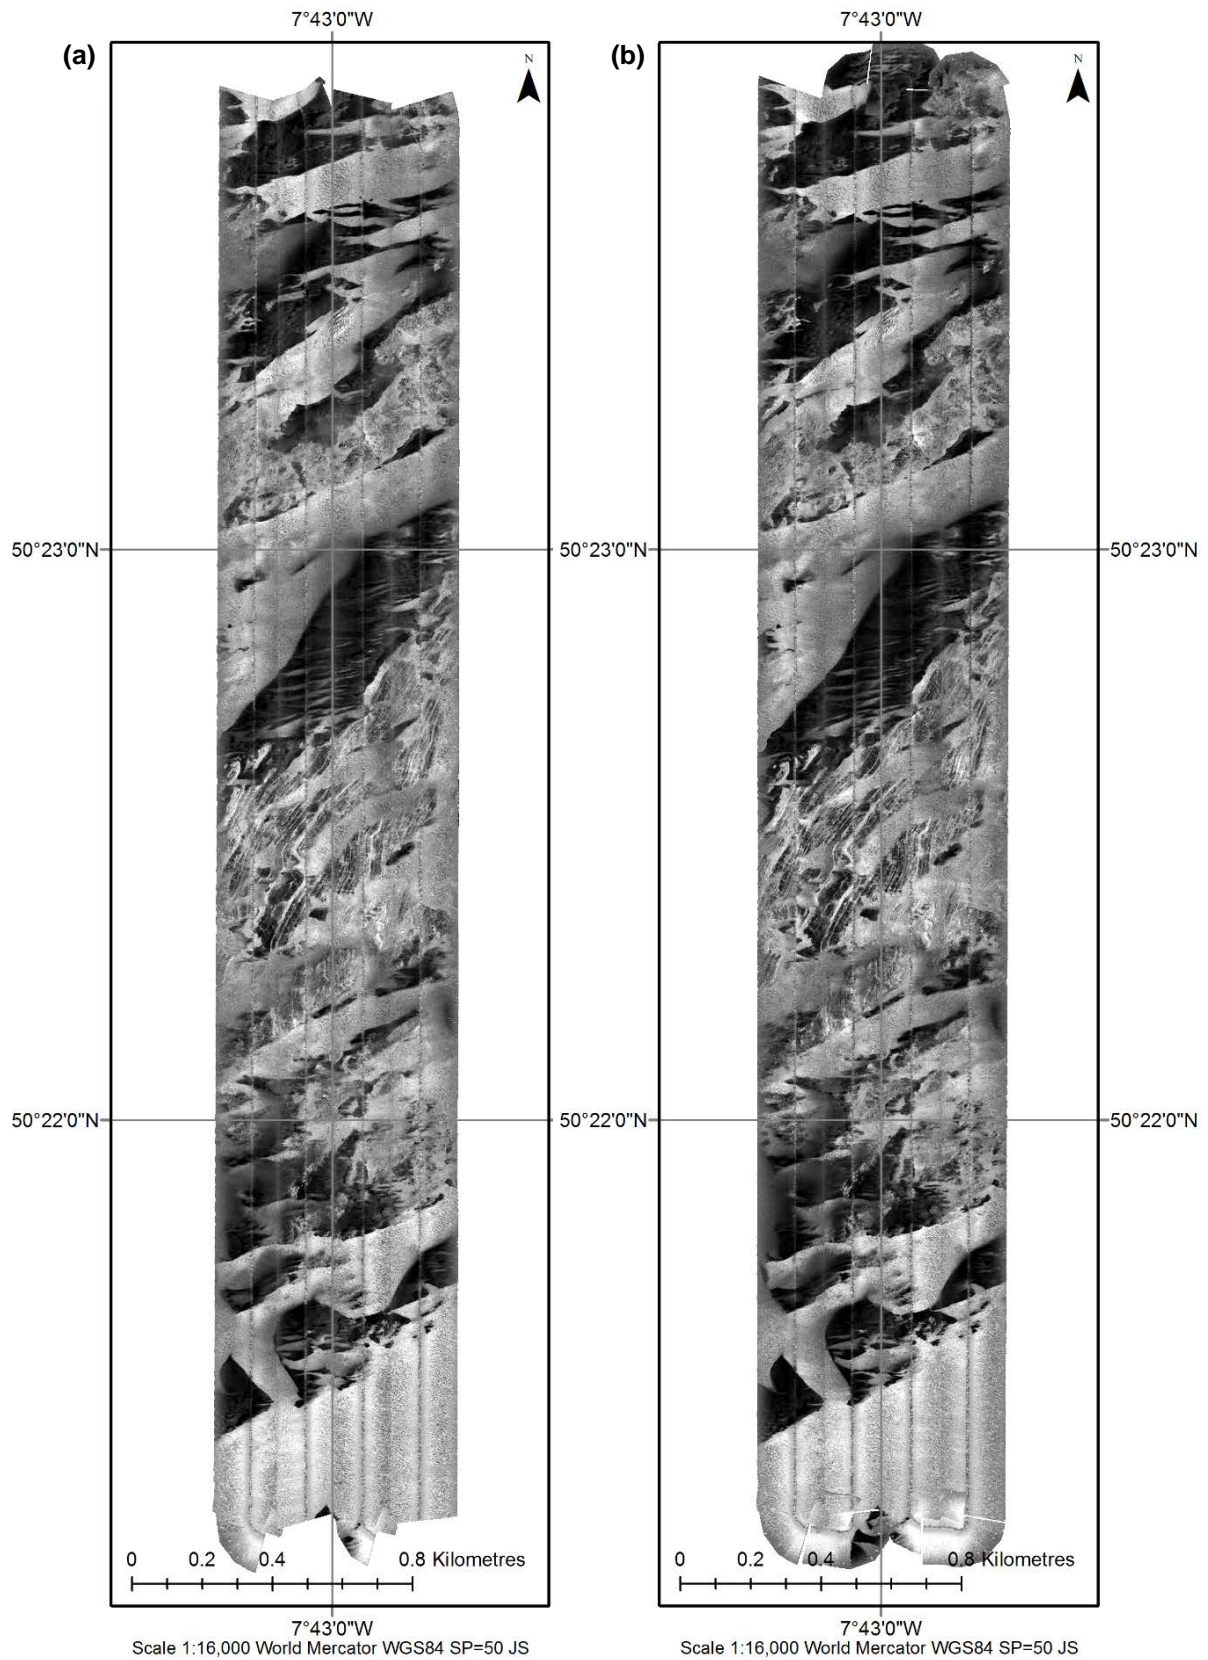
Fig. R.4. Autosub6000 mission 143 (a) dive 2 and (b) dive 4 sidescan sonar backscatter. (High backscatter, light; low backscatter, dark).

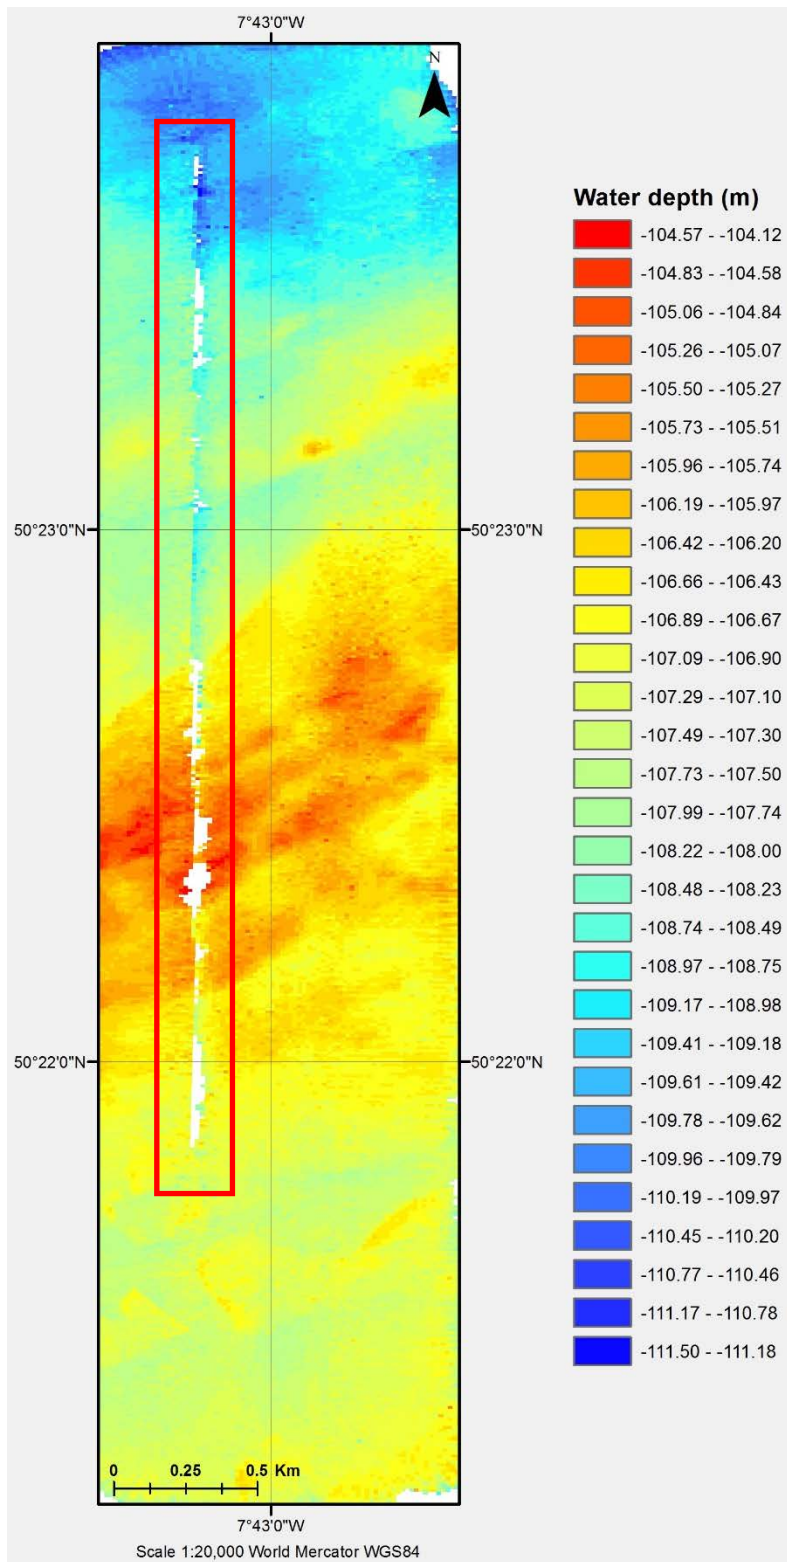
Fig. R.5. Autosub6000 mission 144 dive 2 multibeam swath bathymetry map. (Red box indicates area of missing data caused by non-overlapping survey tracks; see Fig. Haig_Fras_3.)

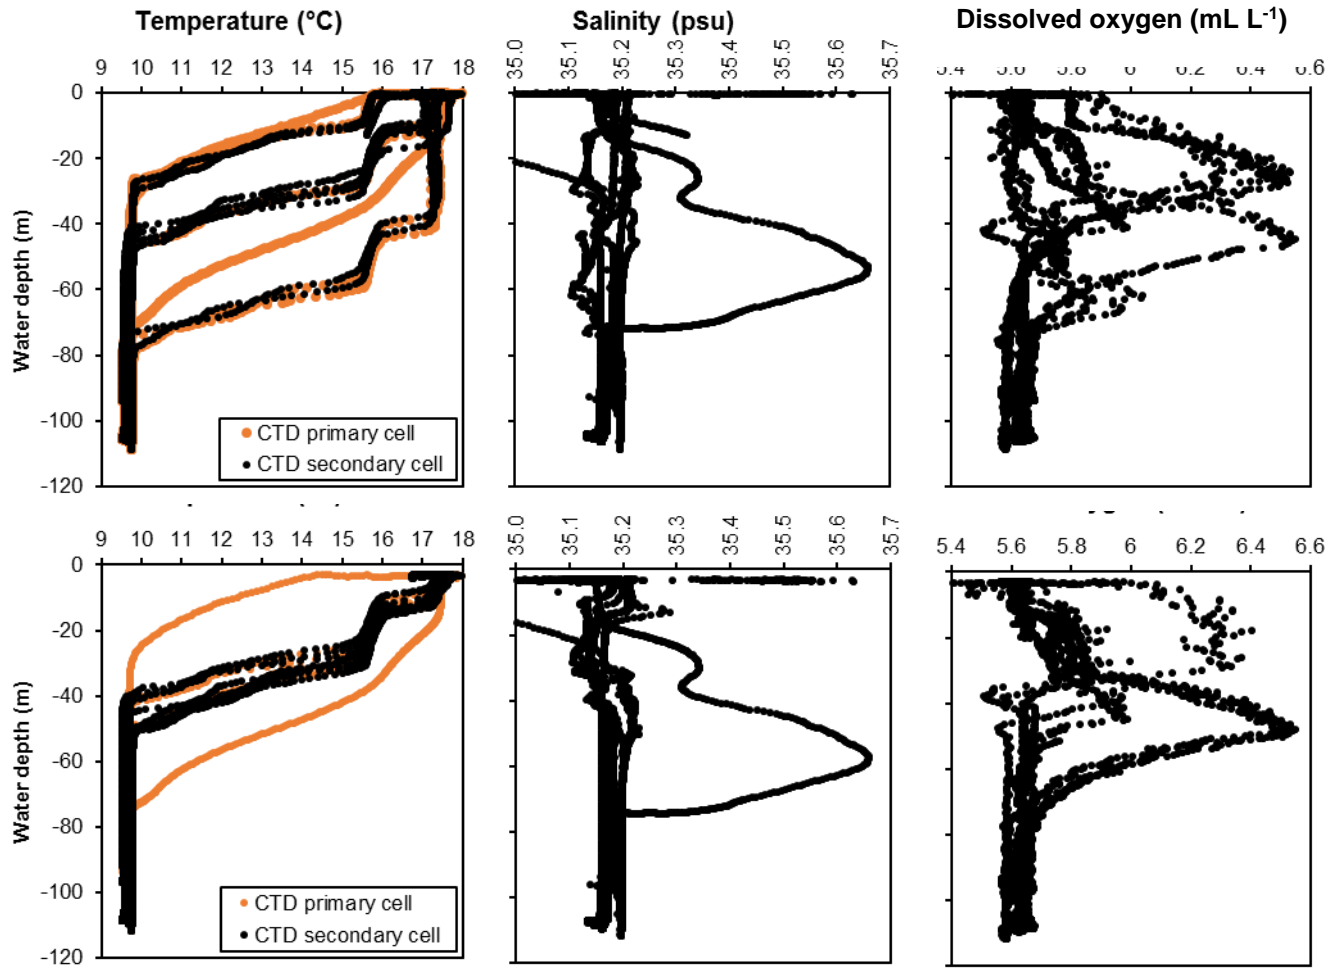
Fig. R.6a. Autosub6000 mission 143 dives 1-5 water column profiles of CTD instrument data – temperature (°C; left), salinity (psu; centre), dissolved oxygen (mL L⁻¹; right). Water depth (m) as determined by the AUV internal depth sensor (top pane) and by the CTD instrument (bottom panel).

Physical oceanographic information on the over-lying water column was acquired with CTD instruments during missions 143 and 144 (Fig. R.6,b). Data processed on board of the ship indicated the presence of potential problems in field data acquisition and processing using the CTD Seabird software on *Autosub6000*. Error checks revealed two main issues: (1) difference between the two CTD temperature sensors (i.e. primary cell, t090C, secondary cell, t190C); (2) time delay between the CTD cell sensors data and the AUV internal depth sensor data that appears to be causing the apparent hysteresis visible in Fig. R.5. Note this delay only occurred in mission 143 before the first AUV data logger problem occurred (i.e. dives 1, 2), which may be related to the initial start time input into the Seabird processing software.

For missions 143 and 144, according to the temperature data generated from the CTD secondary cell, a strong thermocline is apparent between 30 and 50 m water depth with c. 10 m variance in its location that may be caused by both temporal and spatial variations (Fig. R.6a, b bottom pane). For mission 143 and 144, salinity (as calculated by the CTD software based on the primary cell) and dissolved oxygen profiles exhibit artefacts that are a result of sensor calibration, and noise in the data is apparent at c. 20 m water depth (Fig. R.6,b). CTD data should be further processed and investigated once back at NOC.

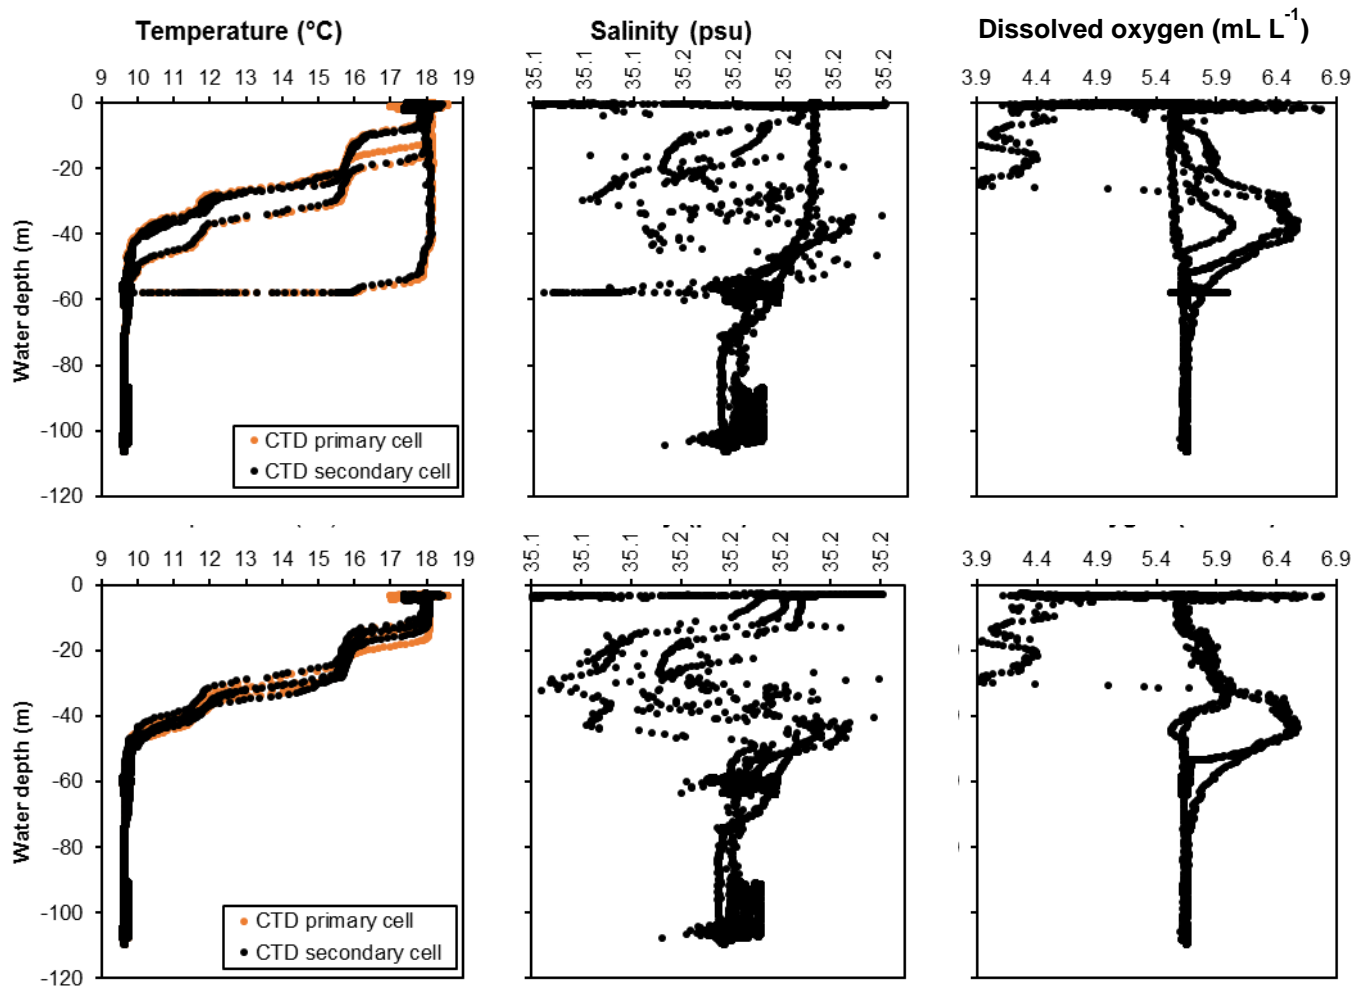
Fig. R.6b. Autosub6000 mission 144 dives 1-2 water column profiles of CTD instrument data – temperature (°C; left), salinity (psu; centre), dissolved oxygen (mL L⁻¹; right). Water depth (m) as determined by the AUV internal depth sensor (top pane) and by the CTD instrument (bottom pane).

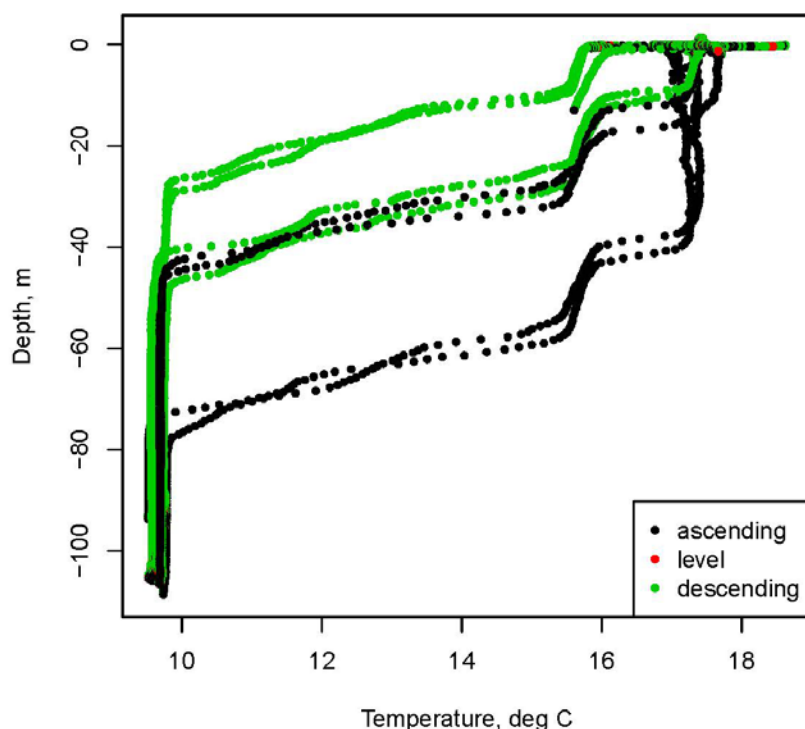
Fig. R.6c. Autosub6000 mission 143 dives 1-5 water column profiles of CTD instrument data showing the differing temperature data for the AUV ascent and descent. Water depth (m) as determined by the AUV internal depth sensor.

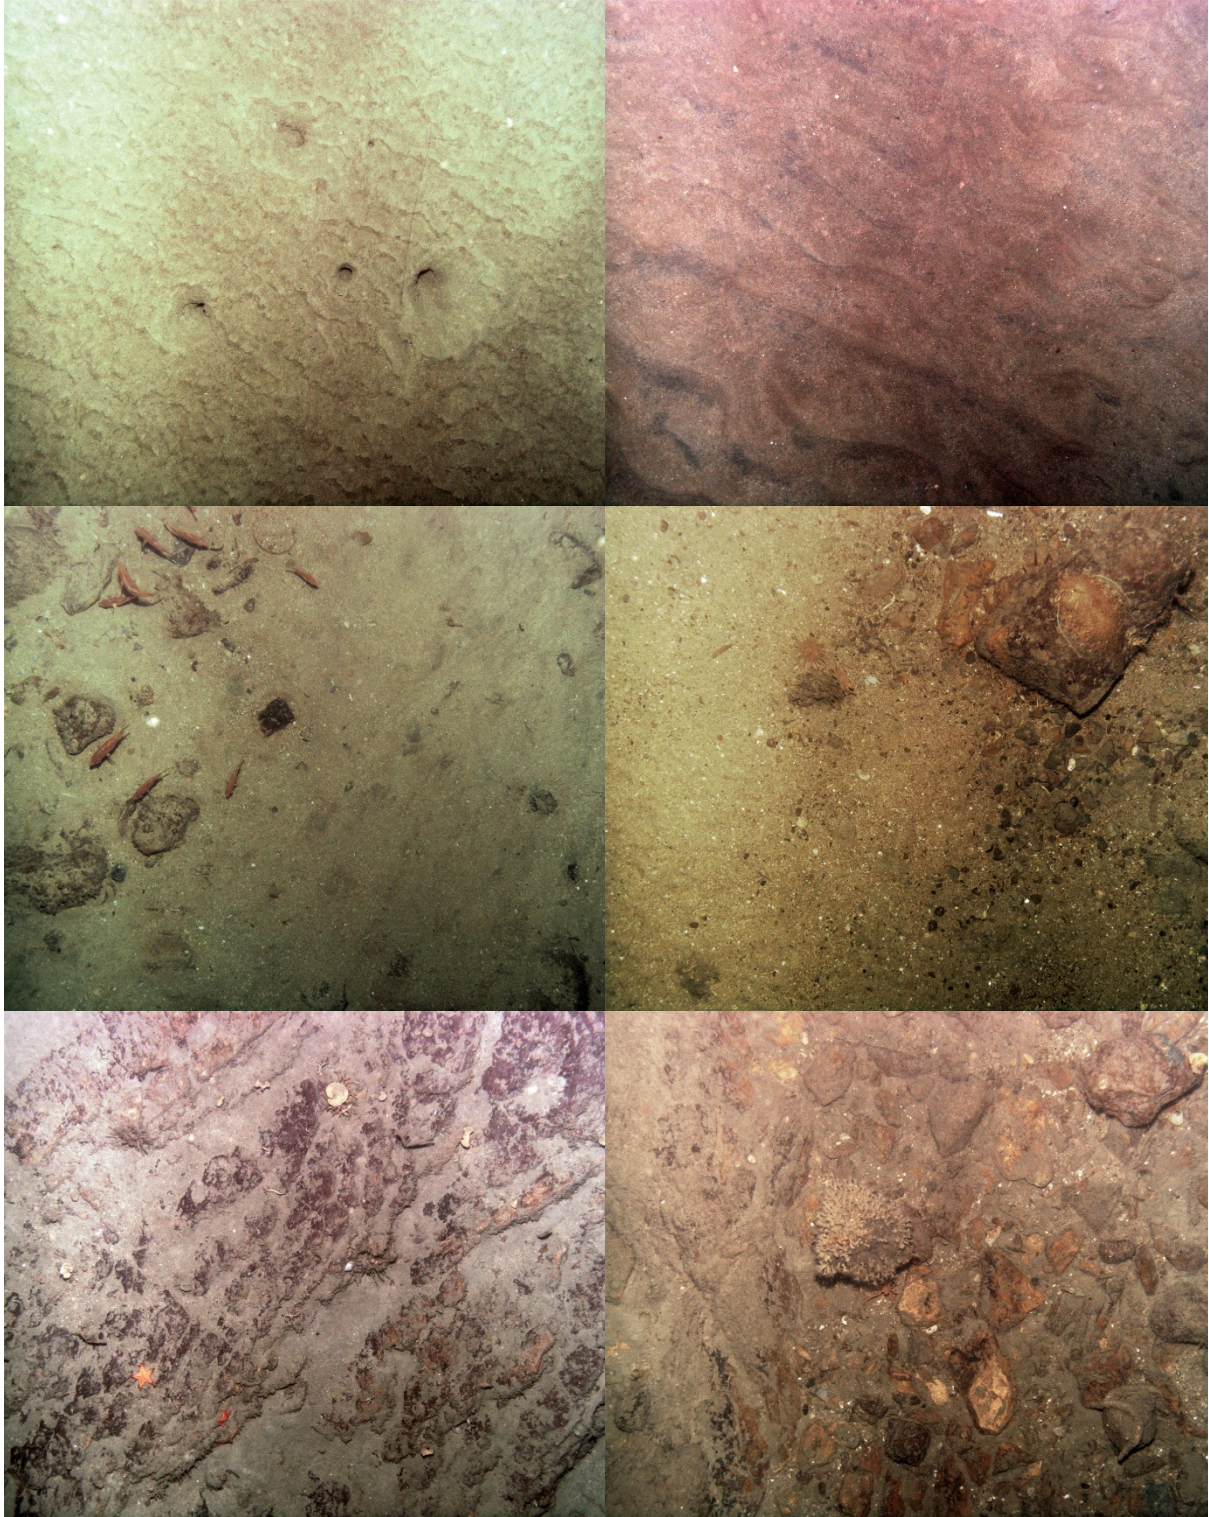
Fig. R.7. Selected examples of substratum types observed during Autosub6000 missions 143 and 144.

Visual classification of the seabed revealed the presence of mobile sediment, including fine sands to coarser sands with pebbles and cobbles (Fig. R.7 images 1-4) and hard substrata under the form of bedrock outcrop (5) and rocks to boulders of varying size (6). Across the survey area, several patches of hard substratum were observed embedded in the sediment, offering mosaic habitat types.

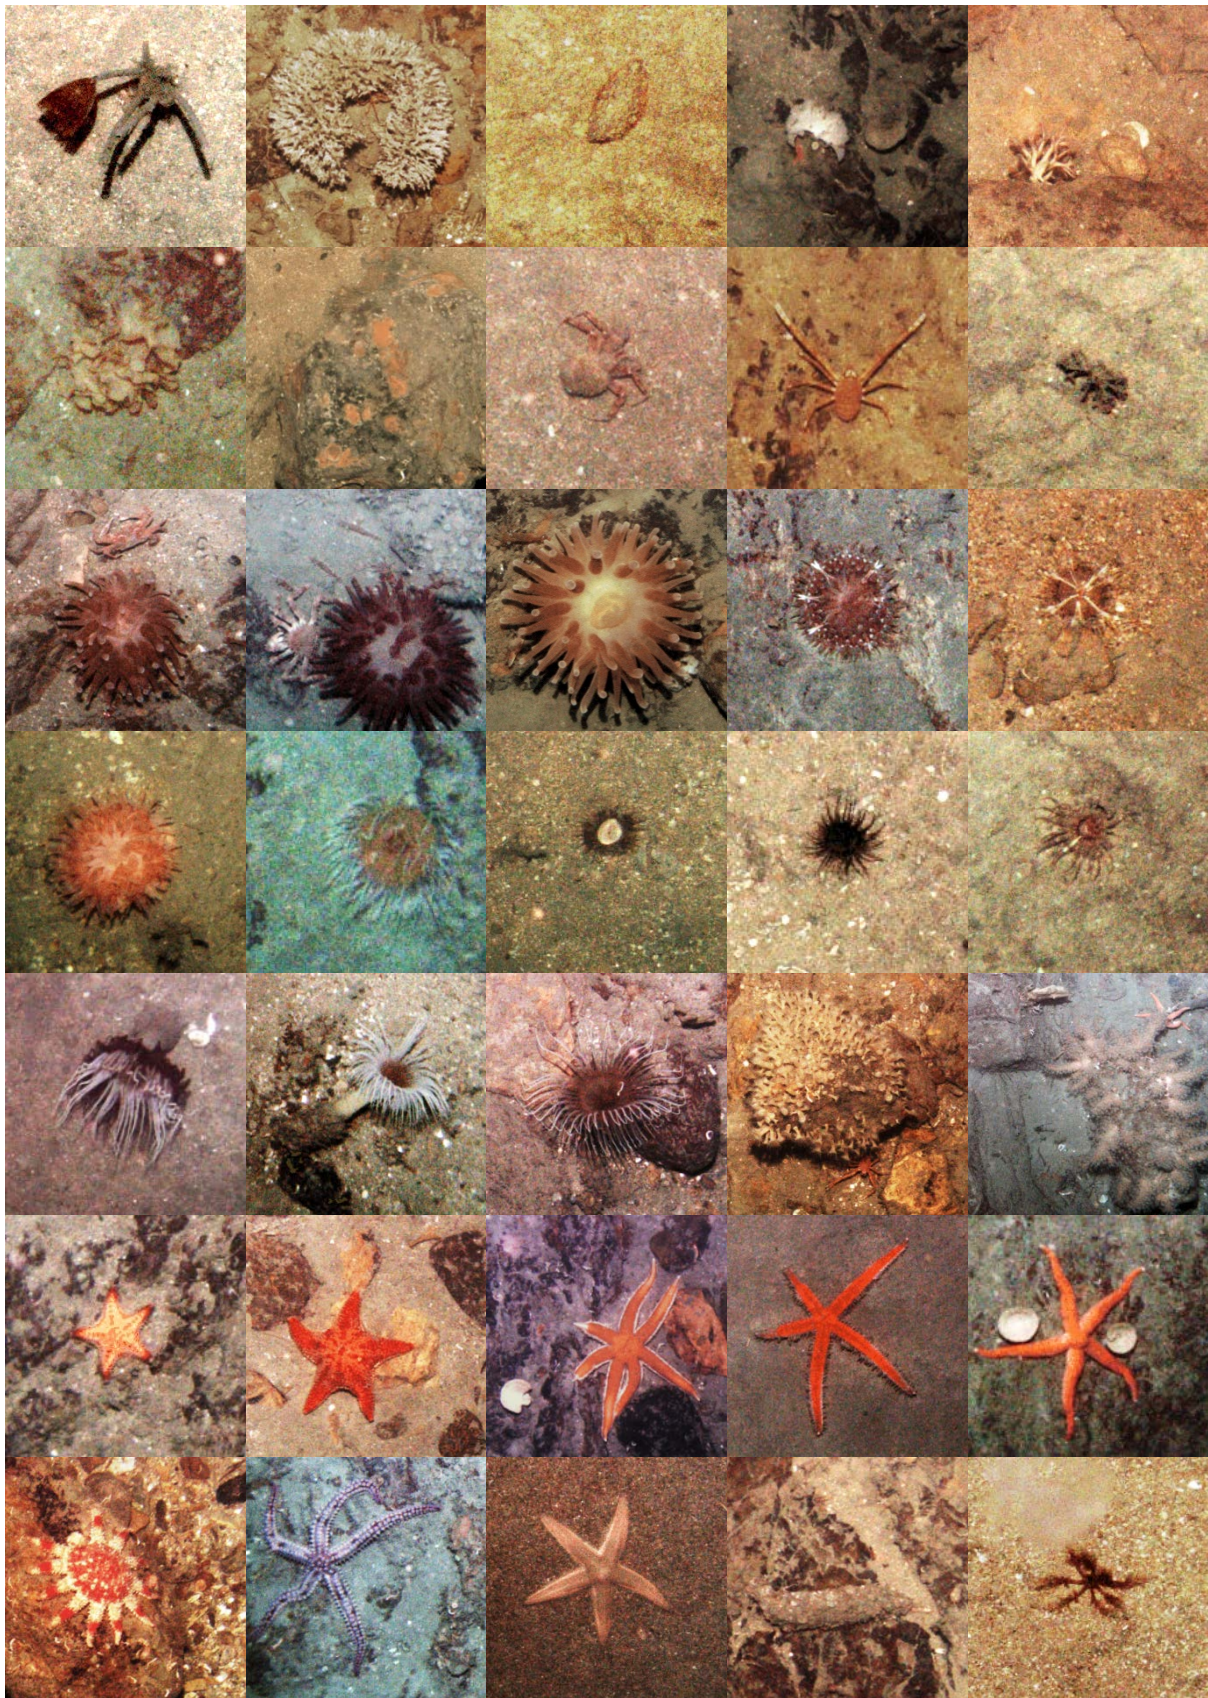
Fig. R.8 (1/2). Selected examples of the benthic invertebrates and demersal fish encountered during Autosub6000 missions 143 and 144.

The invertebrate megafauna comprised several species of annelids (Fig. R.8 images 1-3) including the 'coral worm' *Salmacina dysteri* (2); bryozoans (3-7) including the 'Ross coral' *Pentapora foliacea* (6); arthropods (8-12) including hermit crabs *Paguridae* spp. (8), squat lobsters *Munida* spp. (9), swimming crabs *Liocarcinus* spp. (11), and stone crabs *Lithodes maja* (image 12); anthozoans (anemones: Actinaria; Zoanthidea; Ceriantharia; images 13-24; soft corals: Alcyonacea; 25); asteroids (26-33) including *Porania pulvillus*, *Luidia ciliaris*, *Luidia sarsi*, *Stichastrella* sp., *Crossaster papposus*, *Marthasterias glacialis*, *Astropecten* sp.; holothuroids (34-35); ophiuroids (36-37) including *Ophiothrix fragilis*, *Ophiura* spp.; crinoids (38) including *Antedon* spp.; echinoids (39-40) including *Echinus esculentus*; octopus (41) including the curled octopus *Eledone cirrhosa*; bivalves (42-43) including the fan mussel *Atrina fragilis* (image 42); sponge (44-53) including *Polymastia* spp., *Suberites* spp., cup sponge, branching and encrusting sponge. Several species of demersal fishes were observed (54-64) including the small-spotted catshark *Scyliorhinus canicula*, rockling *Gaidropsarus vulgaris*, megrim *Lepidorhombus whiffiagonis*, and thickback sole *Microchirus variegatus* (25-30).
