**National Oceanography Centre
Cruise Report No. 56
RRS *James Cook* Cruise JC166-167**

19 JUNE – 6 JULY 2018

CLASS – Climate-linked Atlantic System Science
Haig Fras Marine Conservation Zone AUV habitat monitoring,
Equipment trials and staff training

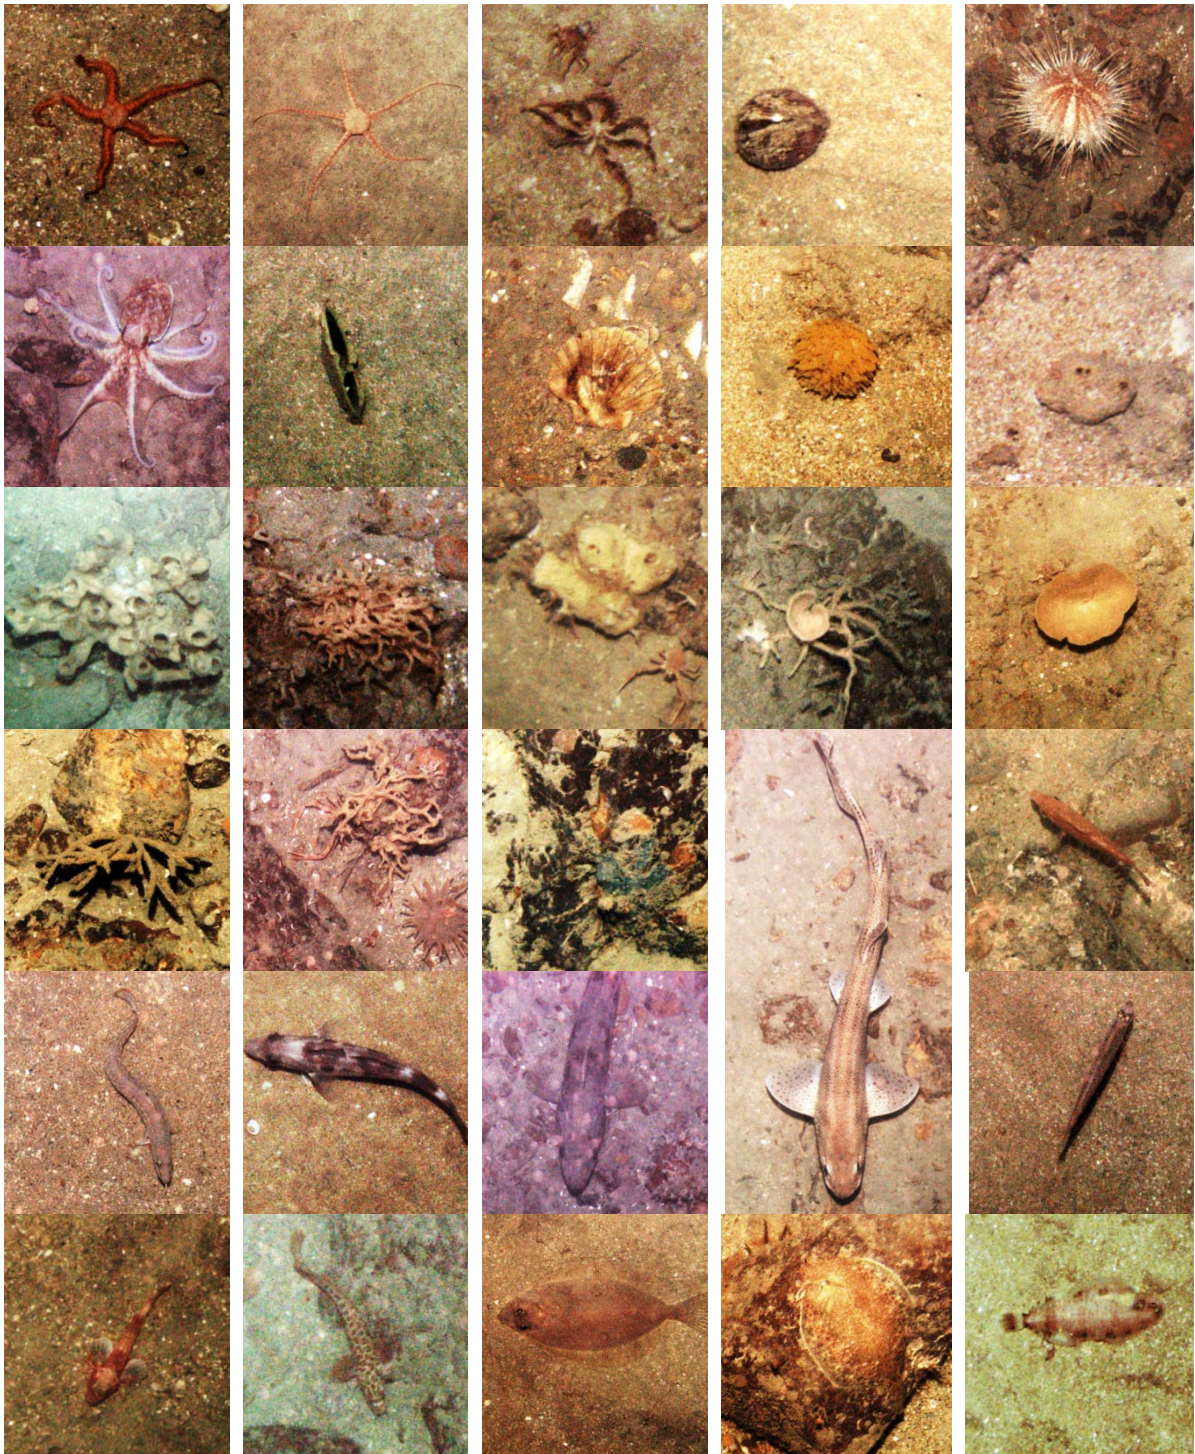
Fig. R.78(2/2). Selected examples of the benthic invertebrates and demersal fish encountered during Autosub6000 missions 143 and 144.

The invertebrate megafauna comprised several species of annelids (Fig. R.8 images 1-3) including the 'coral worm' *Salmacina dysteri* (2); bryozoans (3-7) including the 'Ross coral' *Pentapora foliacea* (6); arthropods (8-12) including hermit crabs *Paguridae* spp. (8), squat lobsters *Munida* spp. (9), swimming crabs *Liocarcinus* spp. (11), and stone crabs *Lithodes maja* (image 12); anthozoans (anemones: Actinaria; Zoanthidea; Ceriantharia; images 13-24; soft corals: Alcyonacea; 25); asteroids (26-33) including *Porania pulvillus*, *Luidia ciliaris*, *Luidia sarsi*, *Stichastrella* sp., *Crossaster papposus*, *Marthasterias glacialis*, *Astropecten* sp.; holothuroids (34-35); ophiuroids (36-37) including *Ophiothrix fragilis*, *Ophiura* spp.; crinoids (38) including *Antedon* spp.; echinoids (39-40) including *Echinus esculentus*; octopus (41) including the curled octopus *Eledone cirrhosa*; bivalves (42-43) including the fan mussel *Atrina fragilis* (image 42); sponge (44-53) including *Polymastia* spp., *Suberites* spp., cup sponge, branching and encrusting sponge. Several species of demersal fishes were observed (54-64) including the small-spotted catshark *Scyliorhinus canicula*, rockling *Gaidropsarus vulgaris*, megrim *Lepidorhombus whiffiagonis*, and thickback sole *Microchirus variegatus* (25-30).

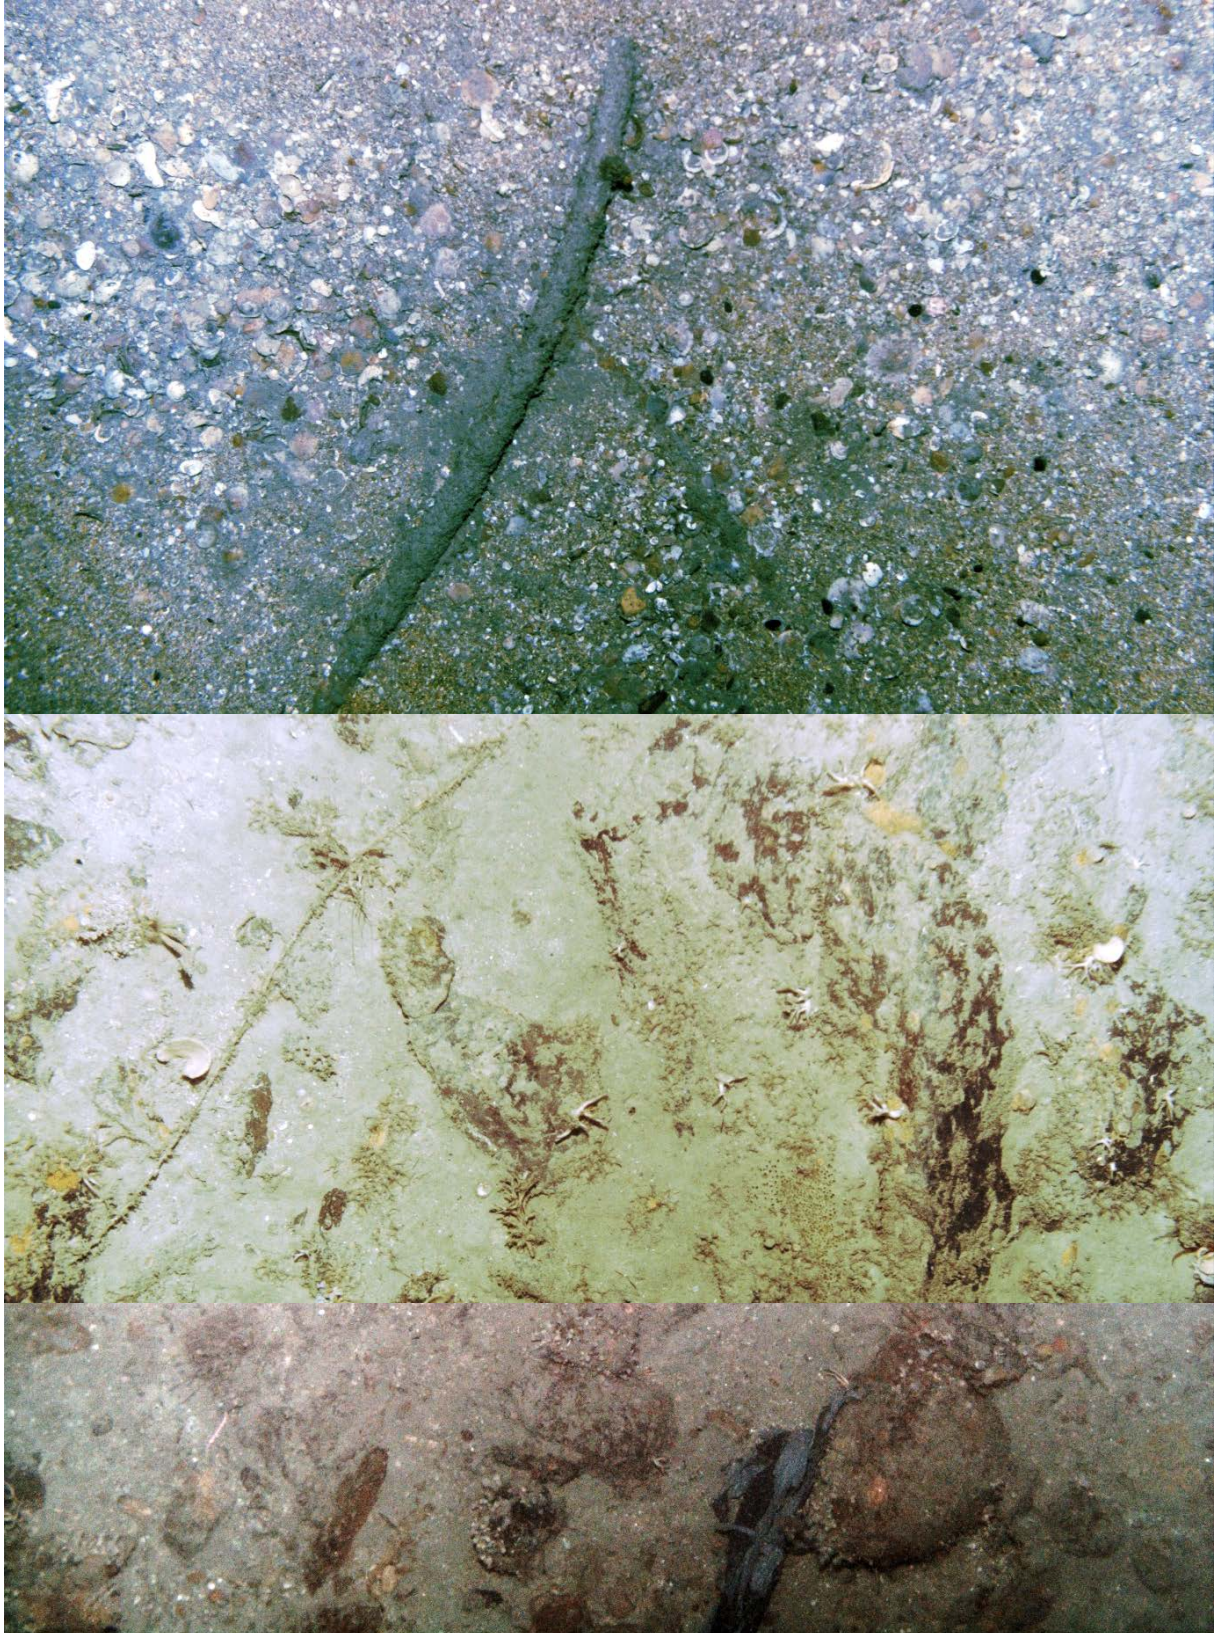
Fig. R.9. Selected examples of anthropogenic litter (fishing gear, plastic bag) encountered during Autosub6000 missions 143 and 144.

For initial study, the raw format images recorded were batch converted to jpeg images at 100% image quality and with automatic colour correction using IrfanView (V 4.33) software. Overall, seafloor photographs were of good quality for both substratum type characterisation and megafauna specimen identification. A minority of those photographs were somewhat degraded by particle backscatter in the near-bottom water (particularly >3.5 m AUV altitude); however, they are of good quality for seabed characterisation. Selected examples of the substratum types and benthic invertebrates and demersal fish encountered during *Autosub6000* mission 143 dive 5 (day-time) and mission 144 dive 1 (night-time) are shown in Fig. R.7 and R.8. Examples of anthropogenic litter are shown in Fig. R.9.

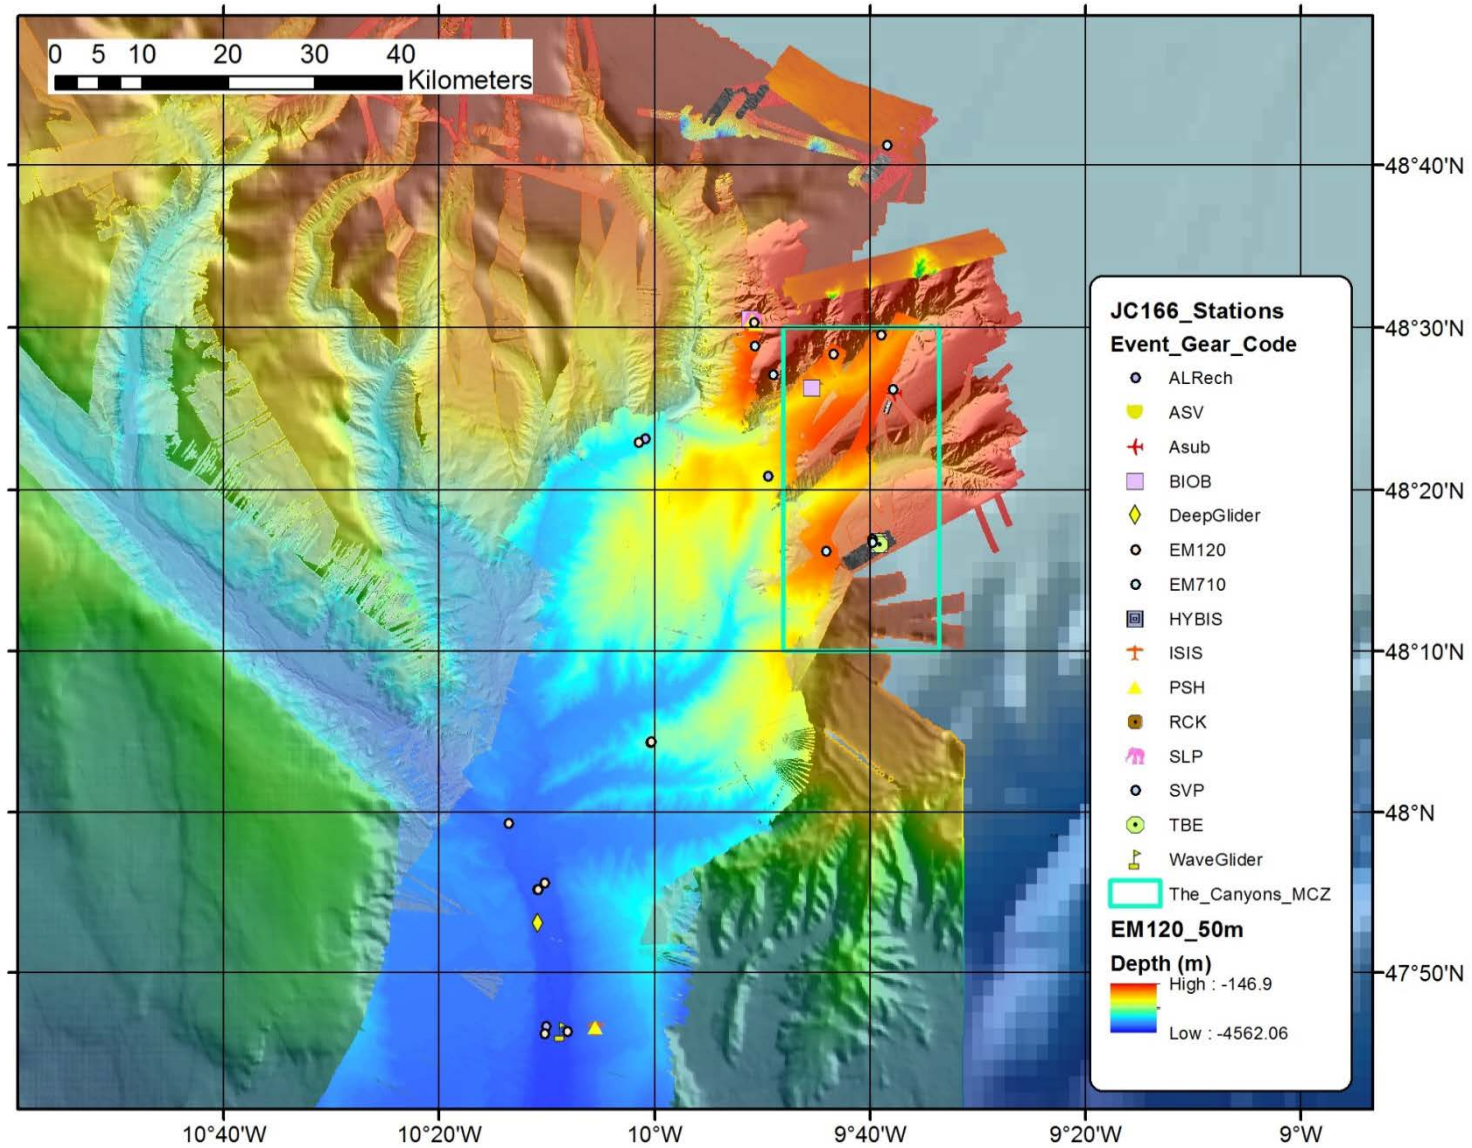
Overview of JC166 work in Whittard Canyon. New bathymetry data presented without hillshading:
