INSTITUTE OF GEOLOGICAL SCIENCES
MARINE GEOLOGY UNIT
Internal Report No. 80/13

Cruise Report 80/FE/09

"FERDER" DRILLING LEG 1

13.8.80 - 4.9.80

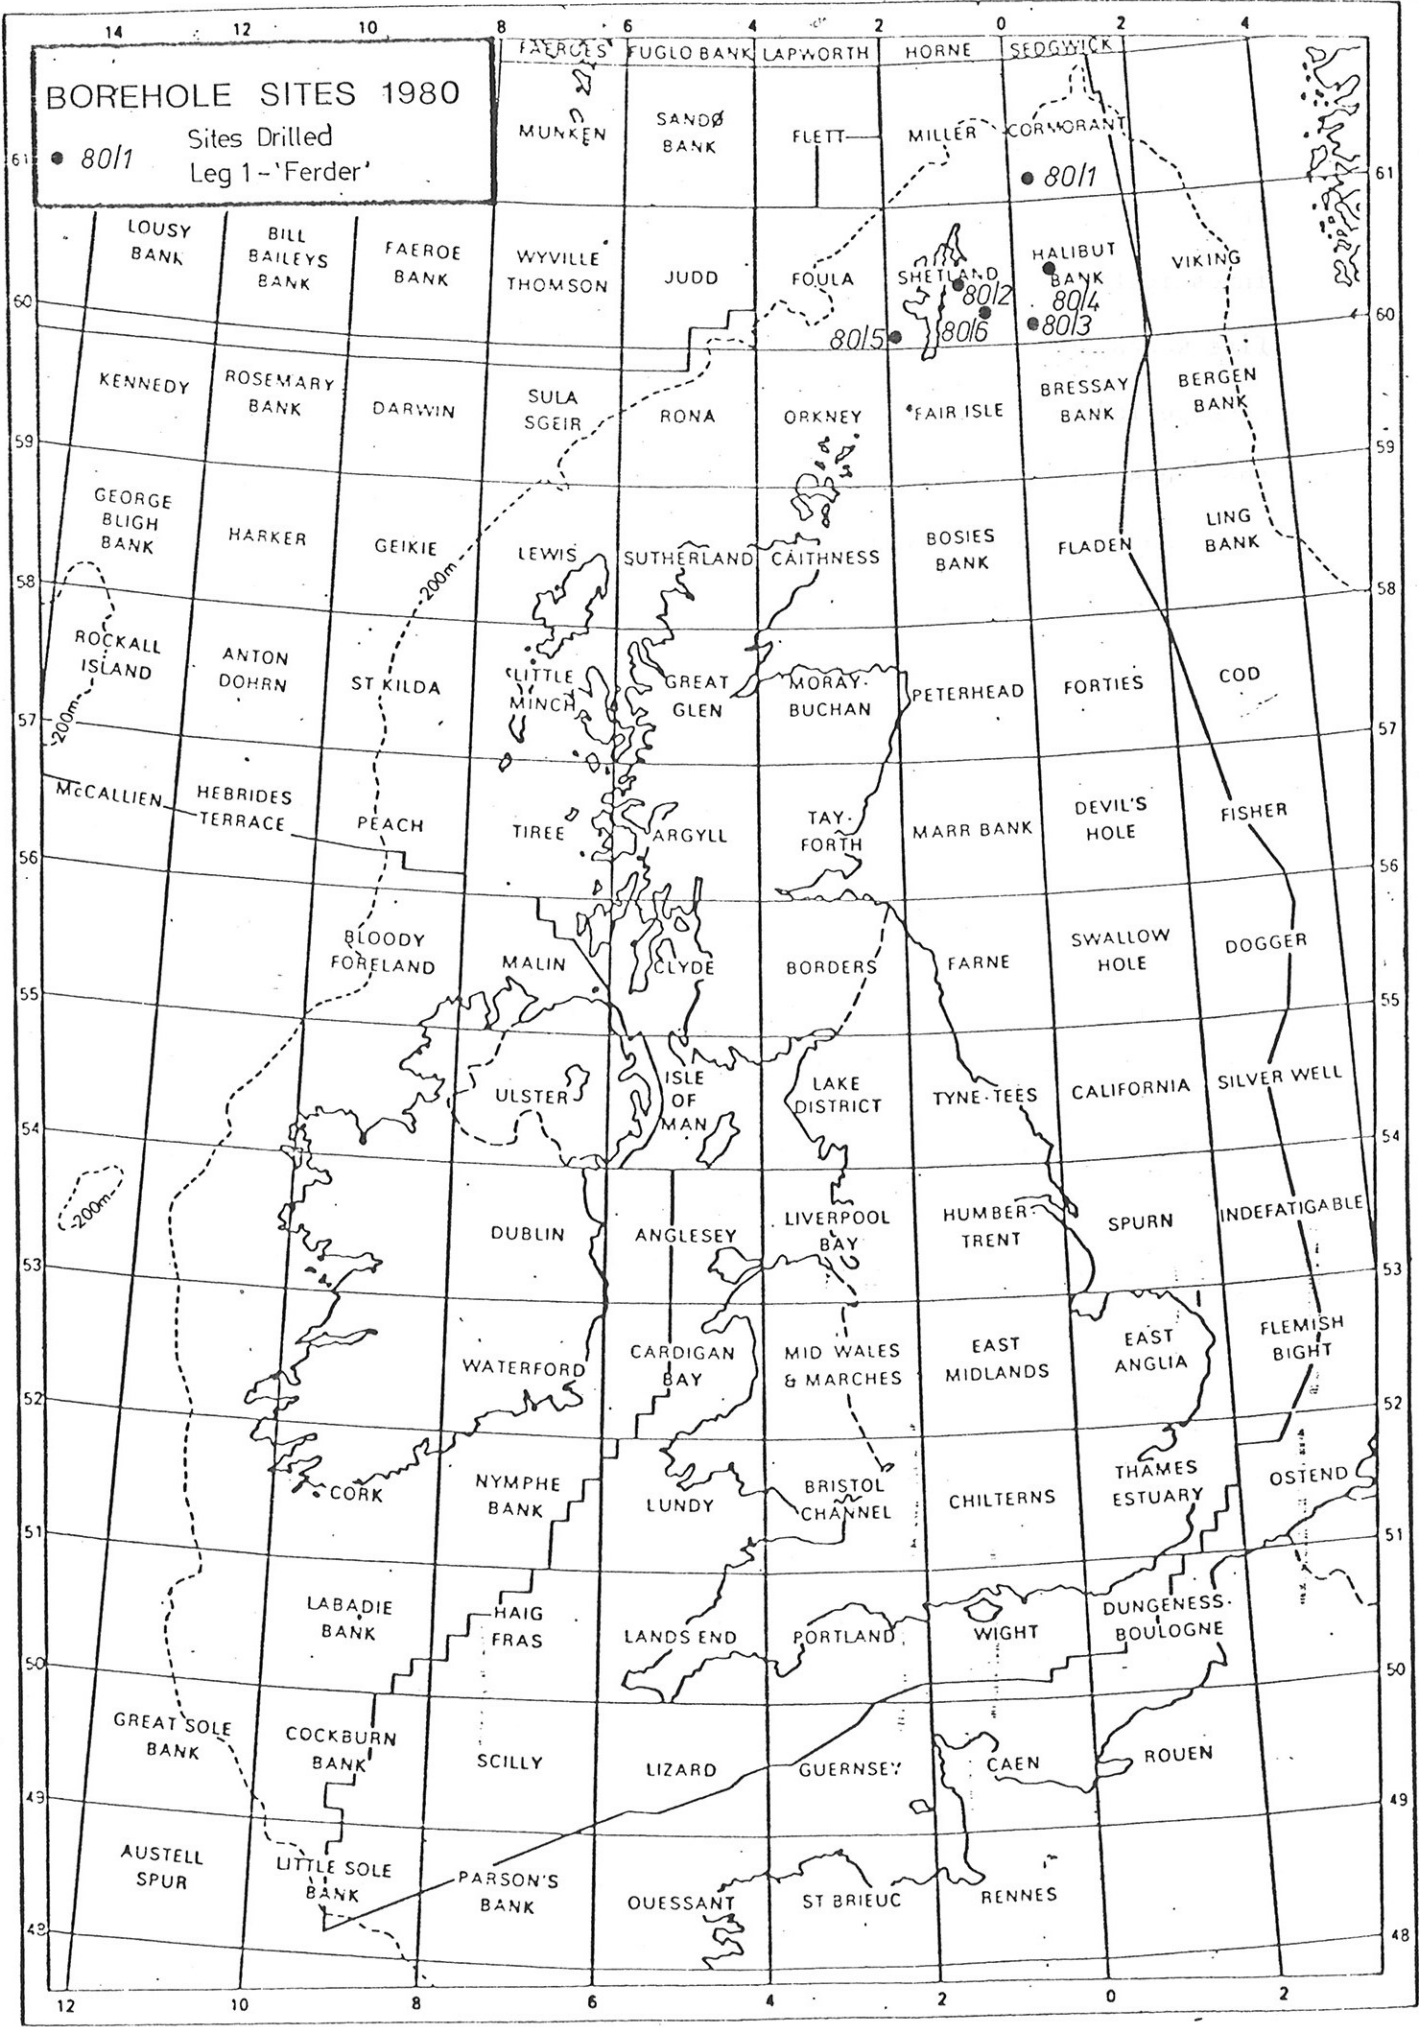
<u>Page</u>
BOREHOLE SITES 1980 (MAP)	1
INTRODUCTION	2
PERSONNEL	2
EQUIPMENT	2
SHIP PERFORMANCE	3
RESULTS	4
CONCLUSIONS	5
RECOMMENDATIONS	6
APPENDIX I - TABLE OF BOREHOLE DATA	8
APPENDIX II - TIME ANALYSIS	10
APPENDIX III - CAPTAIN'S LOG	14
