**RRS James Clarke Ross
Antarctic Peninsula and Weddell Sea
Geophysics and Physical Oceanography
February 1992 - March 1992**

Cruise JCRO 1
February to March 1992

Geophysics and Physical Oceanography
Antarctic Peninsula and Weddell Sea

B.A.S. Reference No. UK/I 99 1 /GP3

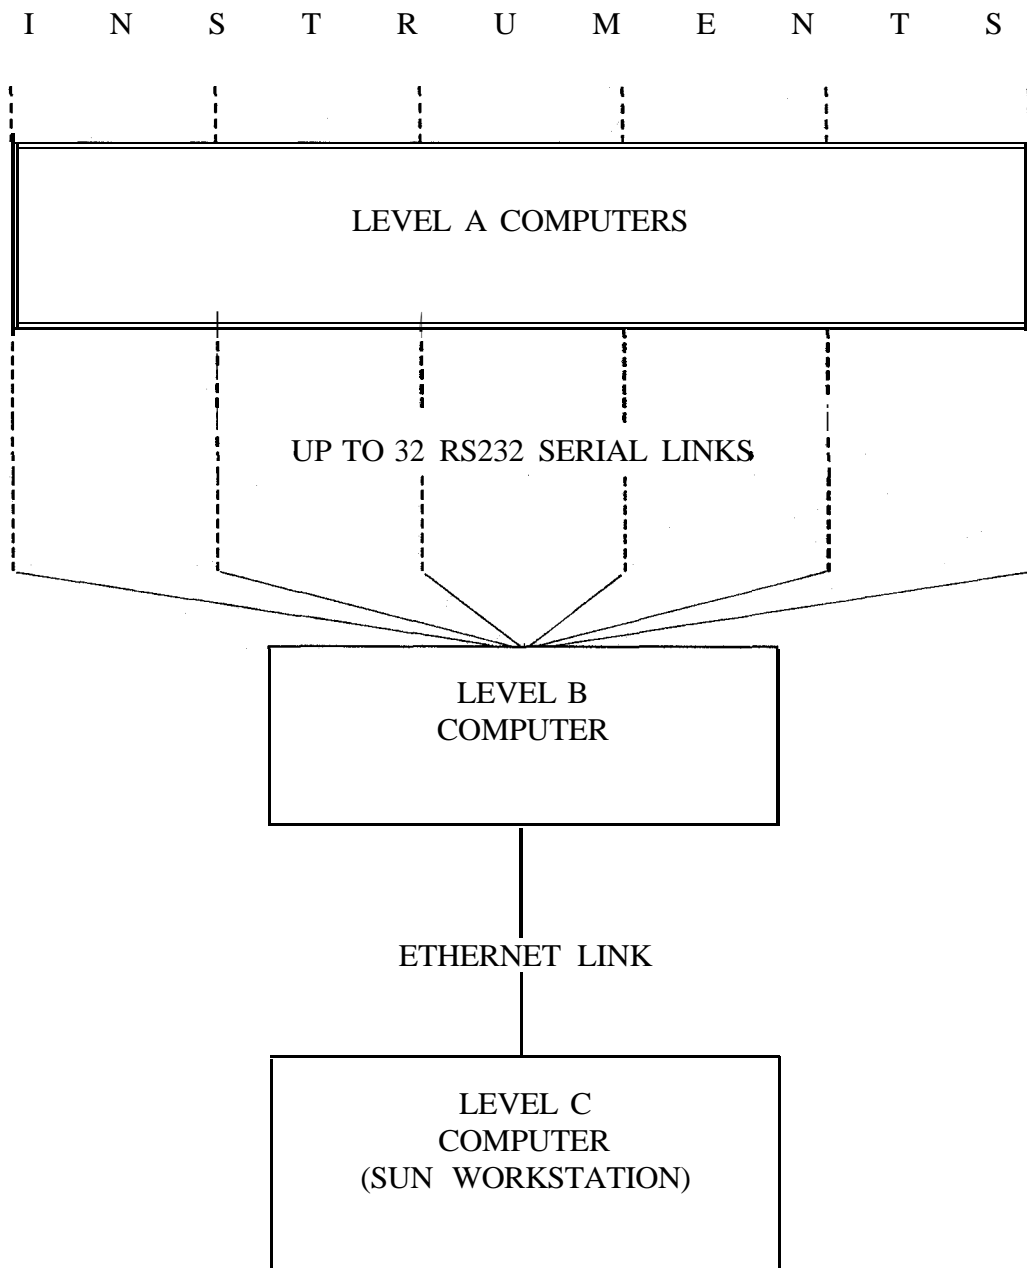
During the cruise the ABC data acquisition system was run almost continually to log data from various instruments on the ship. A block diagram of the structure of the system is shown below:

The Level A and Level B computers were specially constructed for use in the data acquisition system. Level A machines are based around a Motorola 68000 processor

and are used to acquire data directly from individual instruments, the data are then checked and converted into a standard format for transmission to the Level B archiving computer via RS232 serial links.
