**RRS 'James Clark Ross'
Voyage 1**

**ACCLAIM: Sea level measurements in the
Scotia Sea and Drake Passage**

Cruise Report No. 14

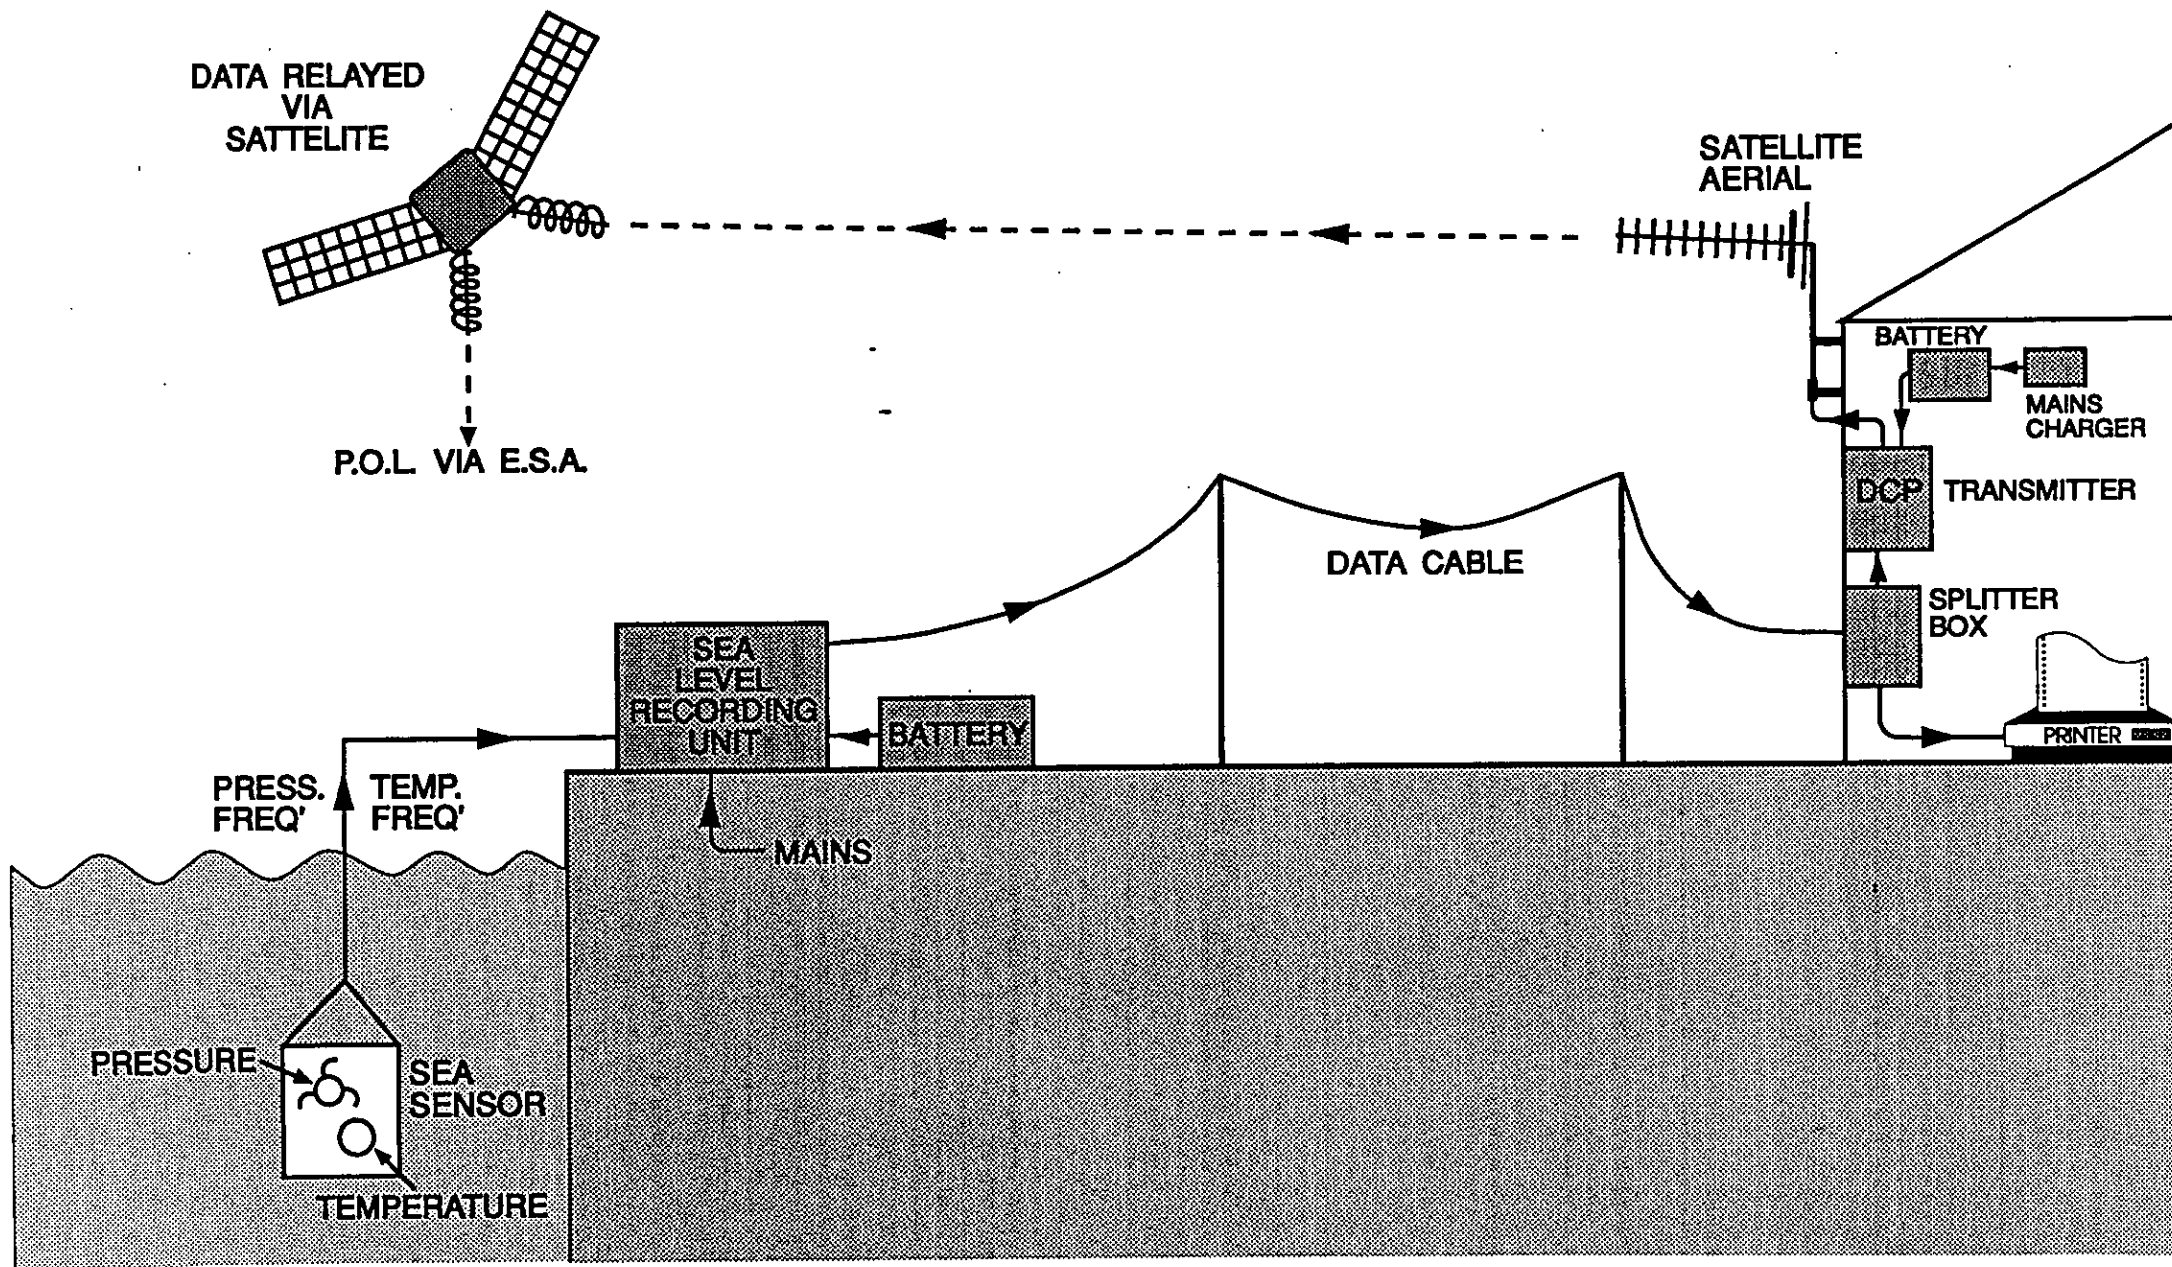
BLOCK DIAGRAM - REMOTE SLR INSTALLATION

Figure 2: Layout of SLR installation
