RRS DISCOVERY CRUISE 111 LEG 2

8 JULY - 30 JULY 1980

GEOPHYSICAL STUDIES OF THE CONTINENTAL MARGIN AROUND THE GRAND BANKS

CRUISE REPORT NO 104 1980

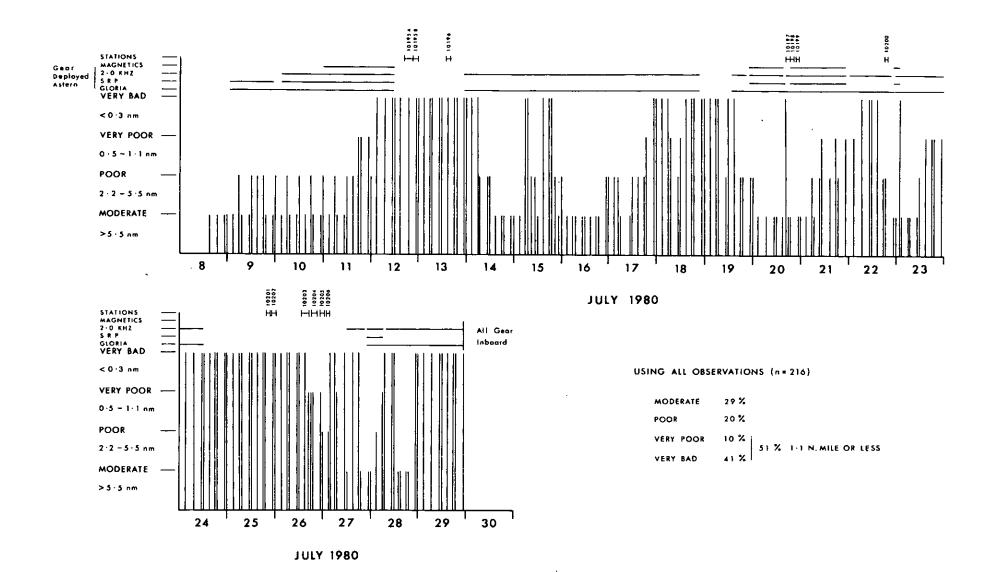
The cruise was bedevilled by thick fog throughout. The graph (Figure 2) shows that visibility was less than O.lnm for 55% of the cruise and that periods of good visibility were brief. conditions, the scientific work had to be restricted. Although it was possible to tow GLORIA, speeds had to be kept to 5 kts and to avoid restricting the manoeuvrability of the ship, no multichannel profiling could be done. It was not possible to work elsewhere as on occasion the fog bank extended from Newfoundland to New York and for 750 miles eastward into the Atlantic. That some scientific work was carried out was due entirely to the dedication of the Master who remained on the bridge for about twenty-one days. It is a personal pleasure for me to record my thanks to the Master and the officers for their efforts in these trying conditions and by no means least to the scientific party for their hard work despite frustrating circumstances. I also wish to thank Dr. Longhurst, Director of Bedford Institute, Dr. R. Howarth and Dr. A.C. Grant of the Atlantic Geoscience Center for their help and hospitality at Bedford Institute.

Air temperatures, both dry and wet bulb, agreed to 0.4°C or less. The dry and wet bulb readings were frequently the same, as about 50% of the cruise was spent in fog, with a horizontal visibility of one nautical mile or less, frequently much less. The range of dry bulb temperatures was from 9.2°C to 22.3°C.
