Cruise Report No. 18

RRS *James Cook* Cruise JC009T

01 MAY - 11 MAY 2007

Trials of the Isis Remotely Operated Vehicle

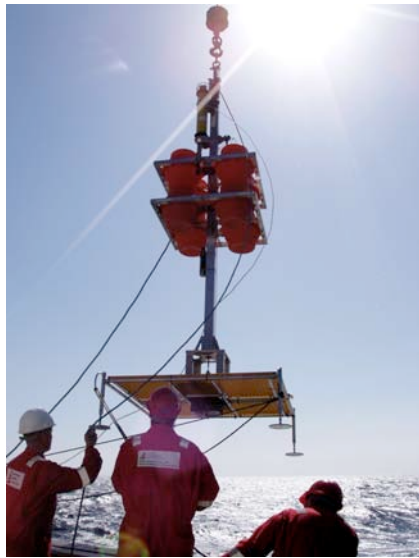
Figure 1(a) 8-sphere elevator being launched, (b) floating, showing water level nearly midway up the upper floats.

At 0900Z the ship arrived at the designated trial site, in ~118m of water at 49° 20'N 6° 25'W. The first task was a trial deployment of the new 8-sphere elevator (Figure 1a). At 0923Z the elevator was deployed by crane over the stern, tethered to the crane, to check the floatation level (Figure 1b) when the elevator was loaded with 45kg ballast representing the expected maximum working payload. The water level was not quite half-way up the upper hardhats. To help minimise potential damage to the

ship's workboat should the elevator be recovered by the boat, a fender could and should be fitted to the upper aluminium square frame (arrowed in Figure 2b).

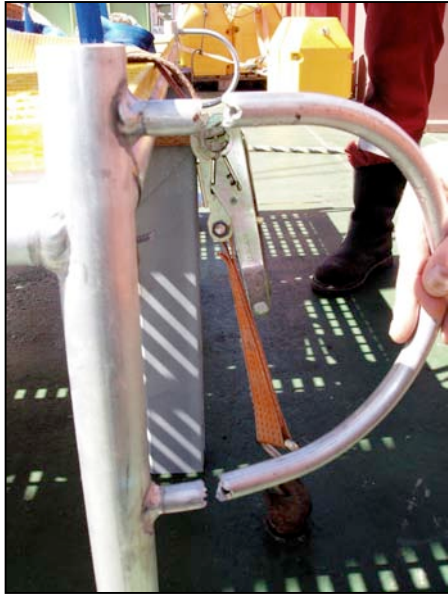
Figure 3 Broken 'grab' on the elevator after impact with the side of the ship.

The elevator surfaced near the ship, and was quickly recovered, however one of the 'grab' brackets of aluminium tubing fractured at the top and bottom drain holes on impact with the side of the ship (Figure 3). Such impact is almost inevitable.

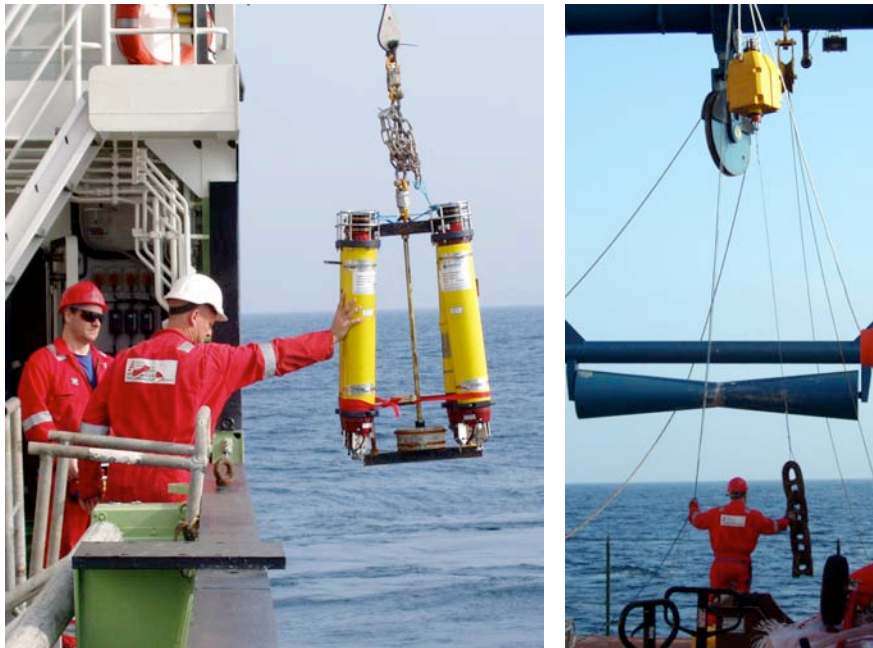
Figure 6 (a) Deployment of four Compatts on a weighted frame to enable mode change, (b) deployment of a Compatt transponder mooring. The Compatt is within the yellow buoyancy block in the upper part of the picture, and the anchor (three and a half chain links) is being held.

The ship moved under DP to the position for the deployment of No.105 and its anchor was released shortly after 1857Z. This unit behaved splendidly, giving telemetry and tracking from the outset all the way to the bottom. This enabled its descent rate to be estimated (Figure 7), averaging $3.16 \pm 0.06\text{m/s}$. This was with an anchor of ~91kg chain (weight in water) and 46kg of buoyancy (Figure 6b).

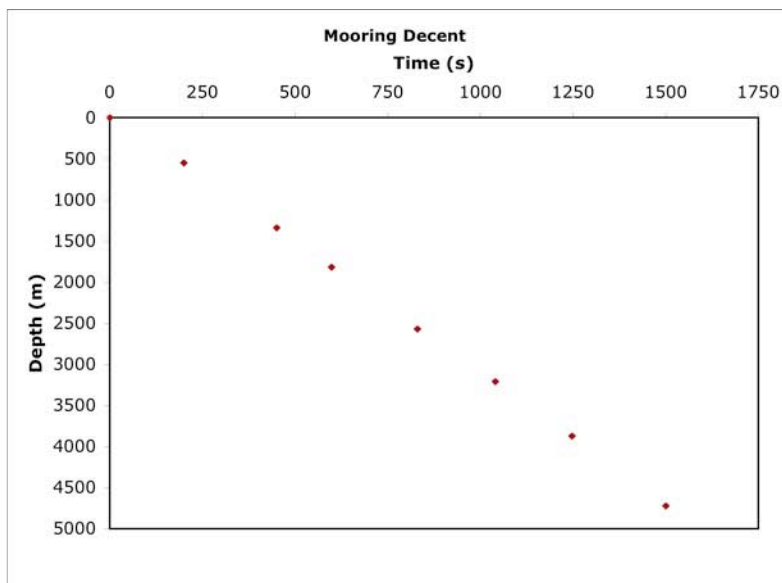
Figure 7 Estimated sink rate of transponder mooring with ~104kg anchor and 46kg buoyancy.

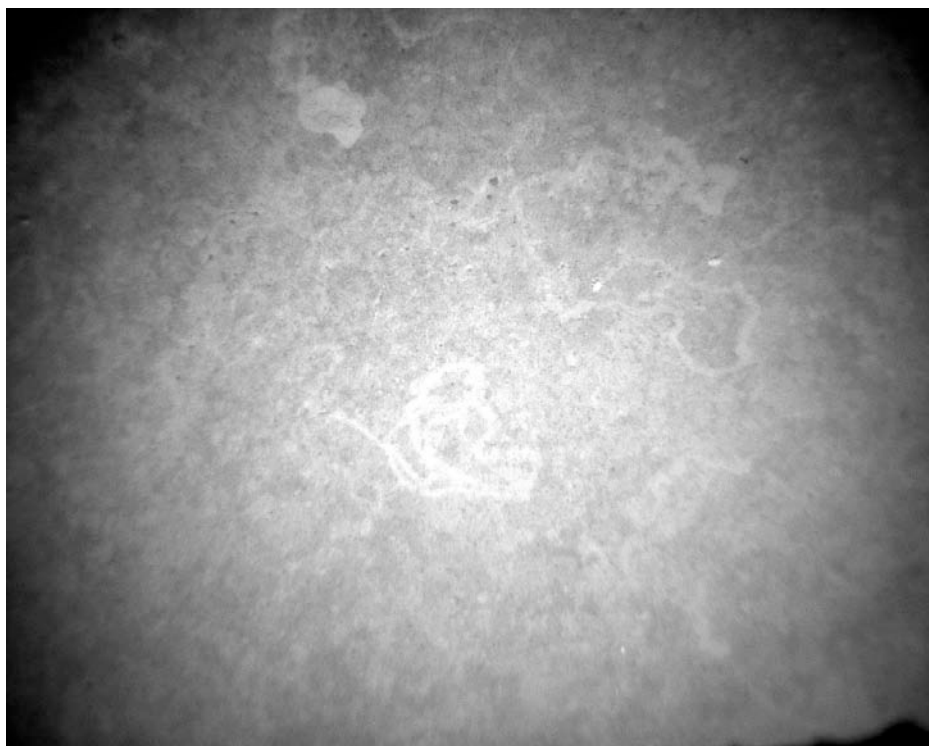
Figure 10 Example image for the Pixelfly camera at an altitude of 8m at 1821Z on 07 May 2007. The scale is ~12m across and ~8m tall. In the centre of the image, the lighter coloured surface mark the tracks of holothurians. Two holothurians can be seen in the upper right of the image, each at the end of their track.

Further Pixelfly camera tests were made from 1743–1828Z. These were most successful. The most suitable exposure setting was 1250 μ s (an example image is shown in Figure 10). More detailed results are presented and discussed in section 4.
